Board of Education Study Session
Monday, June 12, 2023 5:30 PM

Seward Elementary

Condition Summary

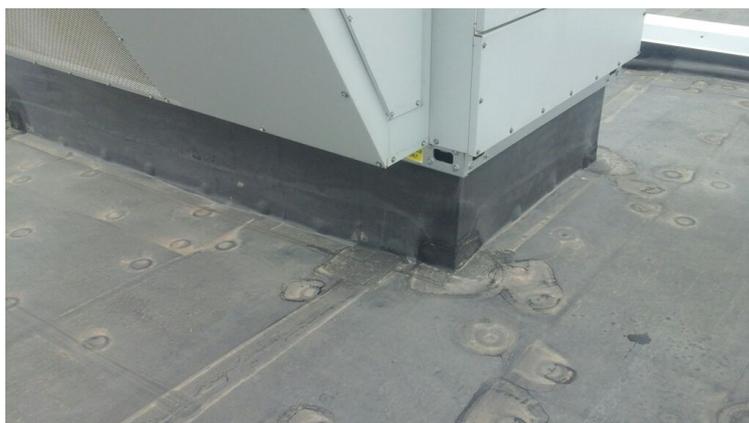
Photo showing condition of projection flashings.

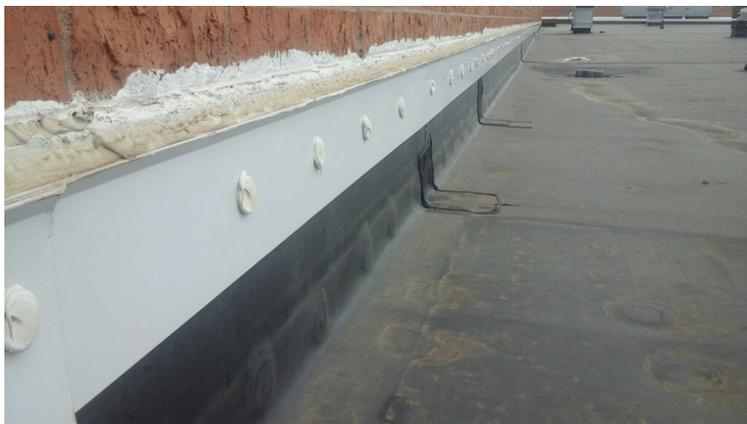
Photo showing condition of the perimeter flashings.

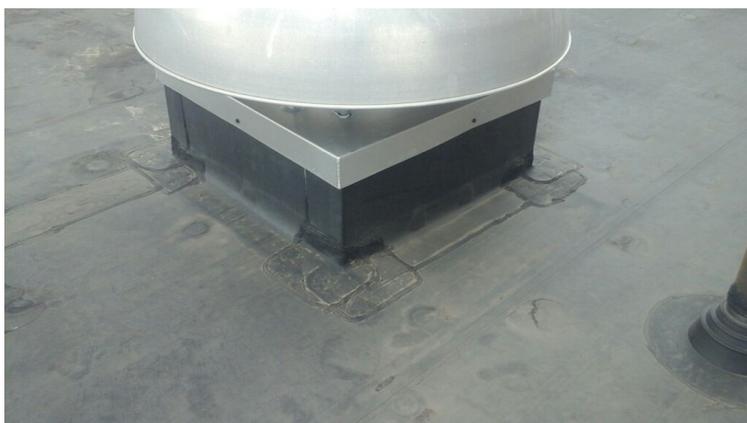
Photo showing condition of projection flashings.

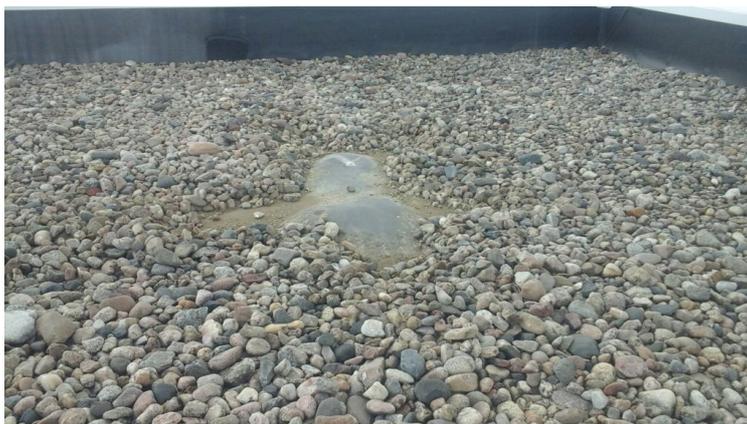
This roof is in fair condition and appears to be performing well. There are several areas where the membrane is being lifted up by extruding insulation.

Photo showing additional area where isolation is extruding against the field membrane.

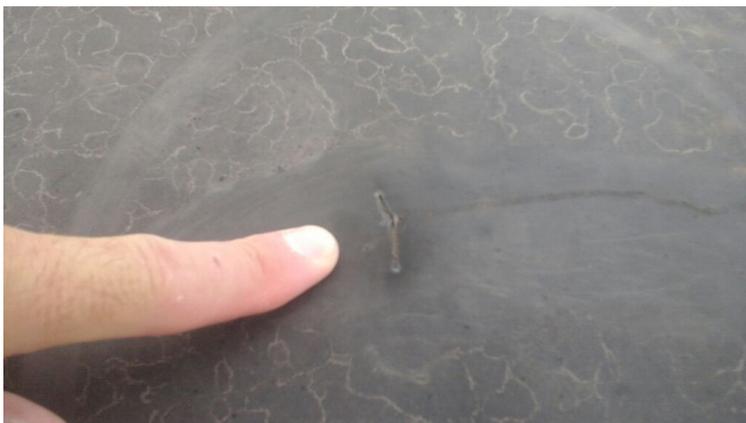
This roof is in good condition. There is some ponding water around the central drain do to missed taper design. There was one hole found in the field membrane.

Photo showing a hole in the field membrane.

I recommend patching hole and continued inspections and maintenance.

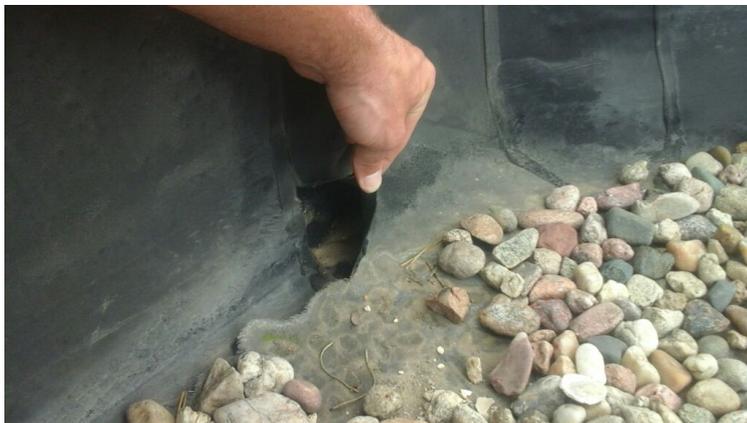
This roof is in fair condition due to the aging and tenting perimeter flashings. There were several areas where flashing patches were pulling loose.

Photo showing patch pulling loose on perimeter flashings.

I recommend repairing holes and monitoring perimeters which may eventually need to be relaxed. I recommend continued inspections and maintenance.

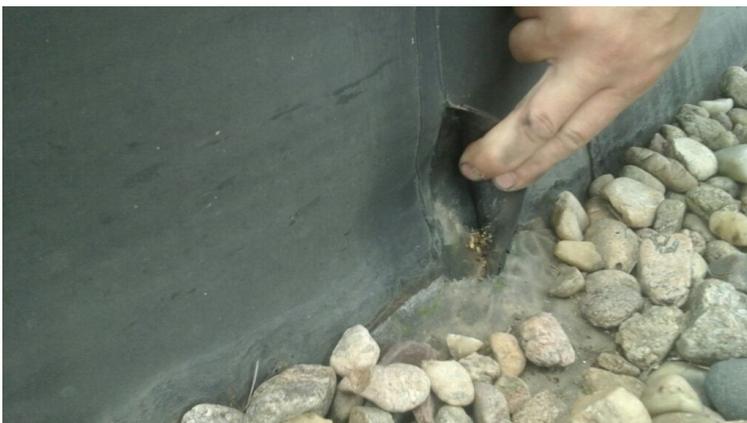
Photo showing patch pulling loose on perimeter flashings.

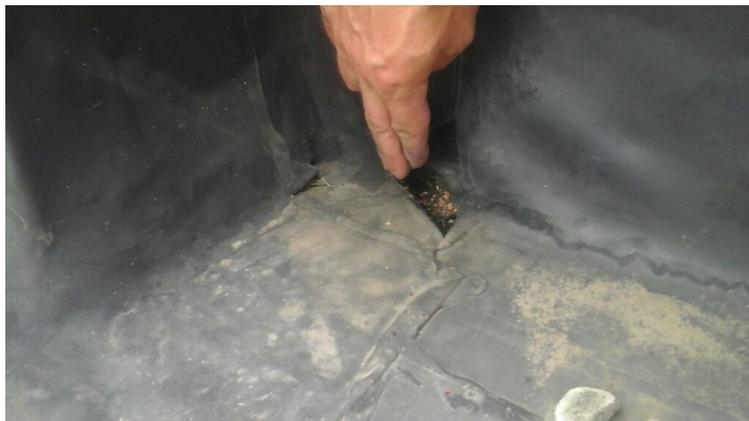
Photo showing a patch pulling loose along the perimeter flashings.

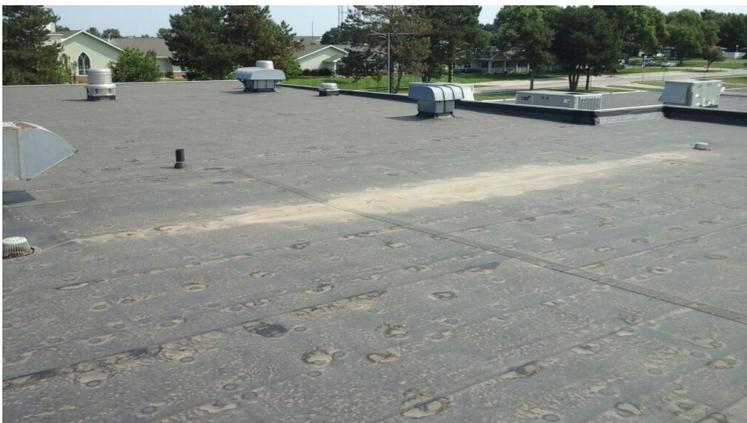
Photo showing evidence of ponding water in the drain valley.

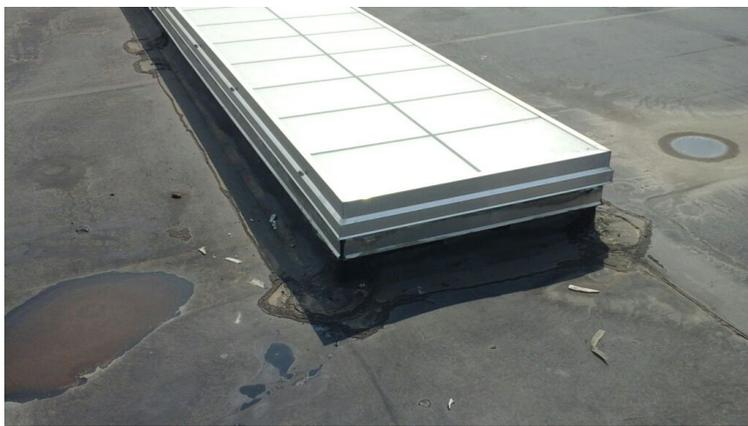
This roof is in good condition and appears to be performing well. There is a persistent leak on the corner of the skylight that is likely caused by excess caulking under the counter flashing.

Photo showing condition of the skylight. Underside of counter flashing is caulked and likely preventing water from escaping. I recommend removing the excess caulking.

I recommend continued inspections and maintenance. I also recommend removing excess caulking to read evaluate skylight leak.

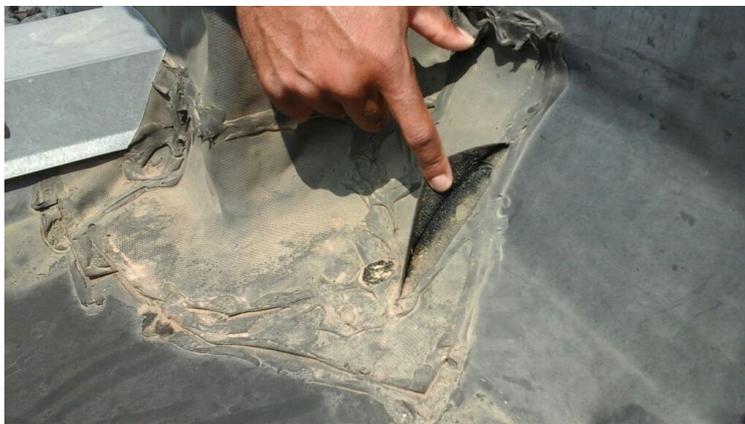
This roof is in fair condition and has deterioration around the projection and perimeter flashing seams due to age.

Photo showing additional blowout patch pulling loose.

I recommend restoring the problem areas in the flashings and continued inspections and maintenance to extend the life of this roof. The estimated budget number for restoring this roof is \$30,000.

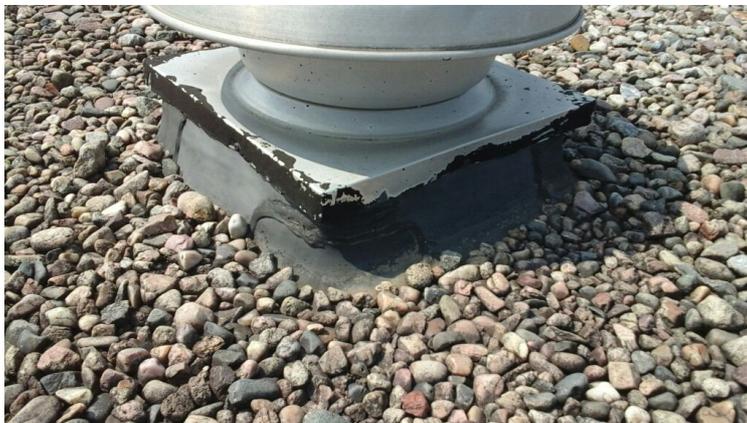
Photo showing condition of projection flashings.

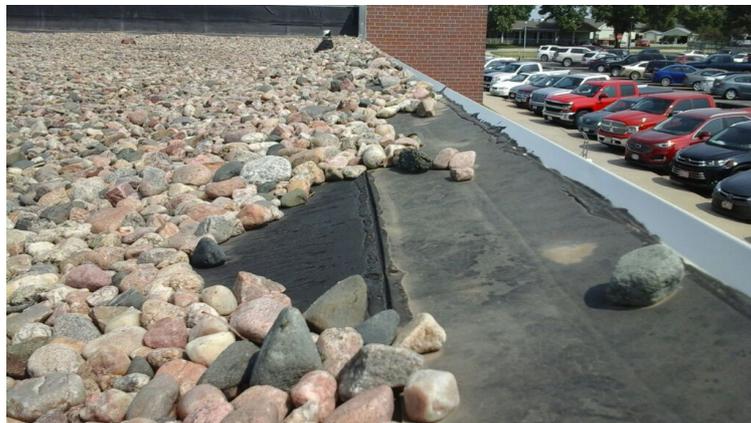
Photo showing condition of form flashing along perimeter edge.

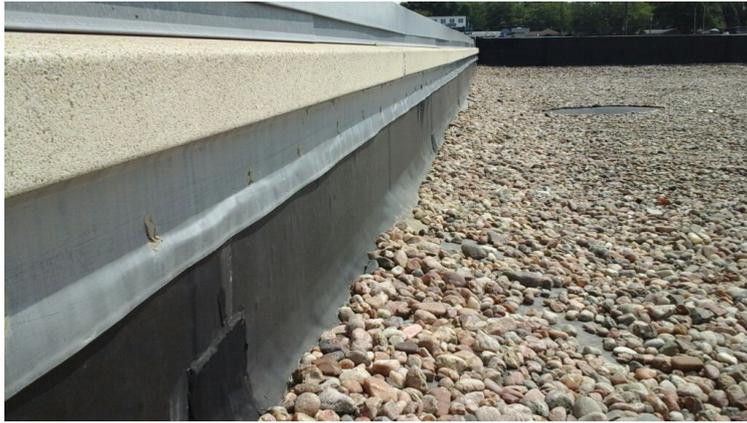
Photo showing condition of the perimeter flashings.

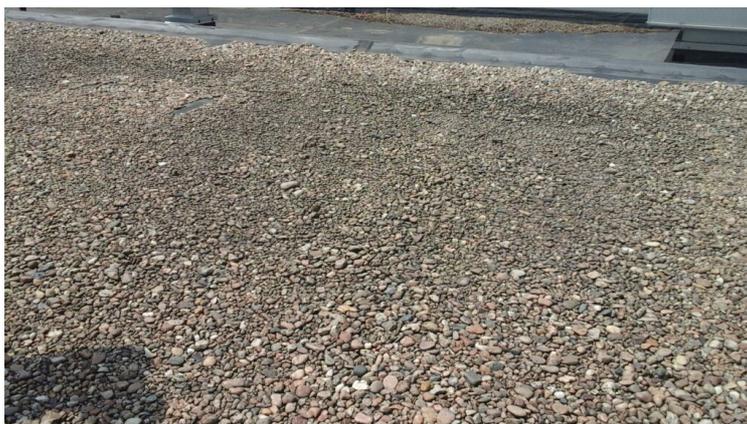
Photo showing evidence of ponding water.

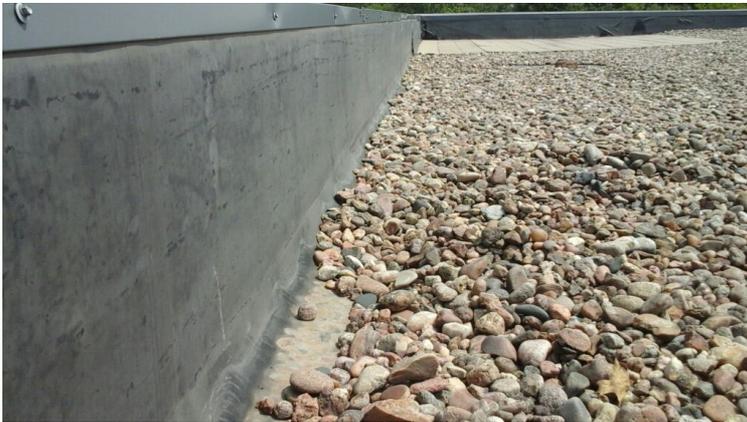
Photo showing condition of the perimeter flashings.

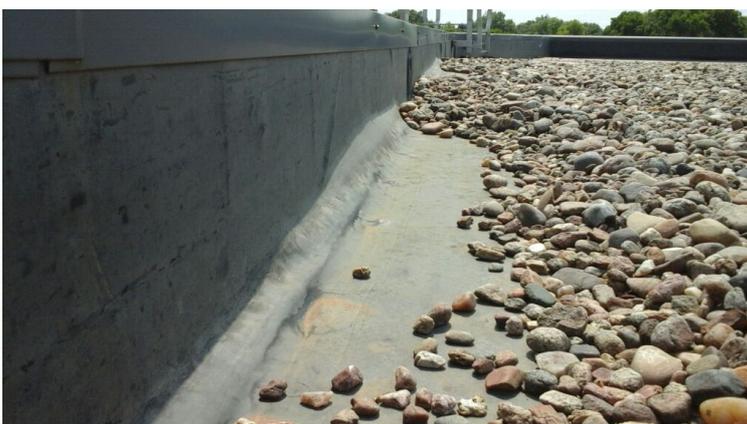
Photo showing minor tenting along the perimeter flashings.

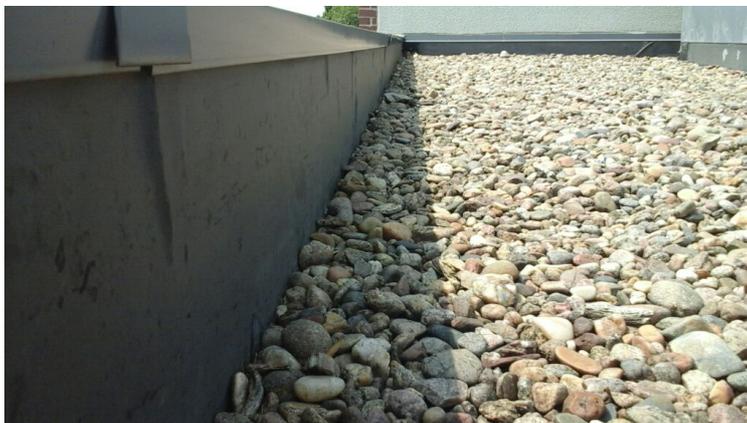
Photo showing condition of the perimeter flashings.

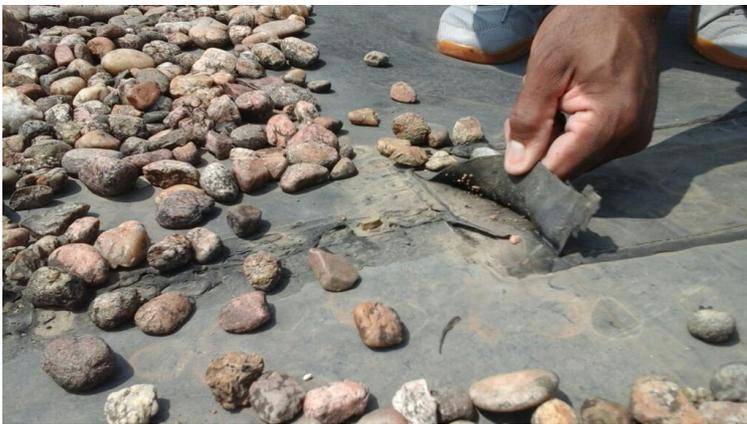
Photo showing patch pulling up along the seam.

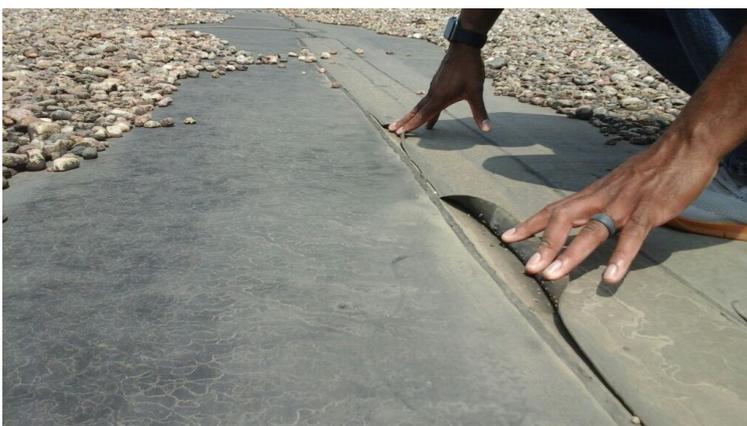
Photo showing patch along seam beginning to pull loose.

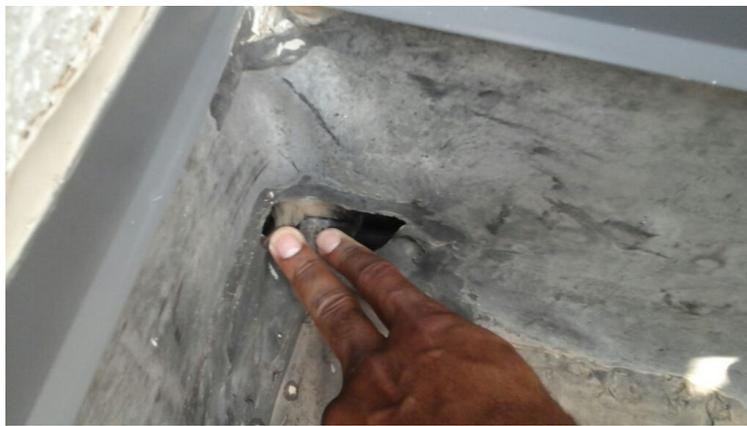
Photo showing patch in the perimeter flashing pulling loose.

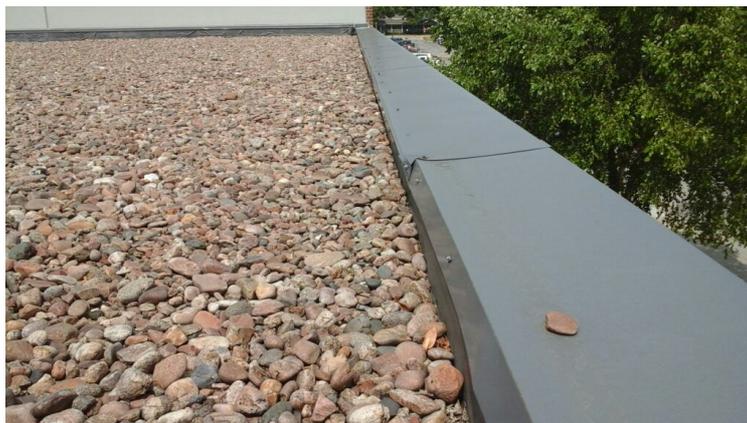
Photo showing mismatched metal sizes.

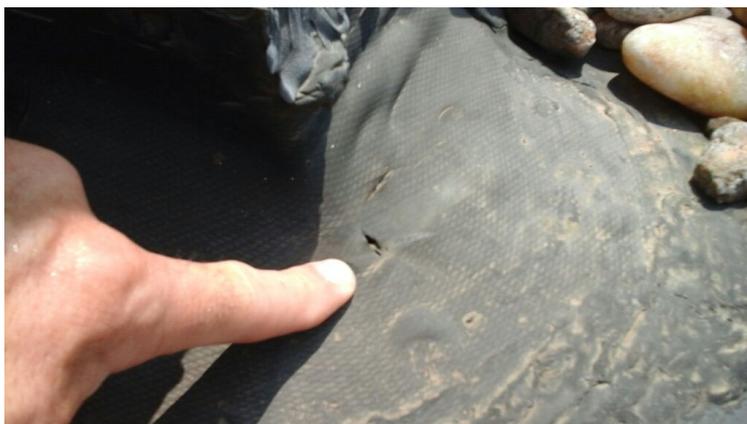
This roof is in good condition and appears to be performing well. There was one hole found in the projection flashing.

Photo showing a hole in the projection flashing.

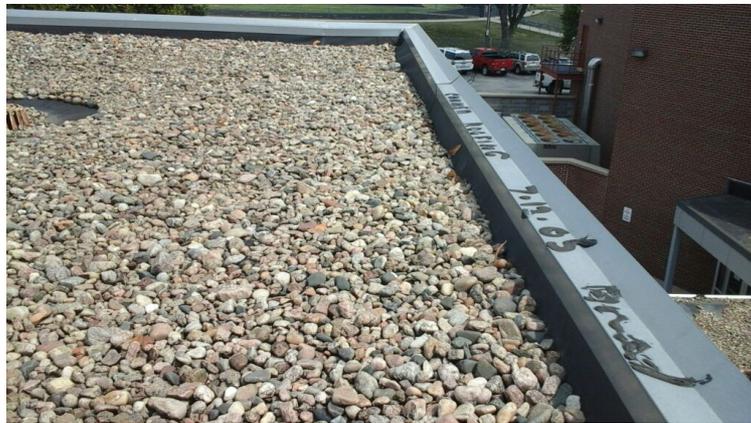
This roof is in fair condition and is beginning to tent and deteriorate along the perimeter flashings.

Photo showing condition of perimeter flashings.

I recommend restoring the perimeter flashings along with continued inspections and maintenance.
