BOX BUTTE COUNTY SCHOOL DISTRICT #07-0010
HEMINGFORD PUBLIC SCHOOLS
BOARD OF EDUCATION MEETING AGENDA
Tuesday, September 10, 2024
South Campus

FACILITY ASSESSMENT & ENERGY AUDIT

MECHANICAL, ELECTRICAL, PLUMBING, FIRE
PROTECTION & TECHNOLOGY SYSTEMS

Hemingford High School (7th – 12th)

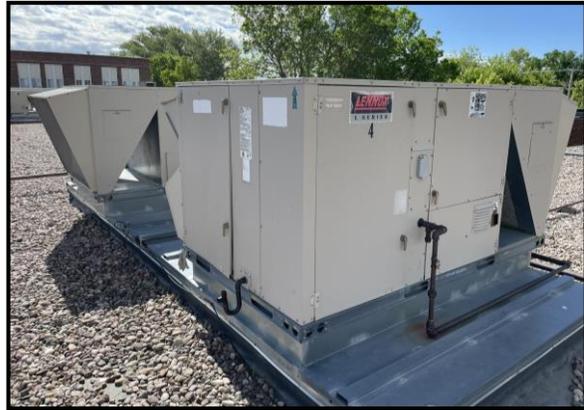
2. 1966 High School: This area is served by four (4) packaged rooftop units (RTUs) with direct expansion (DX) cooling and natural gas heat exchangers. The RTUs were installed circa 2001 and have exceeded their expected 15-year service life.

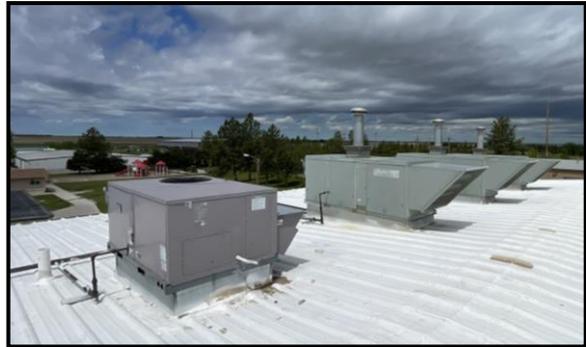
1. Original 1975 Building: This area is served by four (4) gas fired unit heaters. There is no means of mechanical cooling for the gym. Ventilation is provided by a sidewall propellor exhaust fan and makeup louver.
2. 1997 Lobby Addition: The lobby and concessions areas are served by a vertical FCU with a natural gas heat exchanger installed in 2020. There are no means of mechanical cooling in these areas.
3. 2003 Locker Room Addition: This area of the building is served by a packaged RTU with DX cooling and natural gas heating for the stage and three (3) heating only makeup air units (MAUs) to serve the locker rooms and wrestling room. All equipment was installed in 2003 and has exceeded its expected 15-year service life.

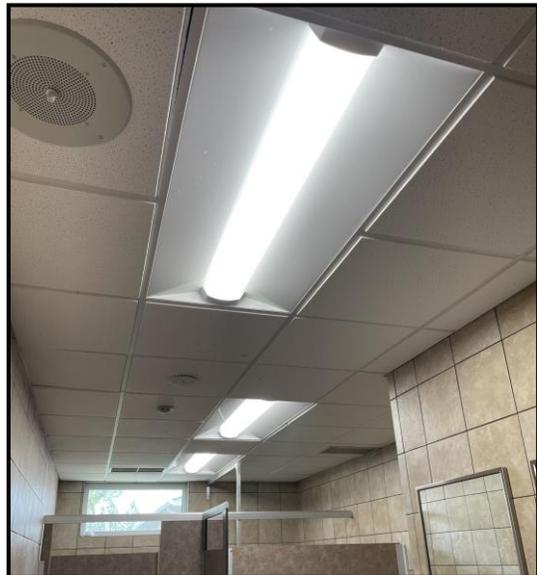
3. 1966 High School: The existing lighting in the corridors is lensed fluorescent wraps that are surface mounted. The restrooms have been remodeled and have recessed architectural volumetric LED troffers and ceiling mounted occupancy sensor. The existing lighting in the classrooms are architecturally lensed fluorescent wraps that are surface mounted. The classrooms have multizone manual switching and some have ceiling mounted occupancy sensors. The mechanical and electrical rooms have screw based incandescent lamp sockets. The exterior lighting appears to be metal halide. Other than the few classrooms and restrooms, no other areas appear that the lighting controls within the area meet current energy code requirements for automatic lighting control.

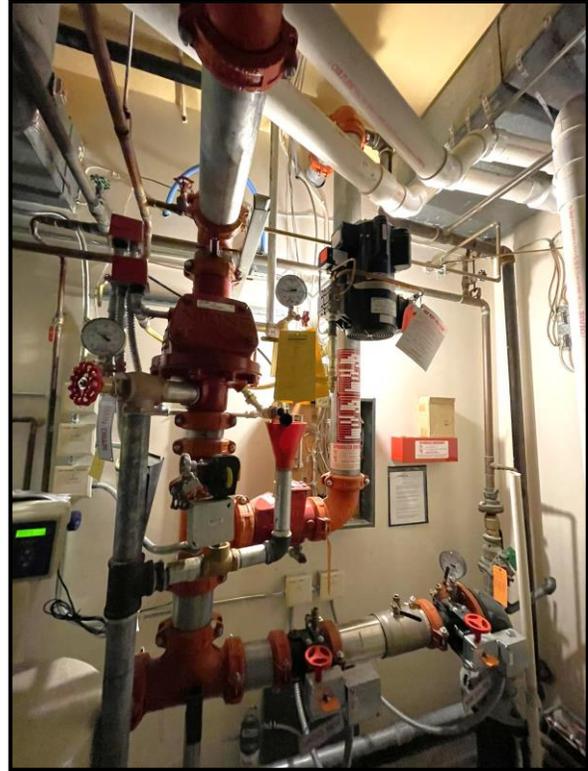
- A. The Main School Building is equipped with a dry pipe automatic fire sprinkler system that appears to be designed in accordance with NFPA 13 but only serves a limited portion of the facility (1980 Administration and 2014 Commons). All other areas of the building are unprotected.
- B. The Gymnasium is equipped with an automatic fire sprinkler system that appears to be designed in accordance with NFPA 13 and provides protection for the entire facility.
- C. None of the other buildings were equipped with a fire protection system.

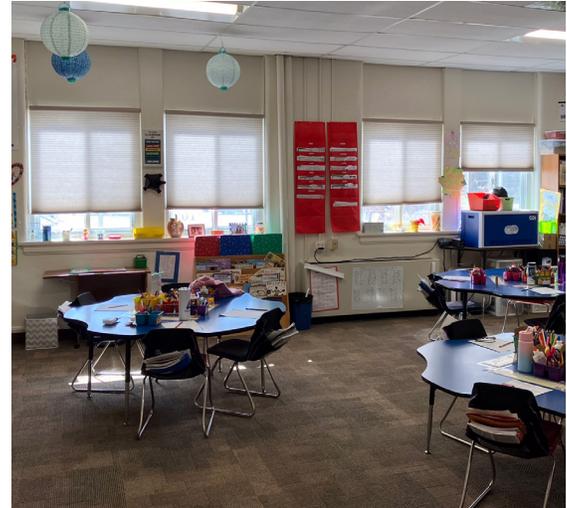
Four single-pane windows in a classroom on the lower level.

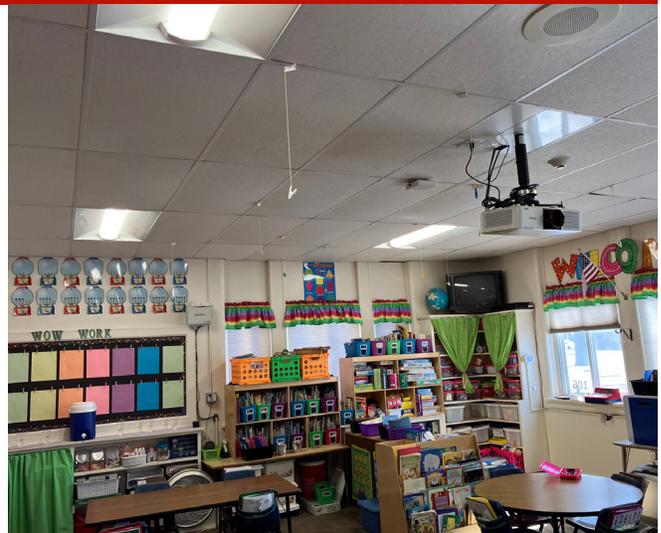
Typical classroom with cluttered areas of storage added with furniture.

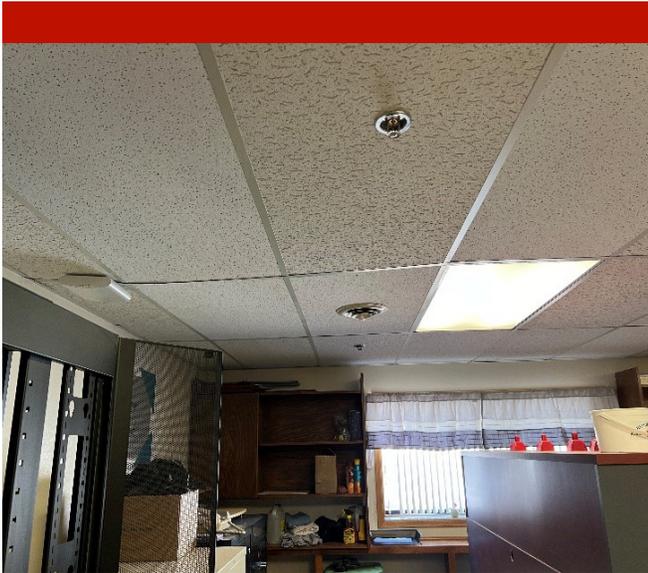
Excessive ceiling deflection in Room 309.
