3.b. Discussion and action report on the structural status report from Erickson Sullivan Architect (ESA) of the Marcellus building project for the NAHTF grant.

## OBSERVATION REPORT

**PROJECT:** Franklin Apartments

**DATE:** May 19, 2025

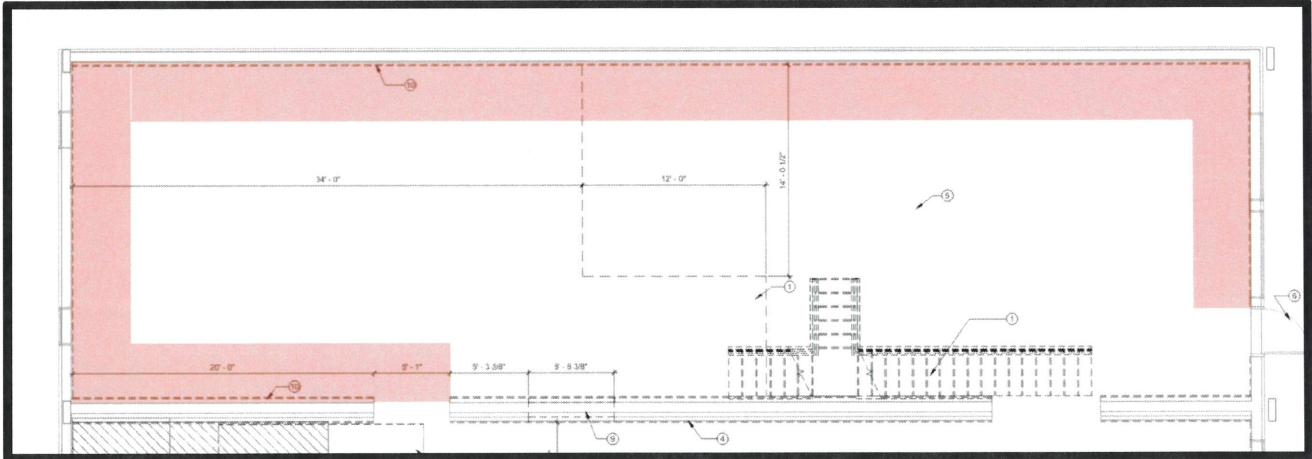
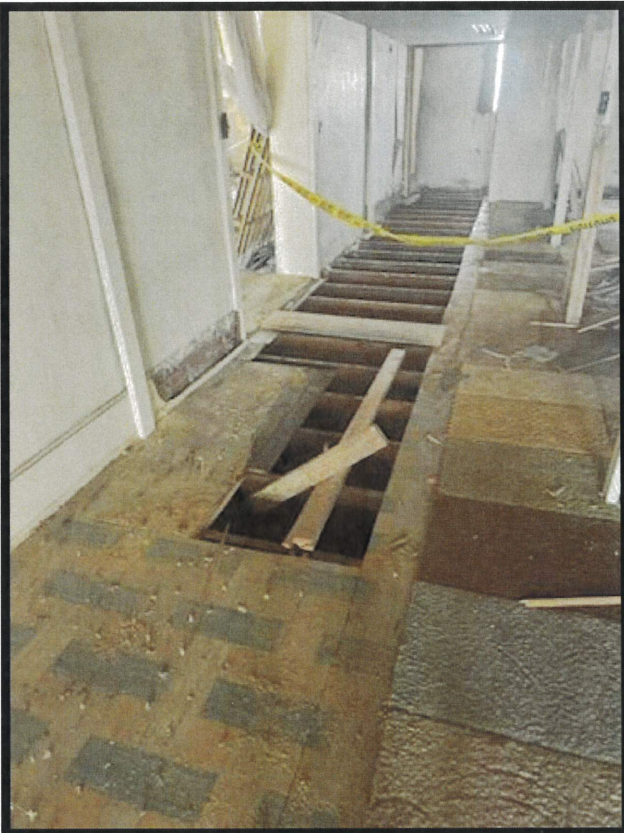
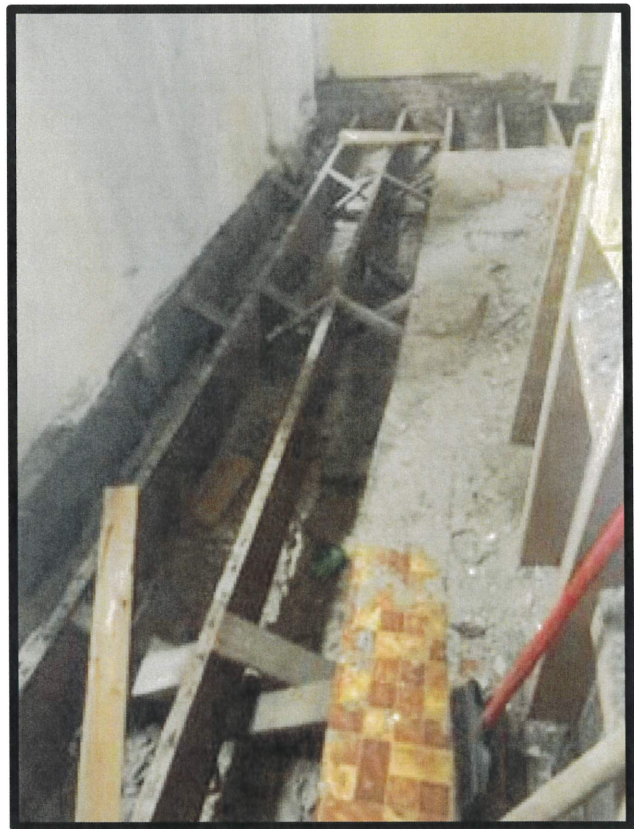
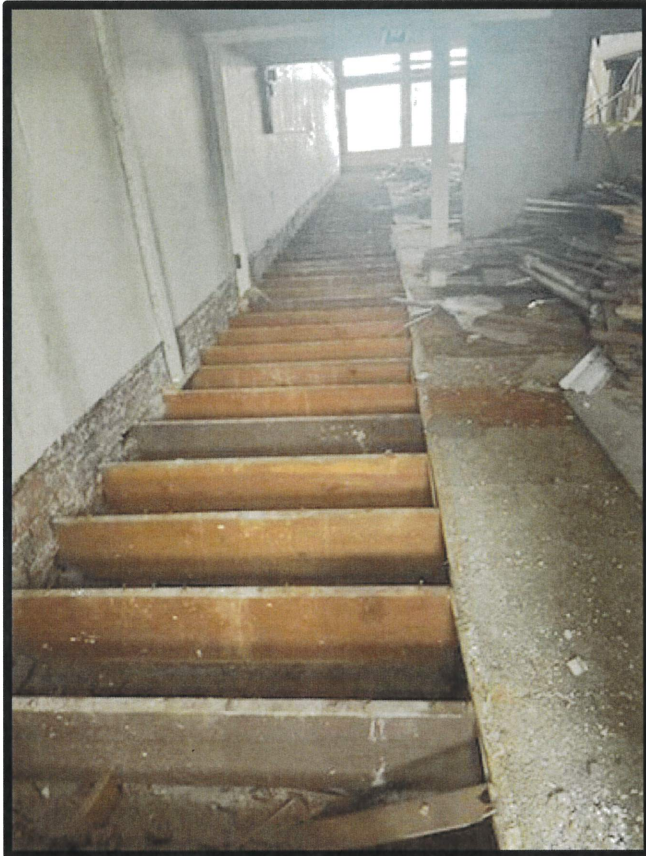
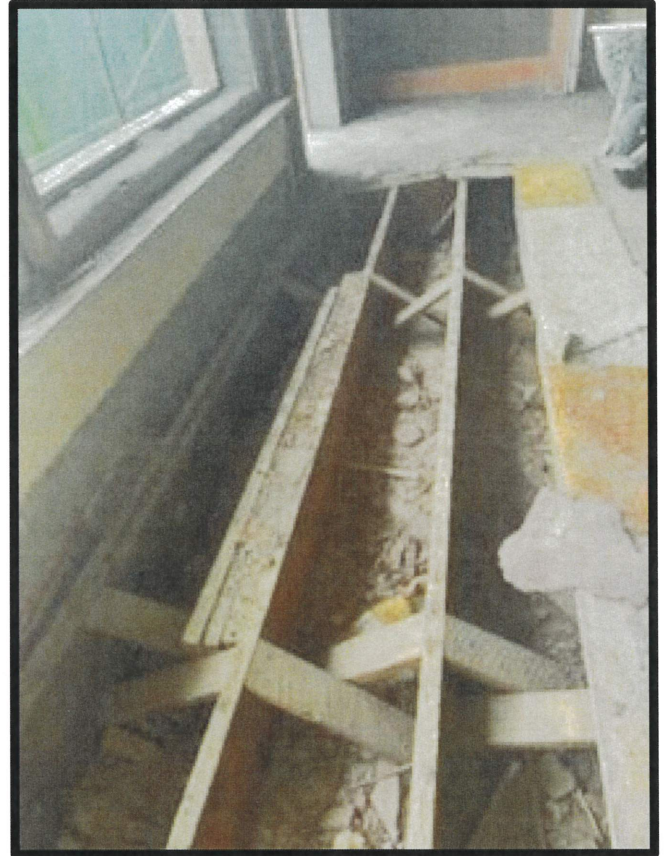
Midwest Plaster & Construction has proceeded with removing some of the existing floors in the north portion of the 1st floor. It is approximately 4' wide and to the extent depicted in the drawing and pictures.

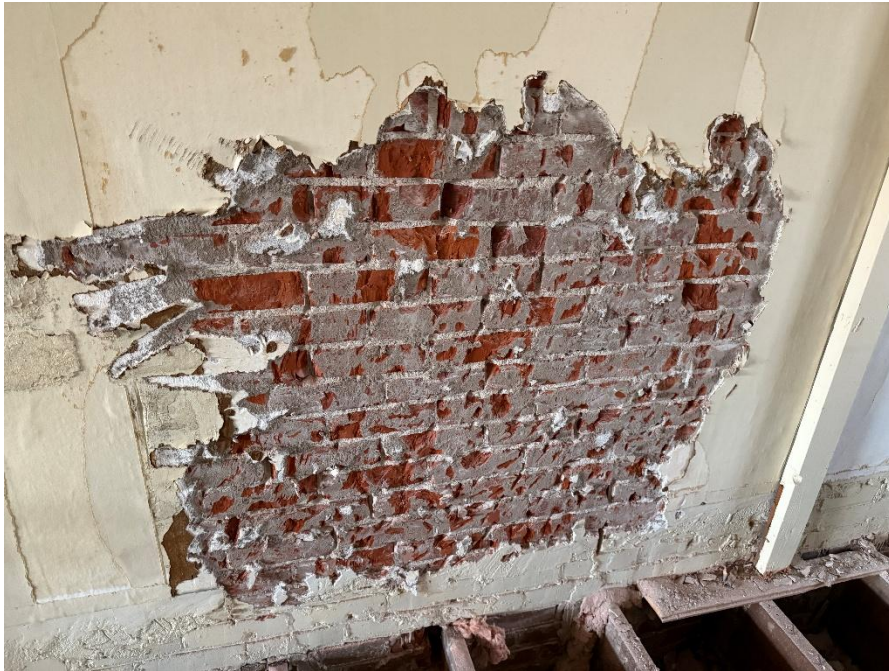
1. The interior of the brick was covered with what appeared to be the original plaster coating. Subcontractors were working on removing the plaster on the first floor. It was evident that the plaster was still well-bonded in locations. The demo subcontractor was directed to stop using the power tools to remove the plaster in these locations as the brick was being damaged to remove the plaster. See photo 1.

Photo 1 - Plaster removal at north face of intermediate first floor brick wall.

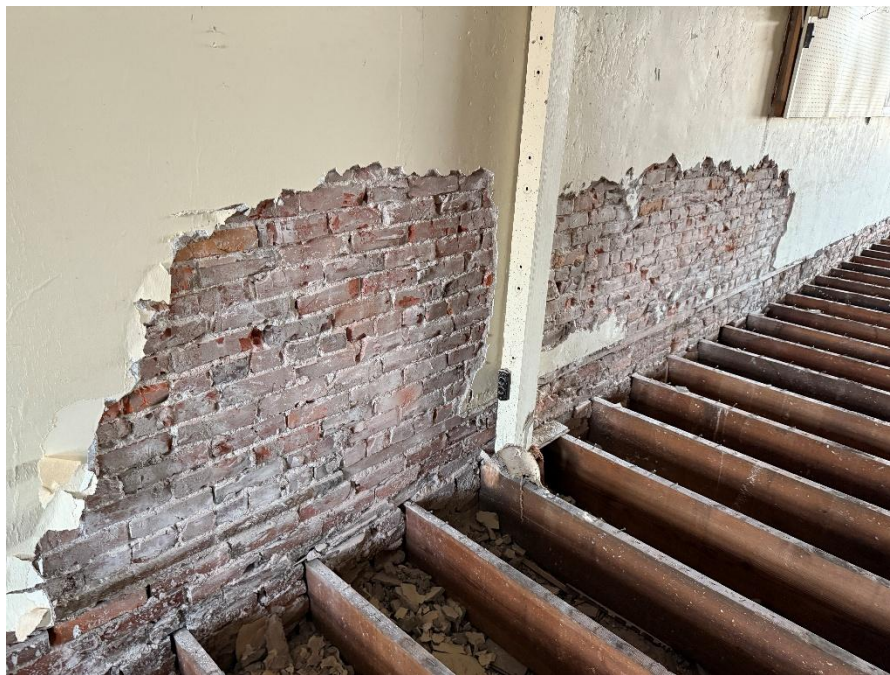
2. The plaster on the inside face of the first-floor north wall was more easily removed. See photo 2. The demo subcontractor was directed to focus on the areas that were loose and easily removed.

Photo 2 - Plaster removal at first floor north brick wall.

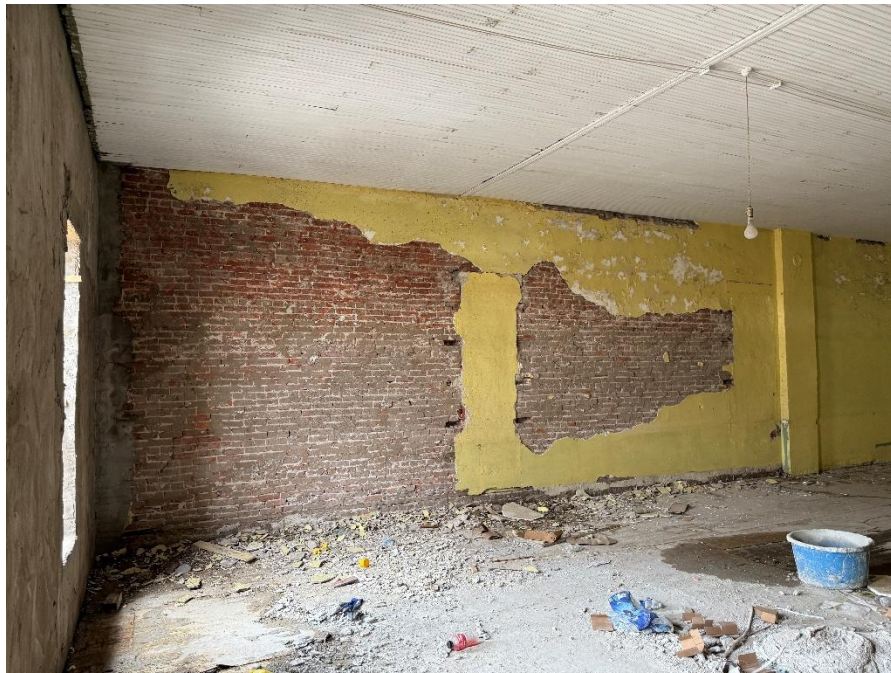
3. Larger areas of plaster had been removed from the north wall on the second floor. More areas are loose on this wall, requiring removal. See photo 3.

Photo 3 - Plaster removal at second floor north wall.

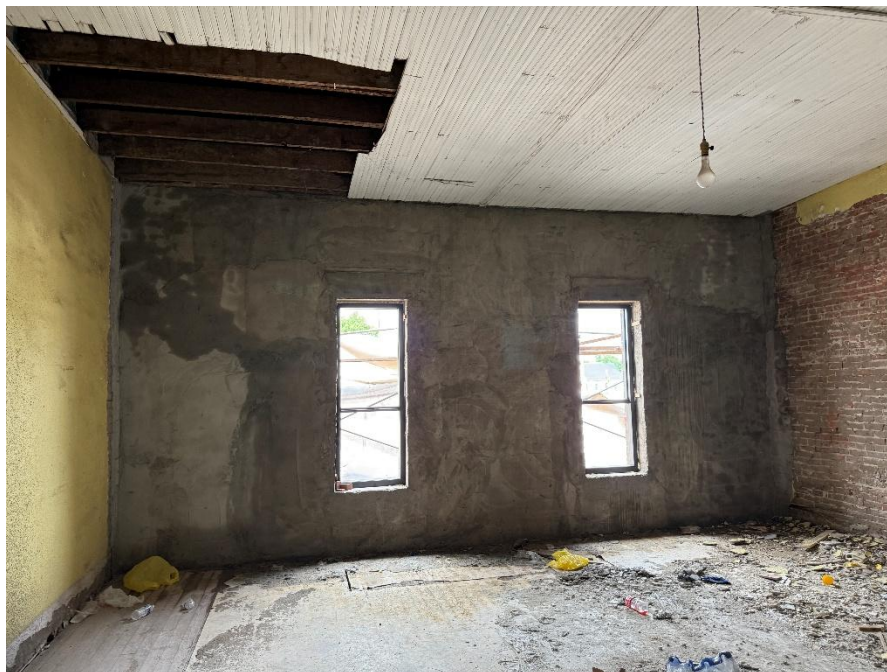
4. The second-floor west wall has been coated with a cementitious product. It appears to be shotcrete by the contractor working on the building exterior. See photo 4.

Photo 4 - Coated west second floor wall.

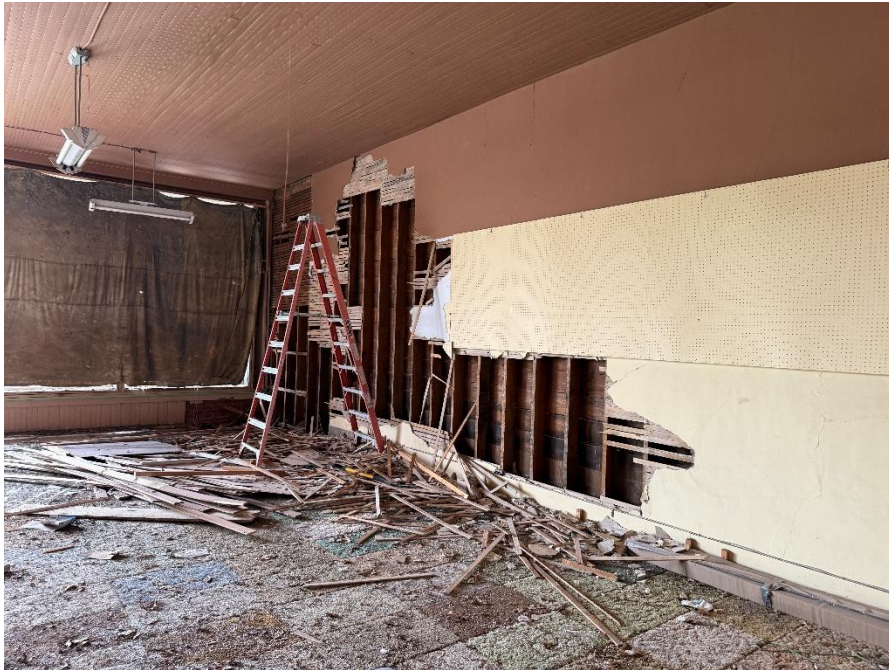
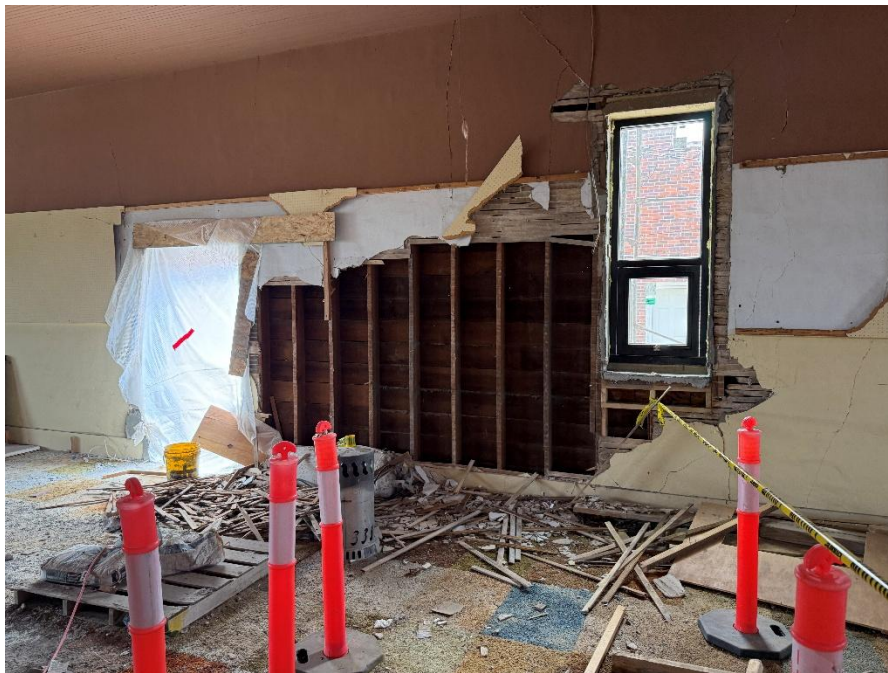
5. Portions of plaster were removed from the interior of the first-floor south wall while I was on site. See photos 5 & 6.
6. The plaster was removed from the second-floor wall framing. See photo 7.
7. Some lag screws were visible at both levels. These were random and the ones that visibly missed studs. They appeared to be 1/4" diameter screws of varied lengths. See photos 8 & 9.

Photo 5 - East end of south first floor wall.

Photo 6 - South first floor wall.

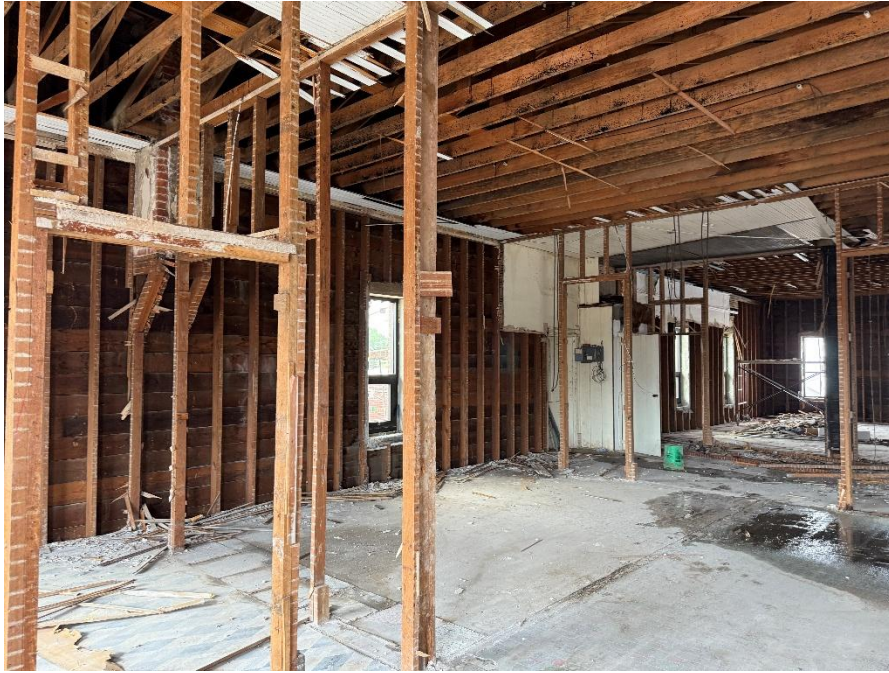
Photo 7 - Second floor wall framing.

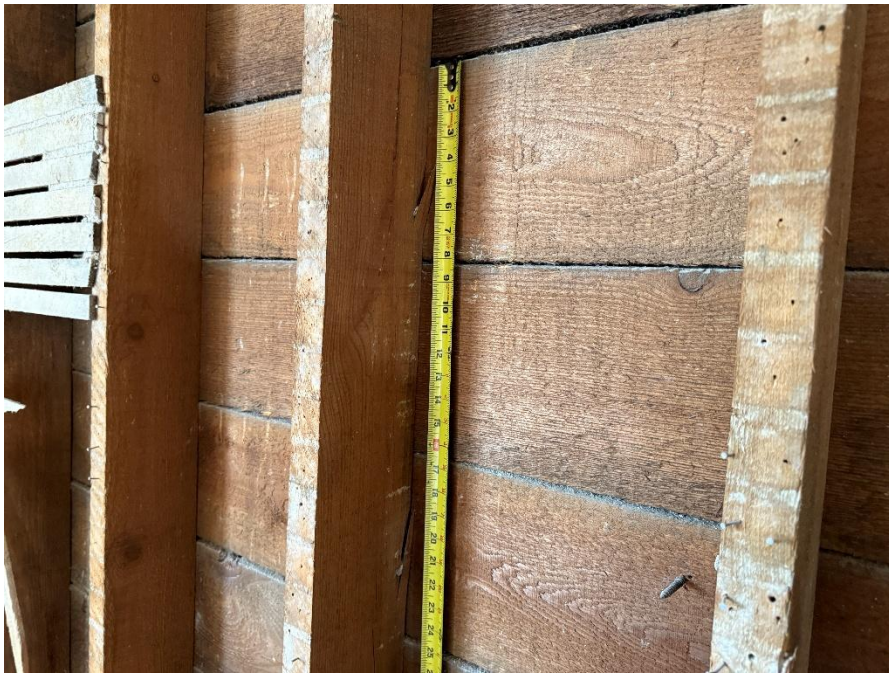
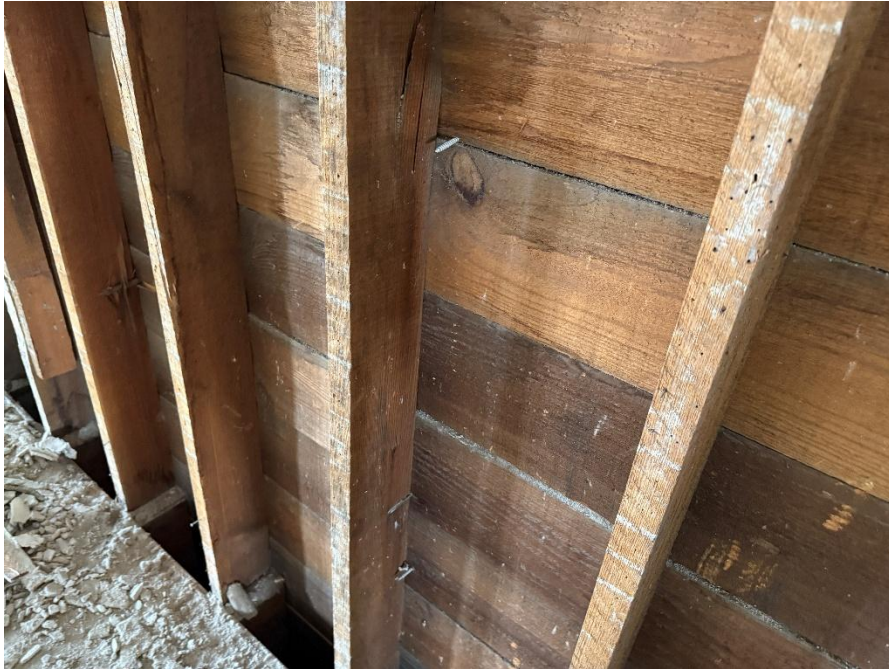
The calculated wind pressure for fasteners on the walls is approximately 38psf (LRFD)/23psf (ASD). Assuming a  $\frac{1}{4}$ " diameter screw was embedded  $1\frac{1}{2}$  inches, excluding the tapered tip, the allowable withdrawal capacity of the lag screw is approximately 195 lbs. Comparing these values, lag screws of this diameter and embedment can resist approximately 8.5 square feet of wind load on the wall per anchor. This would be an area approximately 16" wide and 6 feet 4 inches high per anchor. If the screws were installed as assumed and spaced equal to or less than that noted, the anchorage of the exterior wall modifications back to the wood framing should be adequate.

Photo 8 - Lag screws exposed at south wall.

Photo 9 - Exposed lag screws at south wall.

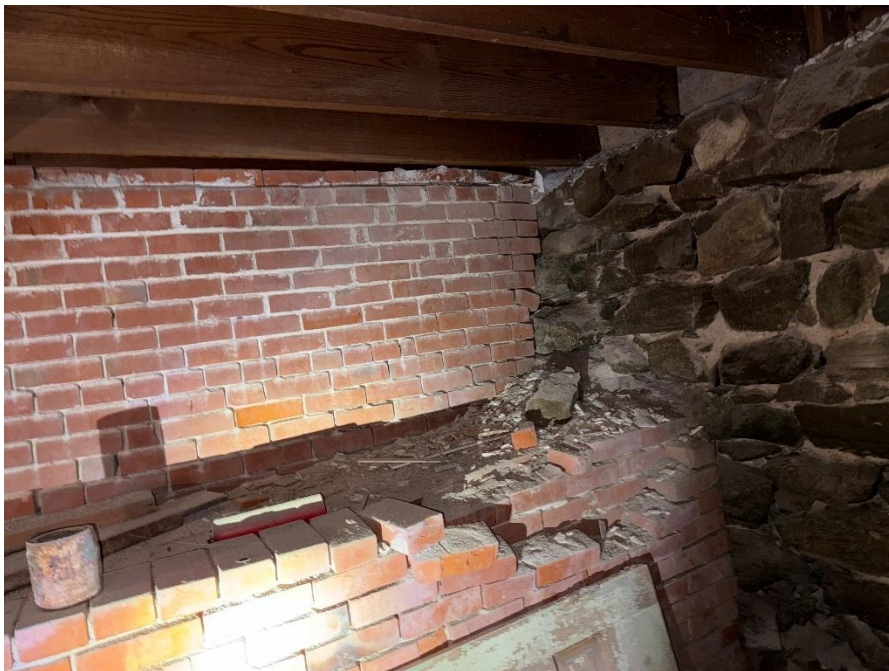
8. The basement was limited to approximately 30 feet of the west end of the south building. The remaining area to the east was crawlspace. The exterior walls were limestone. The center wall was approximately 20 inches thick. A brick wall was present dividing the basement from the crawlspace. See photo 10.

Photo 10 - Basement looking southeast.

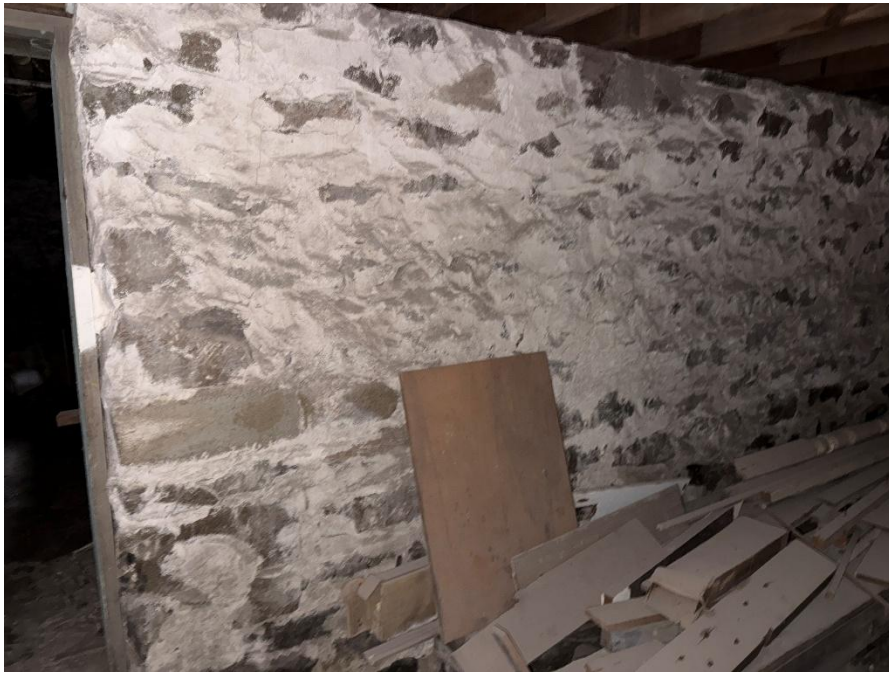
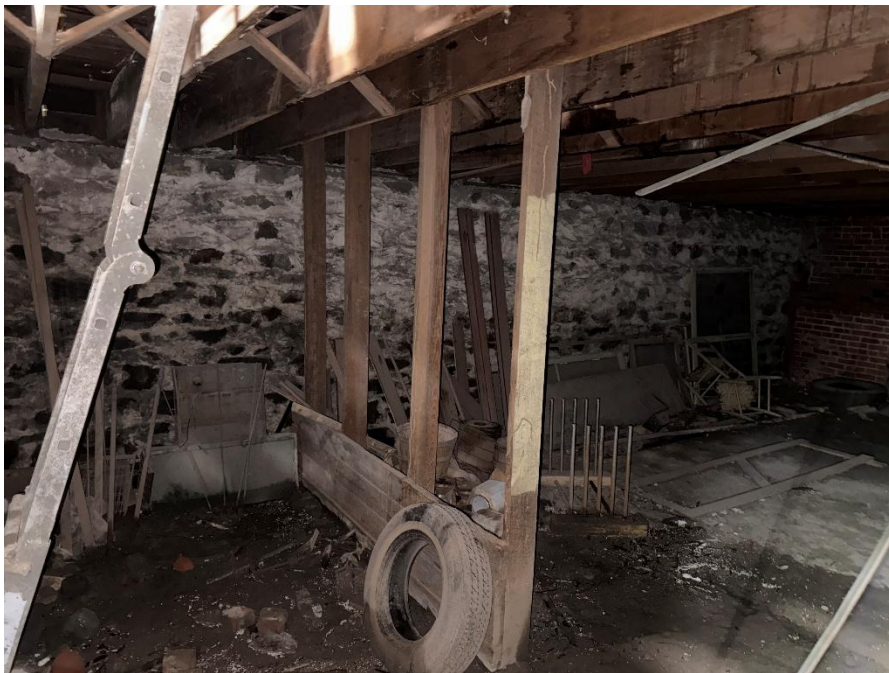
9. The interior wall and north wall have been previously repointed/mortared. See photos 11 & 12.
10. The south basement wall had severely weathered mortar joints, most likely due to the adjacent alley. See photo 13. This wall requires repair. A detail for this will be provided separately.
11. One of the first-floor joists near the west end of the building was split at a knot and requires repair or replacement. See photo 14. This shall be sistered with an  $1\frac{3}{4} \times 11\frac{1}{4}$  LVL like the floor above.
12. The second first floor joists in from the west wall at the north building was rotted at the north end. See photo 15. This requires repair. A detail for this will be provided separately.

Photo 11 - Interior stone wall.

Photo 12 - North basement wall.

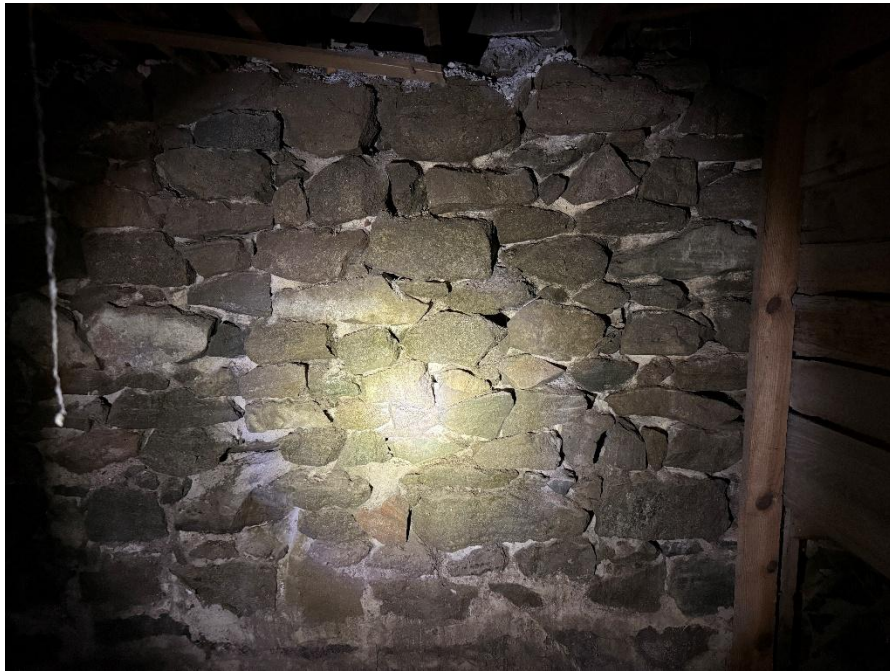
Photo 13 - South basement wall.

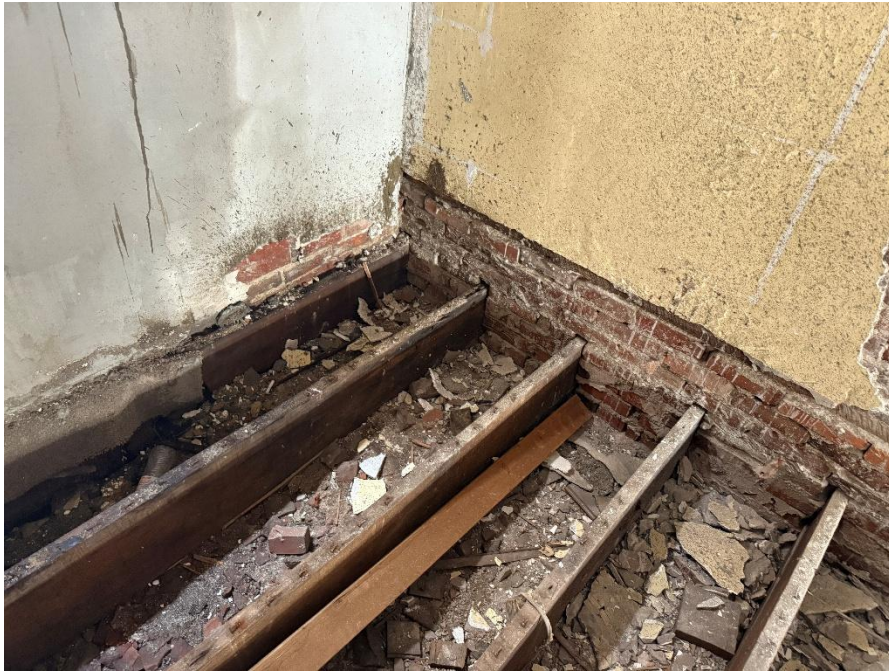
Photo 15 - Second first floor joists in from the west wall at the north building.

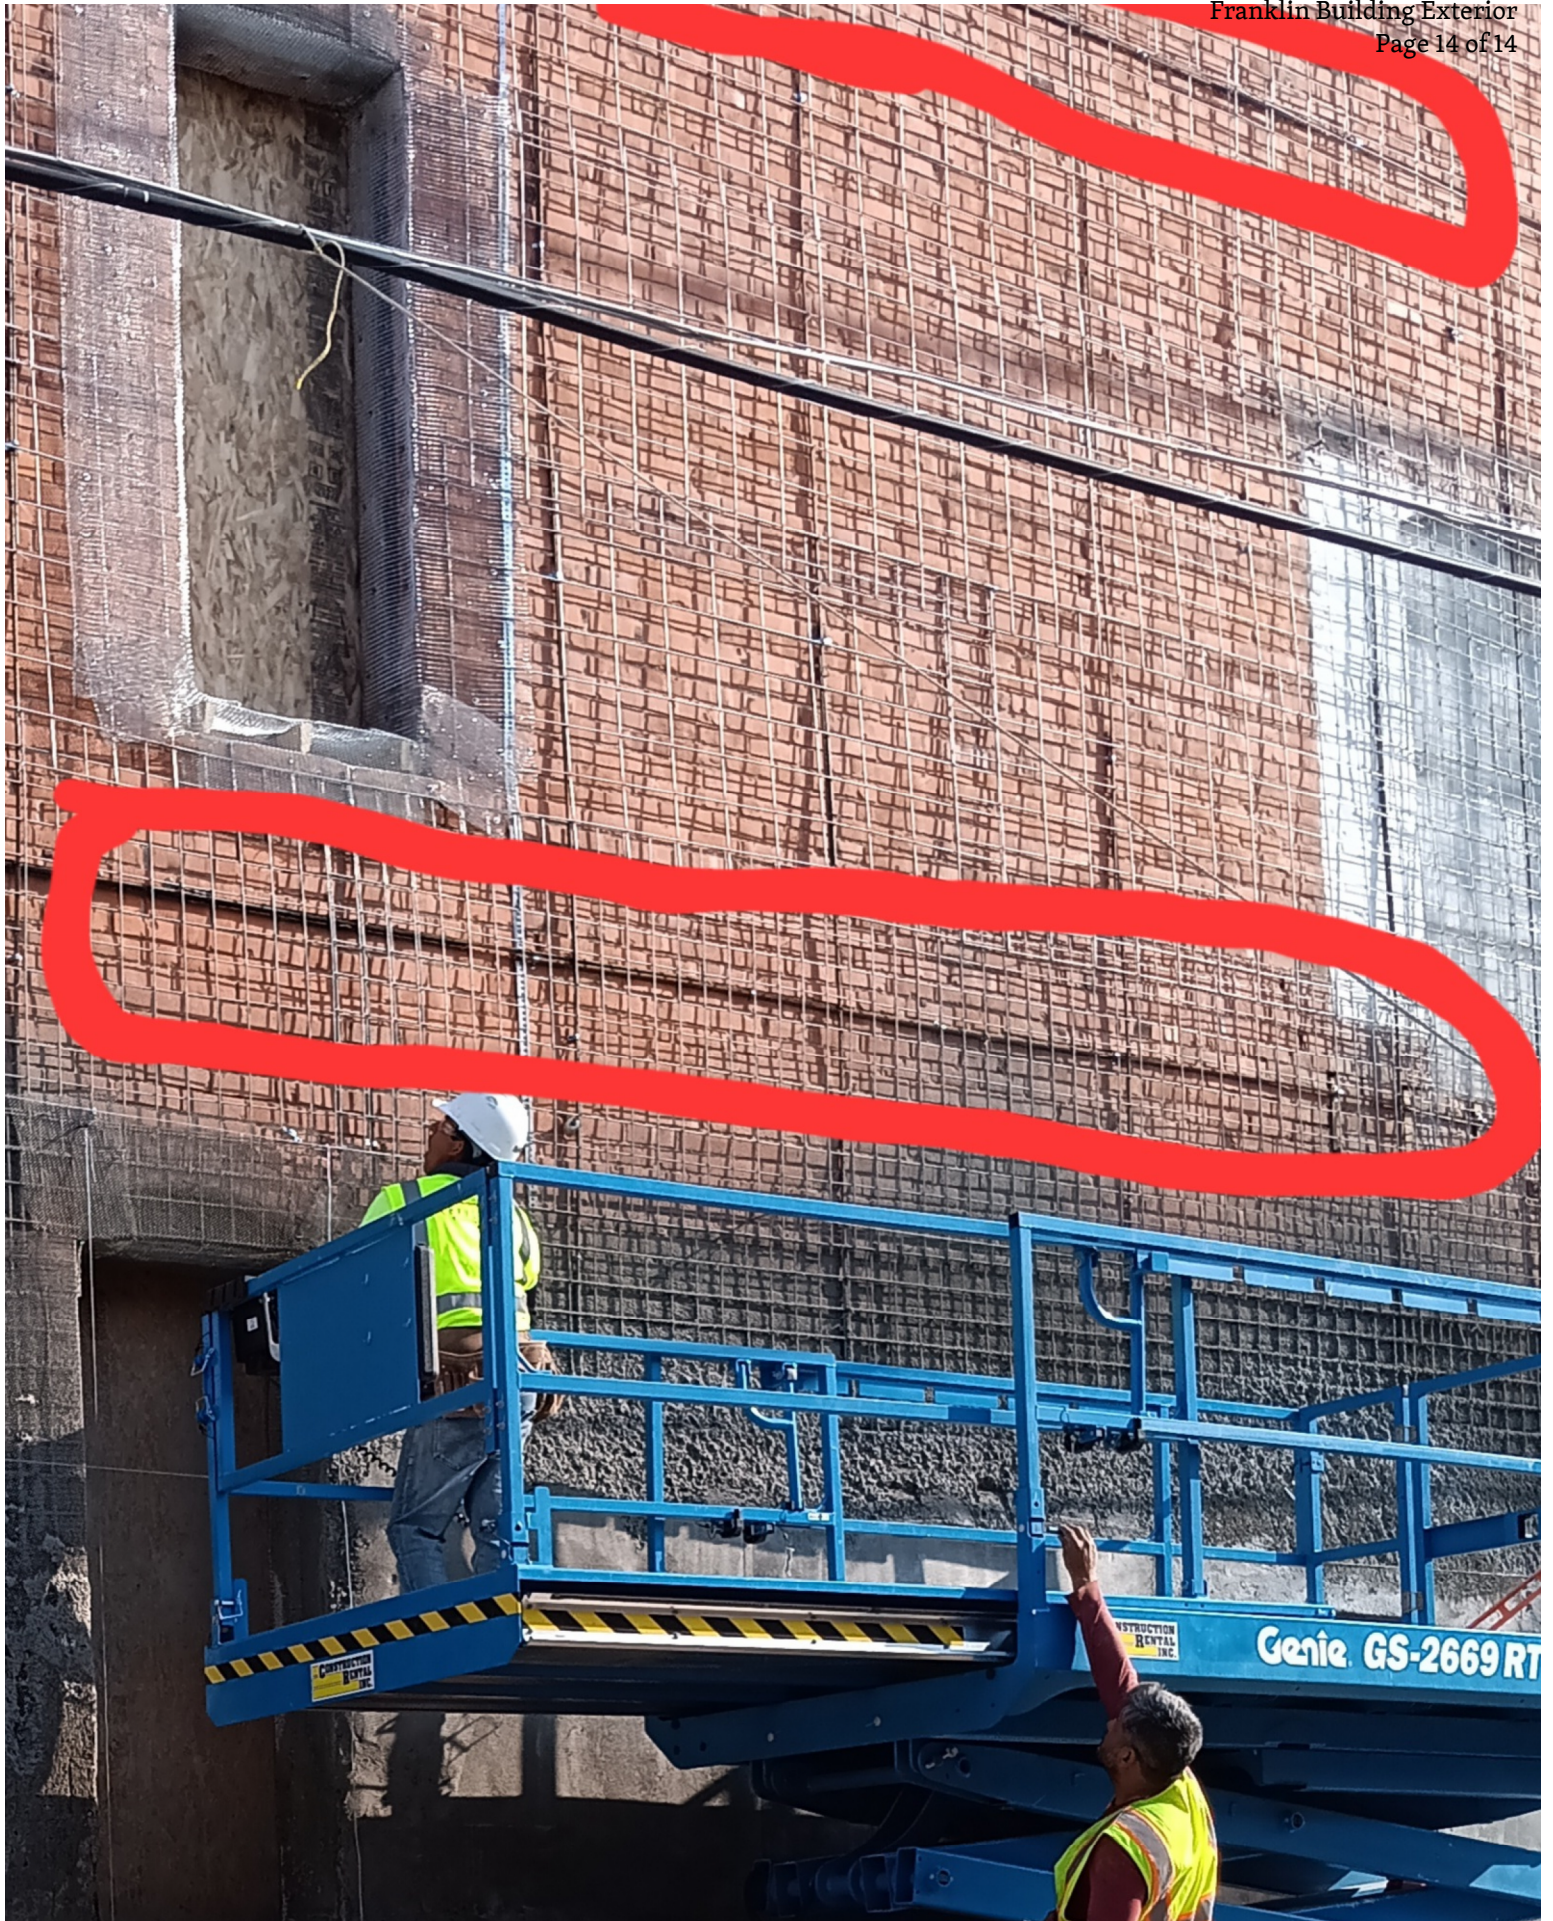
In the email communication and photo dated January 22 & 23<sup>rd</sup>, 2025 (attached), it was noted that mechanical fasteners were installed at 16 inches on center and there were areas circled in the photo. That was not clear whether that was 16" o.c. in one or both directions or how much embedment into the stud framing was achieved with the fasteners.

Grid system is screwed back into original 2x8 wall 16 on Center with 10 inch mechanical fastener 1200 lb per square inch resistance fasteners fasten to Interior floor joists for stabilization
