**RE: Centennial High School East and the Link
Short-Term Radon Testing Results
IEA Project #202511177**

The Institute for Environmental Assessment, Inc. (IEA) placed 169 Air Chek Pro Chek short-term radon test kits in 148 locations in Centennial High School East & The Link for the purpose of evaluating radon levels.

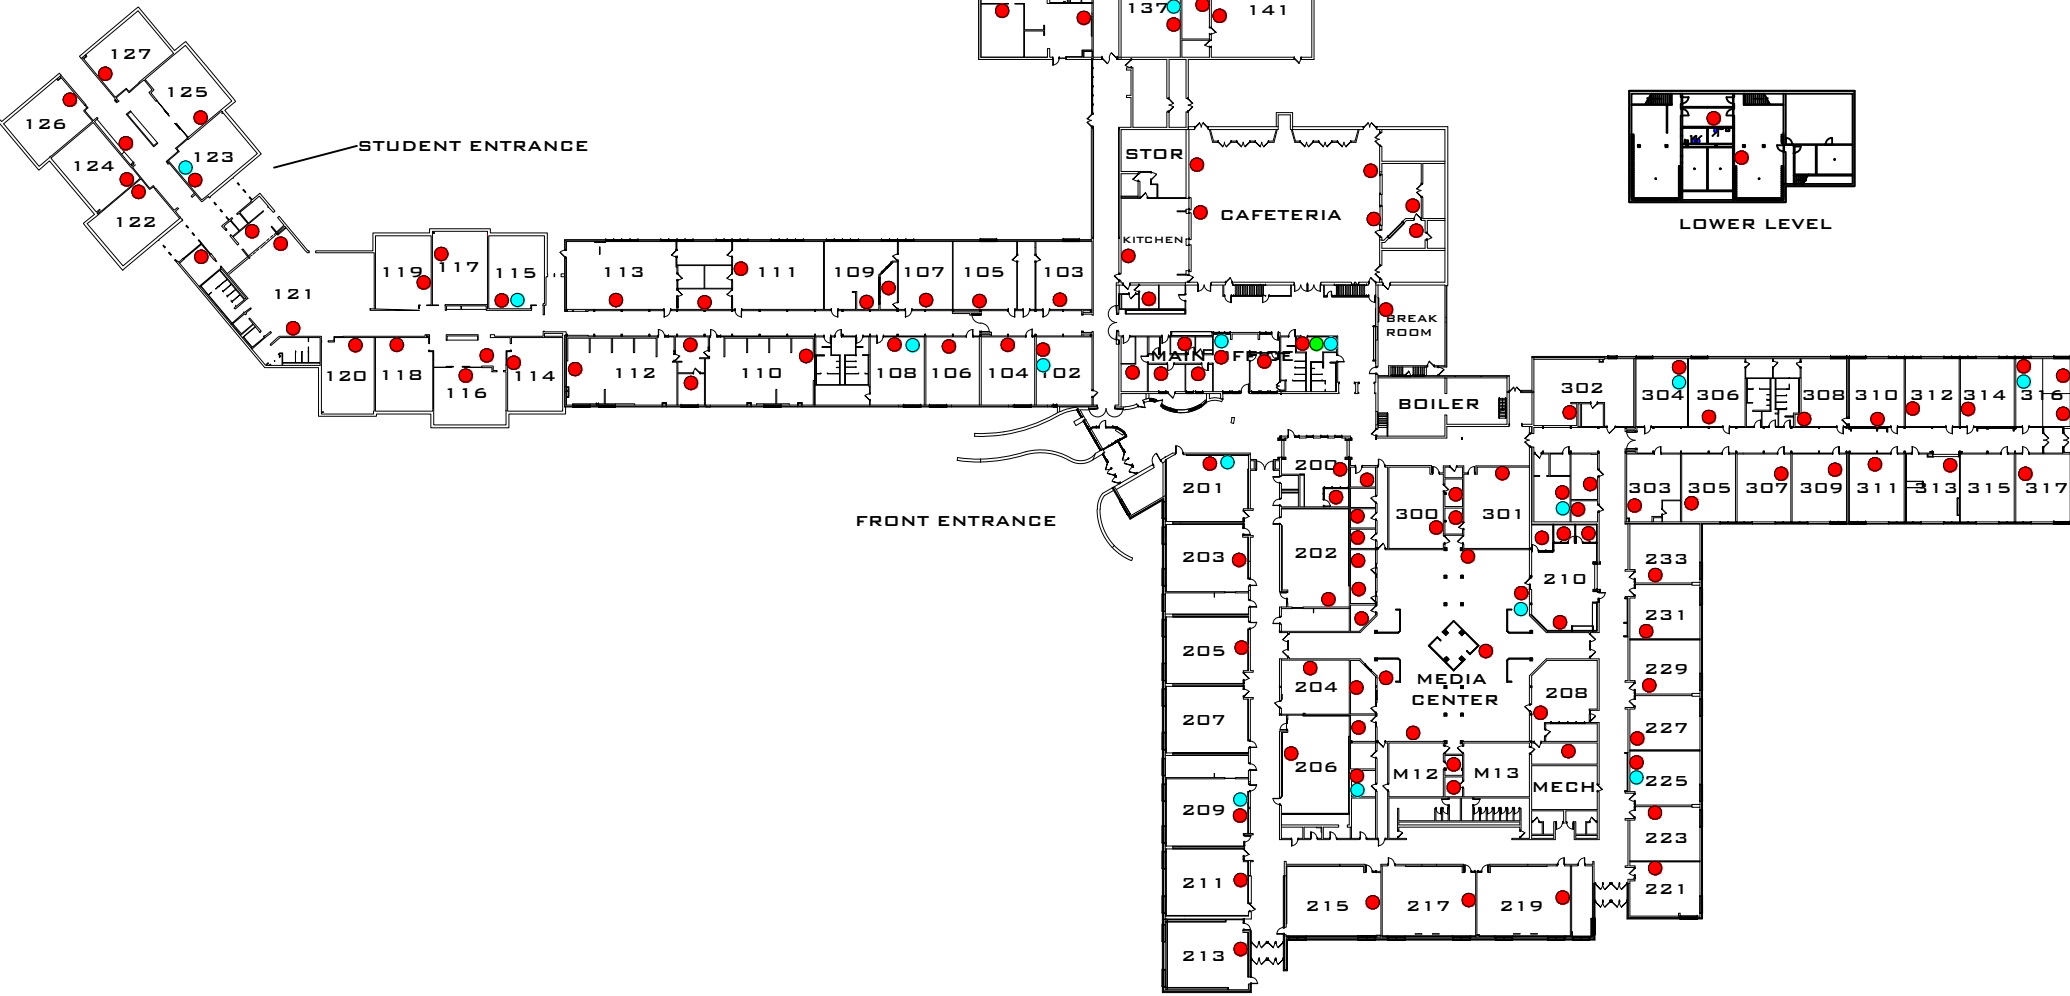
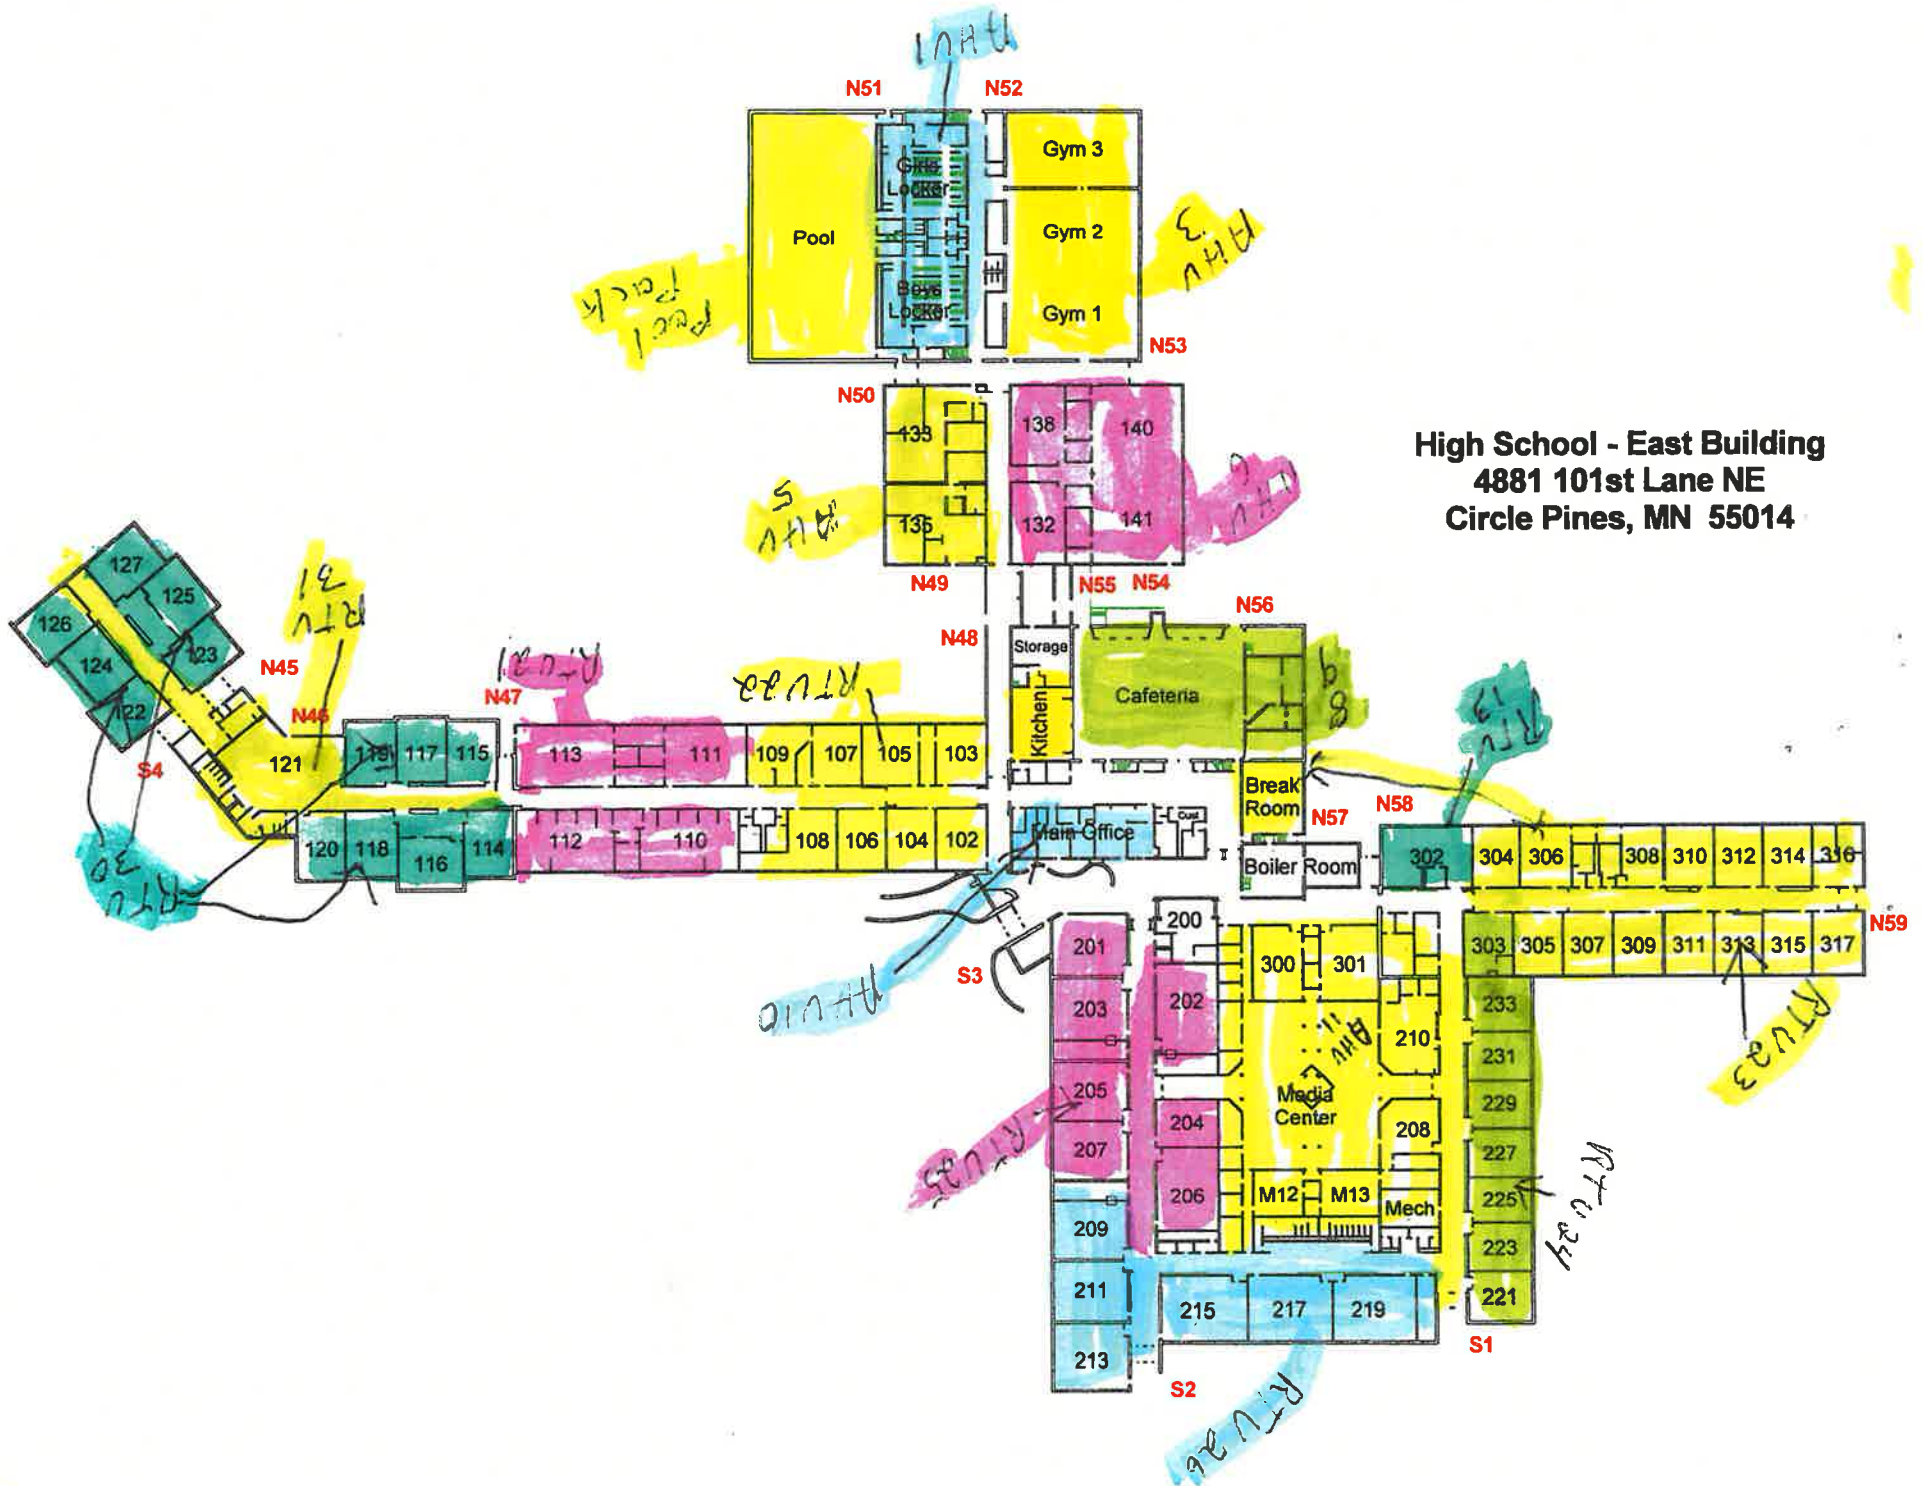
High School - East Building
4881 101st Lane NE
Circle Pines, MN 55014

- RADON DETECTOR LOCATION
- DUPLICATE
- FIELD BLANK

UPPER LEVEL

LOWER LEVEL
