FACILITY AUDIT

BOYCEVILLE COMMUNITY SCHOOL DISTRICT

APRIL 2023

PREPARED BY:
CESA 10 Facilities Management
725 W Park Avenue
Chippewa Falls, WI 54729
888-947-4701
<http://facilities.cesa10.org>

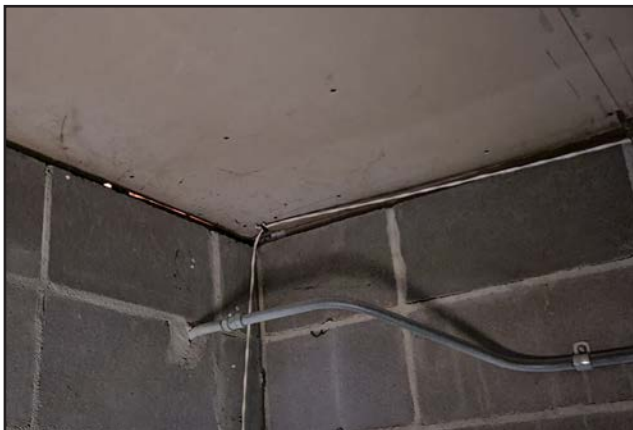
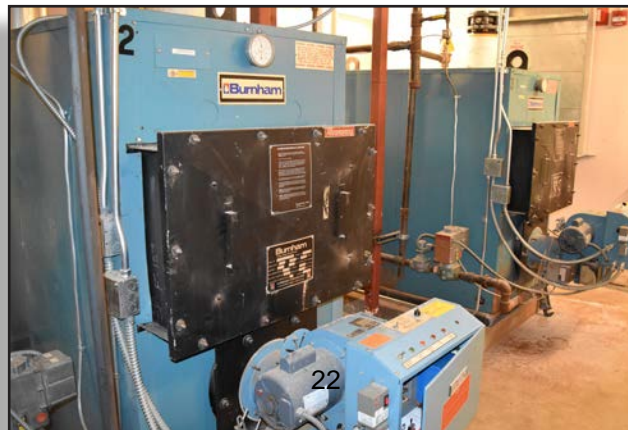
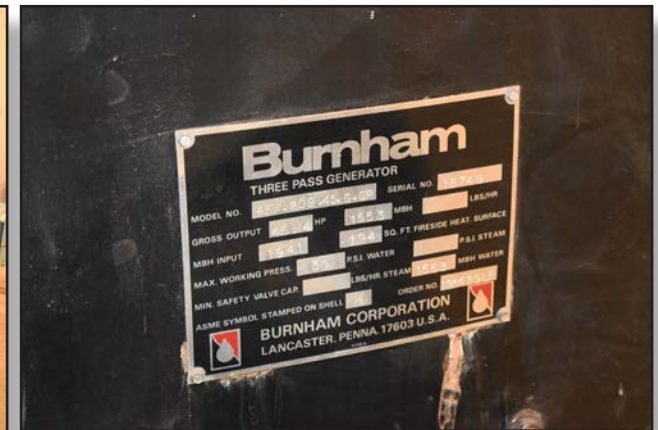
Boiler System	TCE has two Burnham standard boilers from 1990 that are original to the building. The school added a condensing boiler to handle the shoulder months in 2008.	The District should replace the aged boilers with new high-efficiency condensing boilers and consider adding glycol to the system while renovating the boilers to prevent freezing issues. CESA 10 also recommends adding CO2 sensors in the AHUs throughout the building.	8	8	8	8	32	3	\$365,000

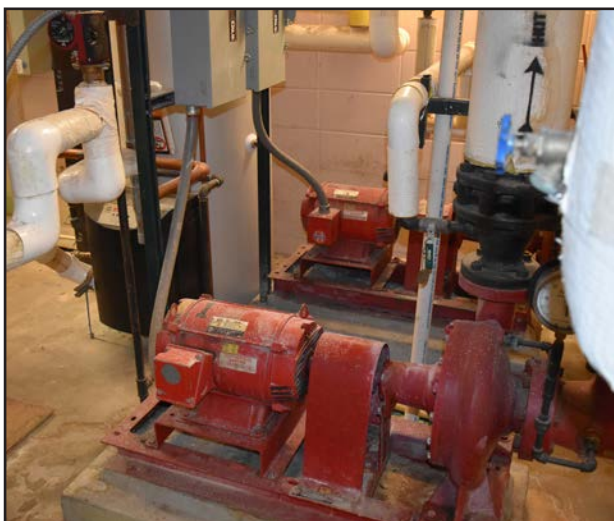
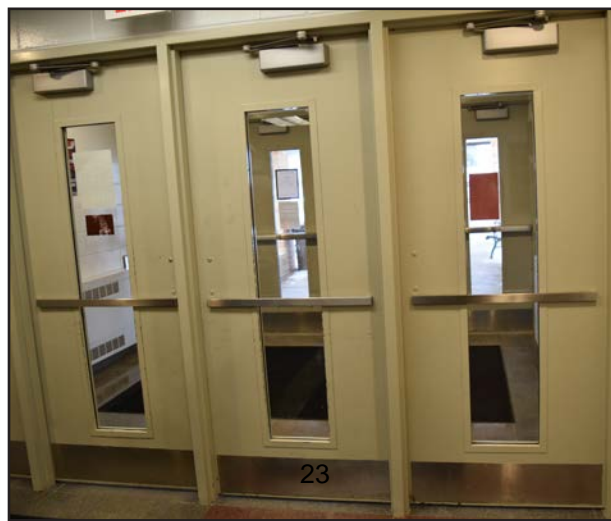
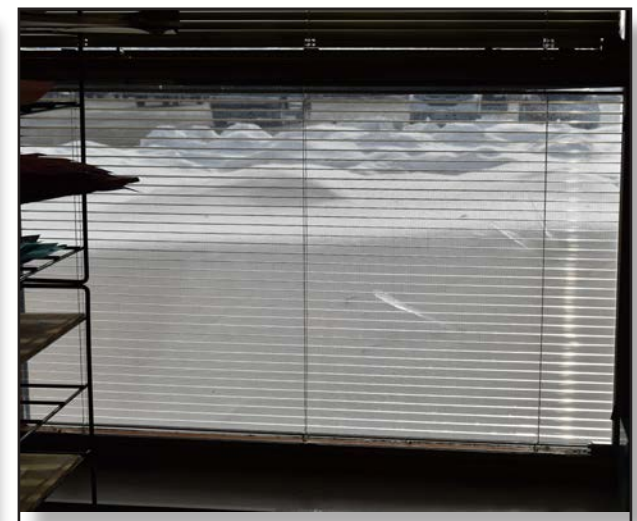
Window/Door Numbering	The District lacks exterior numbering of doors and windows. Reflective exterior numbering can help first responders identify rooms in an emergency.	The District should install four-inch reflective numbering on exterior doors and windows. This will increase the overall safety of the building. The District should also remove student names from outside classrooms to improve security in this location.	8	8	8	8	32	1	\$500

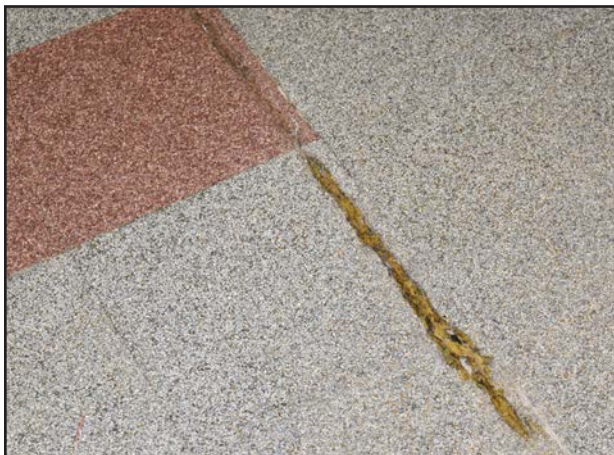
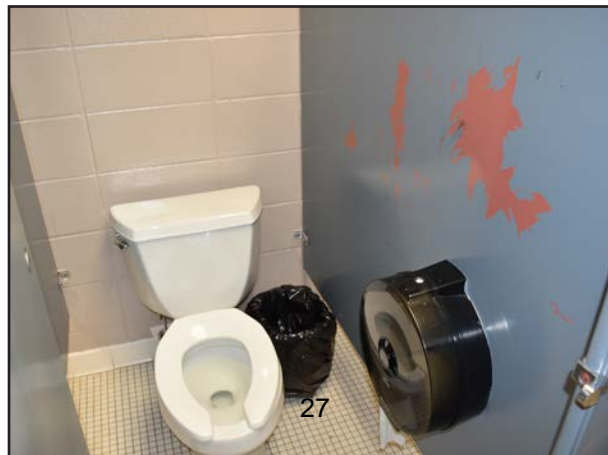
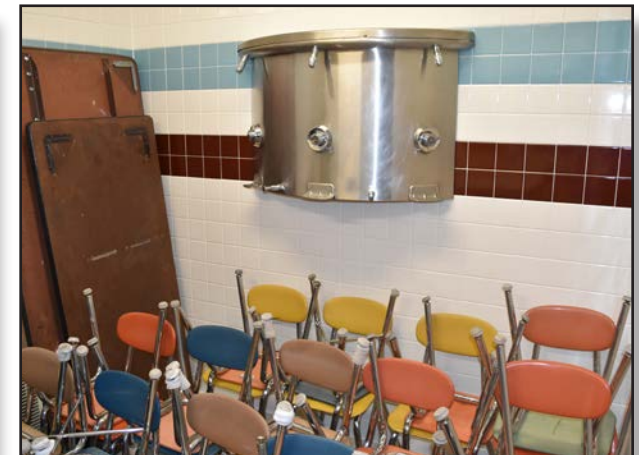
Restrooms	The doors, toilets, sinks, and partitions are dated and aging in numerous bathrooms. The number of bathroom fixtures available to students is deficient in several restrooms.	CESA 10 recommends updating existing bathrooms as the budget allows, including installing low-flow toilet tanks, urinals, and automatic valves to save water and energy. The handwashing stations are also in need of replacement.	7	8	7	7	29	3	\$325,000	
Restroom Shower	The school currently does not have a working shower. The District must rely on sinks and wet wipes if a student needs to be cleaned.	The District should add a shower to accommodate staff if they need to clean up a student. A good location for this shower is in a special education bathroom.	8	7	8	6	29	2	\$13,000

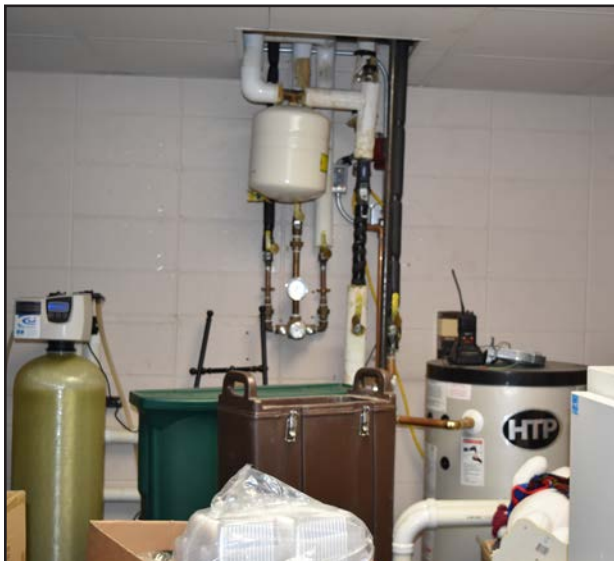
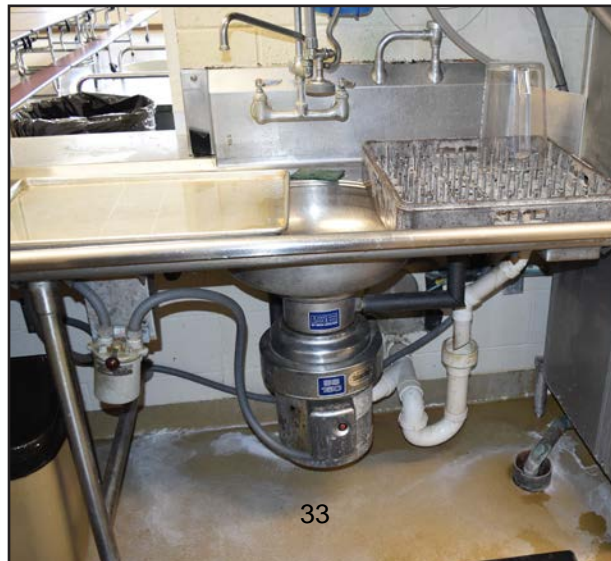
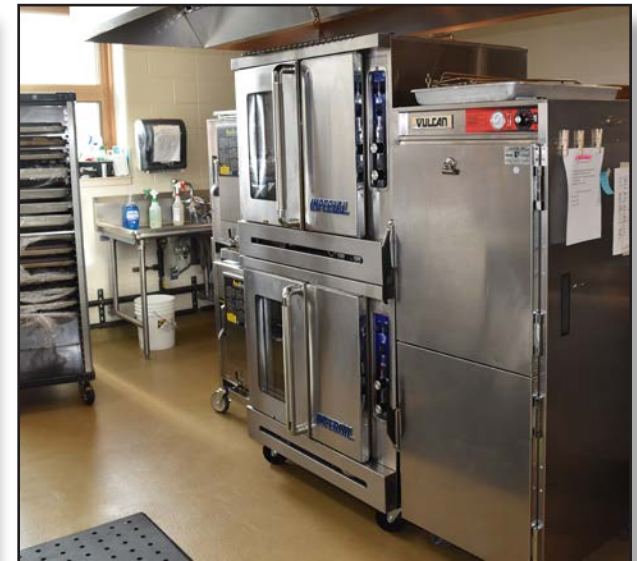
Kitchen Equipment	The kitchen equipment is lacking and should be updated, including replacing the exhaust fan, installing an acid neutralizer on the water heater, adding a walk-in freezer and cooler, establishing storage space, moving the dishwasher next to the three-compartment sink, updating the steamtable and adding a water hookup. The District should also consider adding a server line, so there are two people to help with flow issues.	The District currently prepares most of the food in the Middle/High School and transports it to the Elementary School. This requires temperature checks and staff time. By updating kitchen equipment and storage options, the District can increase the safety and efficiency of this operation.	7	6	6	7	26	2	\$85,500

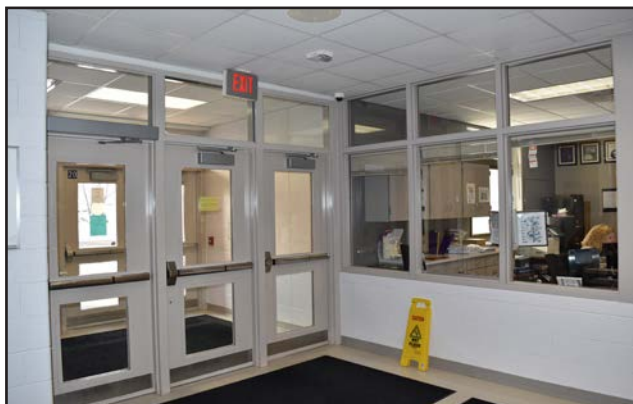
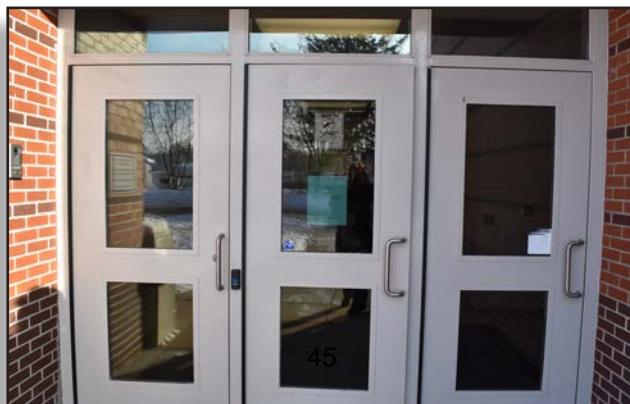
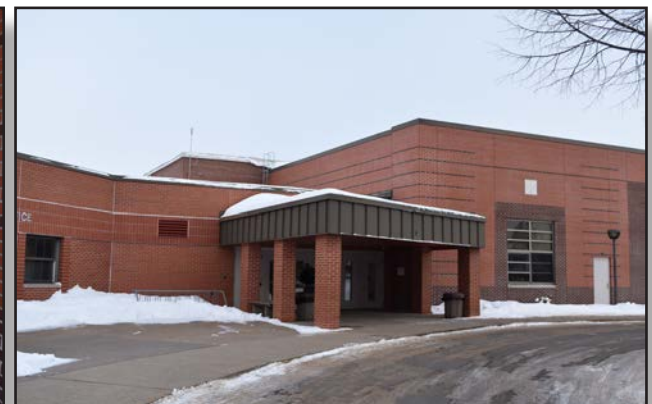
District Office Secure Entrance	The District office entrance is similar to the MS/HS entrance. Visitors are buzzed in by the main office and have free reign of the school.	The District should explore updating the vestibule area and installing a window from the District office storage room to allow office staff to greet guests coming into the building. CESA 10 recommends updating signage to push visitors to the MS/HS entrance.	9	9	8	8	34	3	\$115,000

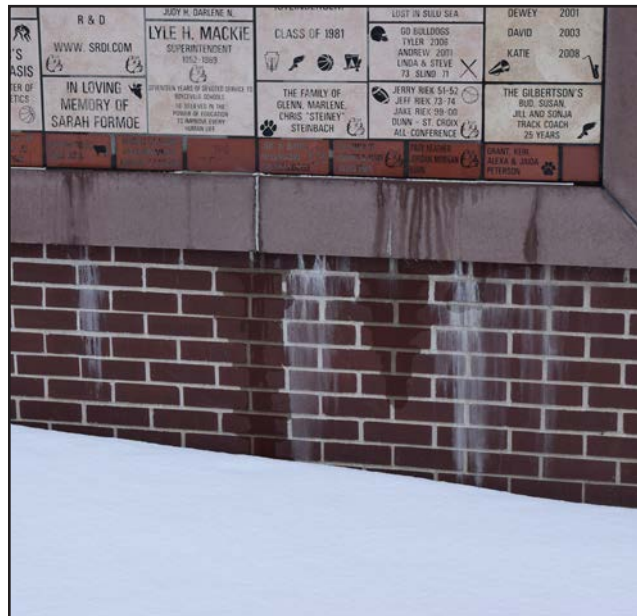
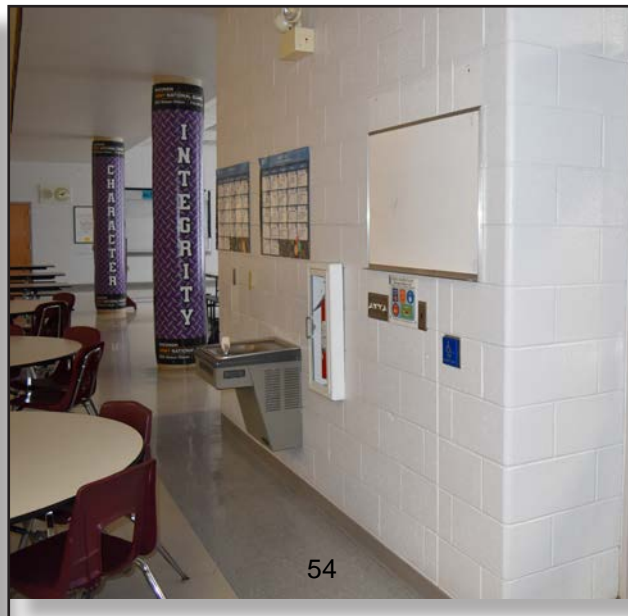
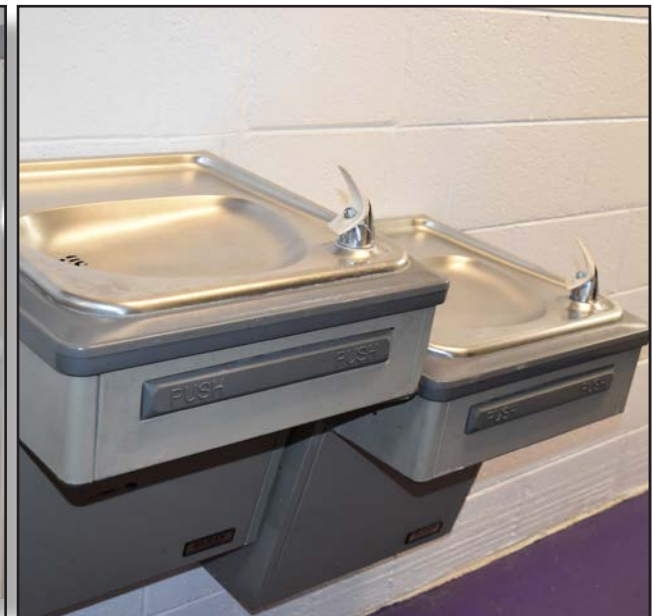
Drinking Fountains	Drinking fountains were found to be in various states, including two stations that were inoperable.	The District should replace drinking fountains with bottle fill stations.	7	7	7	7	28	2	\$15,000

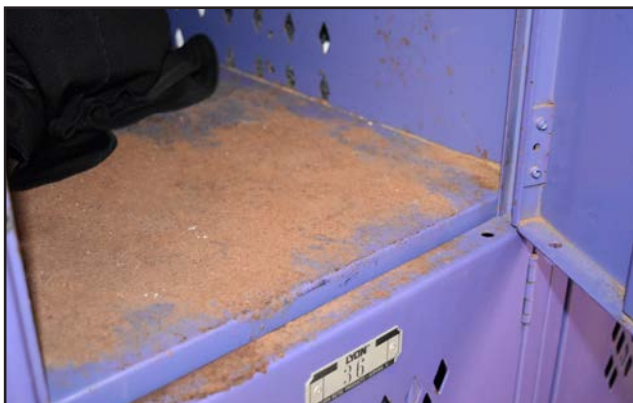
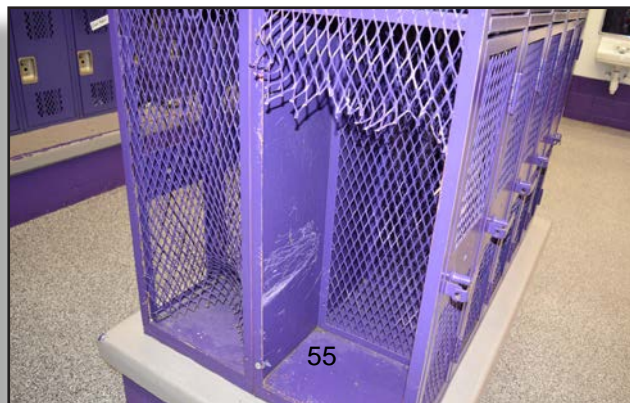
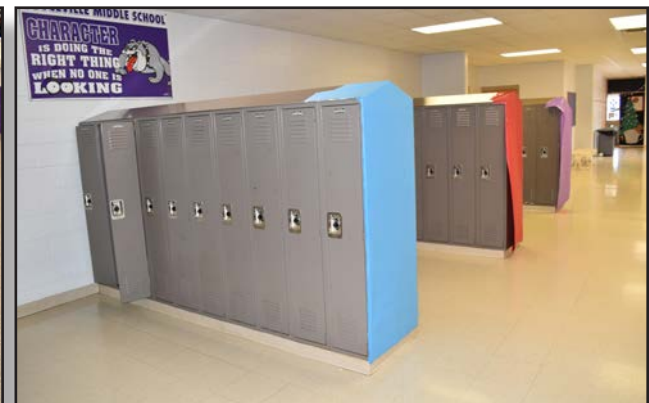
Student Lockers	The Middle School houses a bank of lockers in an open area, which raised a safety concern. While multiple cameras were trained on this area, students can still hide behind the rows of lockers. Plus, it leads to increased maintenance time to clean between each row.	The District should update all Middle School lockers with new ones. The lockers on the southwest side of the building should be flush with the wall to open up the space for safety.	8	7	7	6	28	3	\$135,000

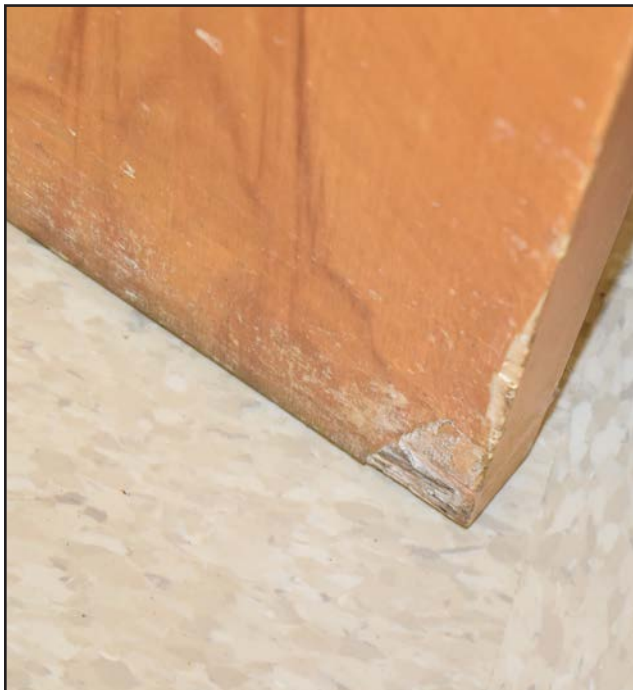
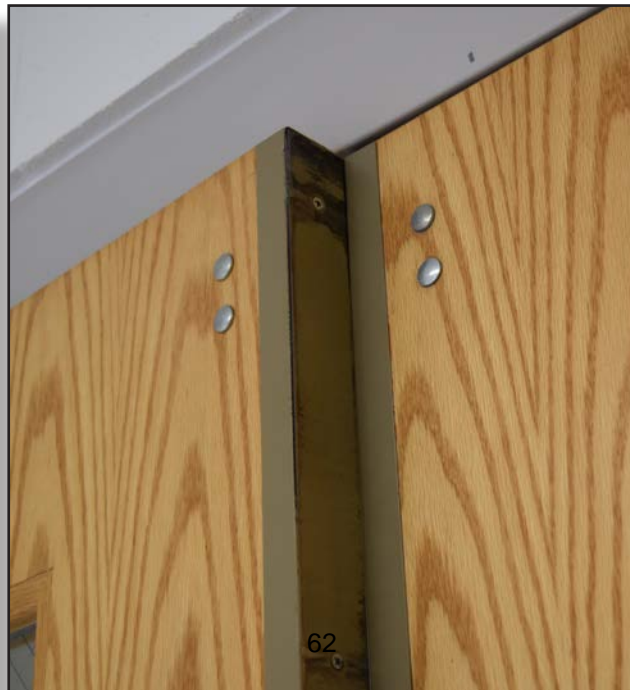
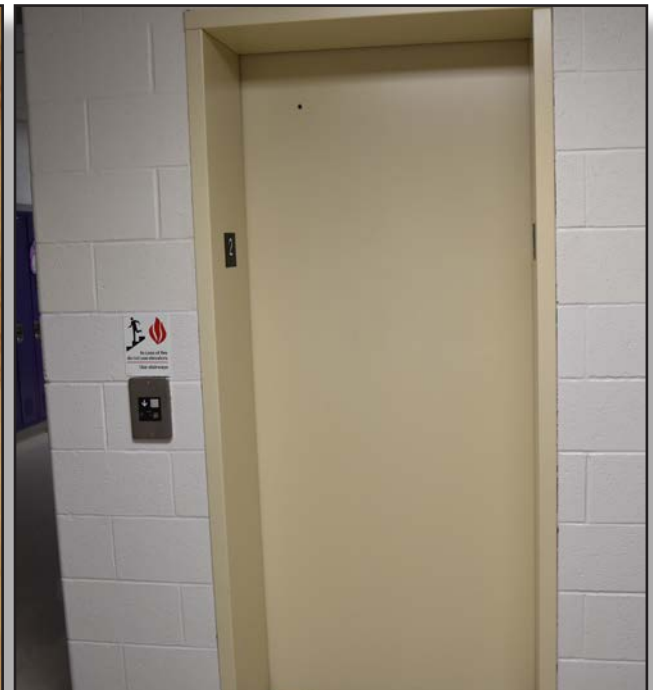
Facility Improvement Measures Boyceville Community School District Middle/High School			Project Recommendation Priority Order						
			<2 yr=10 3-5 yr= 7 5-10 yr= 3 10+ yr= 0	High=10 Med=5 Low=0	Poor =10 Ave =5 Great =0	<2 yr=10 5 yr= 5 10 yr= 2 20 yr= 0	Priority	<\$10K=1 <\$100K=2 >100K=3	
Building System	General Description	Recommendation	Useful Life	EHS Concern	Func. Cond.	ROI	Total Points	Proj. Cost	Cost Est.
Interior Doors	Several wooden interior doors were chipped, scratched, broken, or missing locks.	The District should set a standard for interior door replacements and consider moving from a physical lock to a key fob system to enhance security and ease of use. Also, look at solid doors with no windows for safety purposes.	8	8	8	2	26	3	\$101,000
Elevator	The one working elevator appeared in good condition and had recently passed inspection. The Middle School elevator was inoperable at the time of the audit.	The District should repair or replace the Middle School elevator, depending on its condition. The estimated cost listed is to repair it.	7	7	7	5	26	2	\$42,000

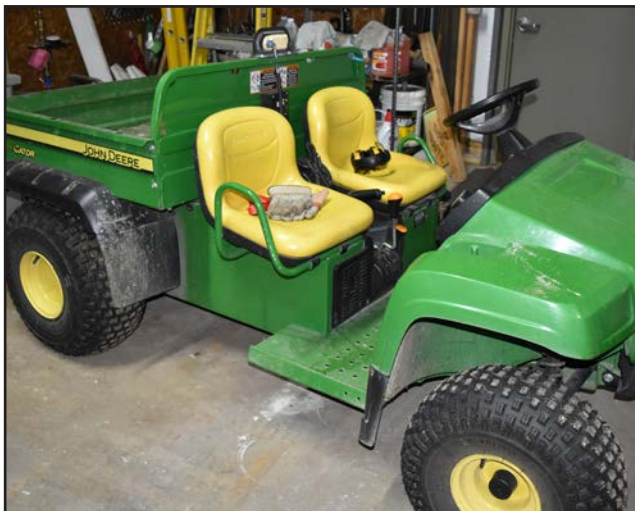
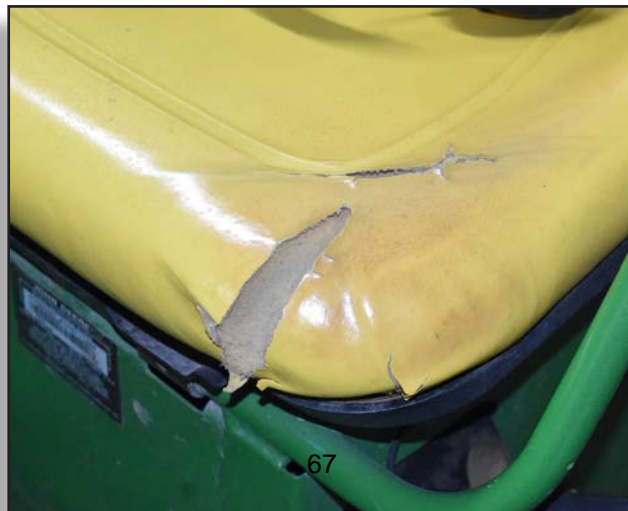
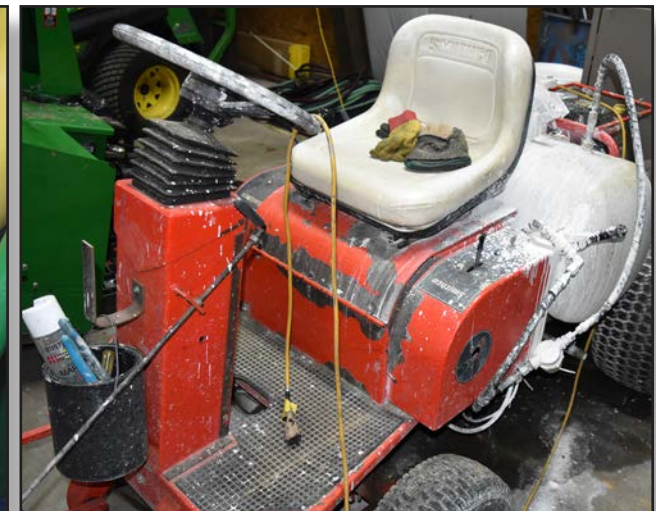
Grounds	Staff members noted several pieces of equipment that need updating, including the paint sprayer, floor scrubber, 1565 mower, and gator. Staff Another ATV is needed with a plow.	The costs estimated are \$15,000 for a paint sprayer, \$25,000 for a floor scrubber, \$35,000 for a 1565 mower, and \$48,000 for a gator with a plow.	7	6	6	5	24	2	\$245,000
Electrical	Minimal electrical outlets were noted in classrooms. The District should add additional electrical outlets.	The computer lab and IMC would be good areas to add electrical outlets as the spaces are renovated for small groups.	5	7	6	4	22	1	\$7,500

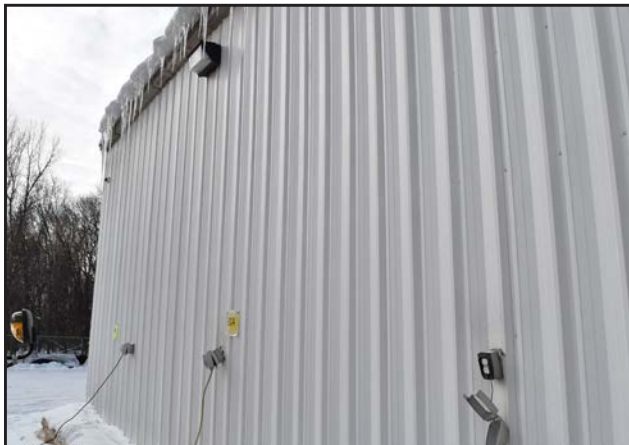
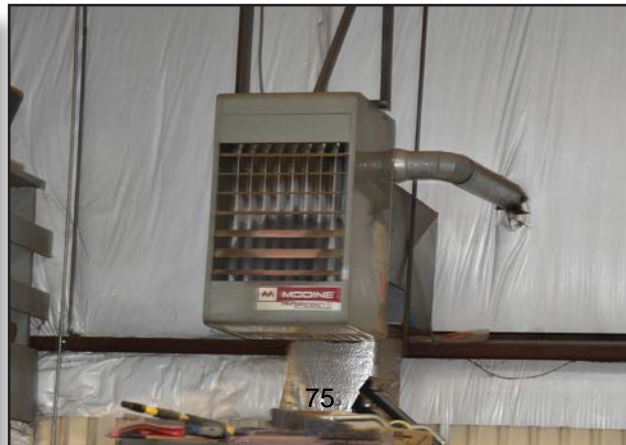
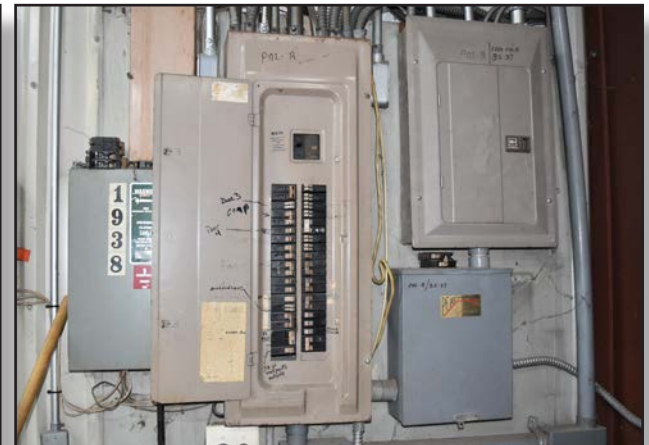
Ventilation	The bus garage smelled heavily of exhaust. While the buses only come inside for maintenance, the District should ensure adequate air quality for staff.	The District should upgrade to a direct gas-fired makeup air unit and monitor ongoing air quality.	8	8	7	6	29	2	\$38,000
Electrical	The bus garage has a 100-amp 120/208v 3-phase service at full capacity. With this current services, it can not add any additional equipment or electrical load to the building.	The District should upsize the transformer to a 200-amp 120/208v 3-phase service. The main building panel and associated feeder must be upsized to accommodate a larger service. Existing circuits can be reused as needed.	7	7	7	7	28	2	\$75,000

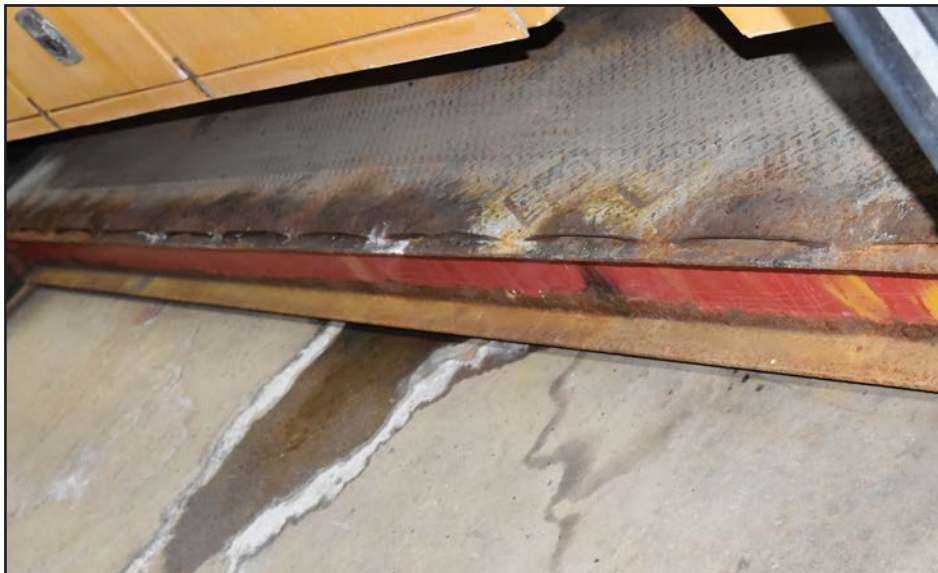
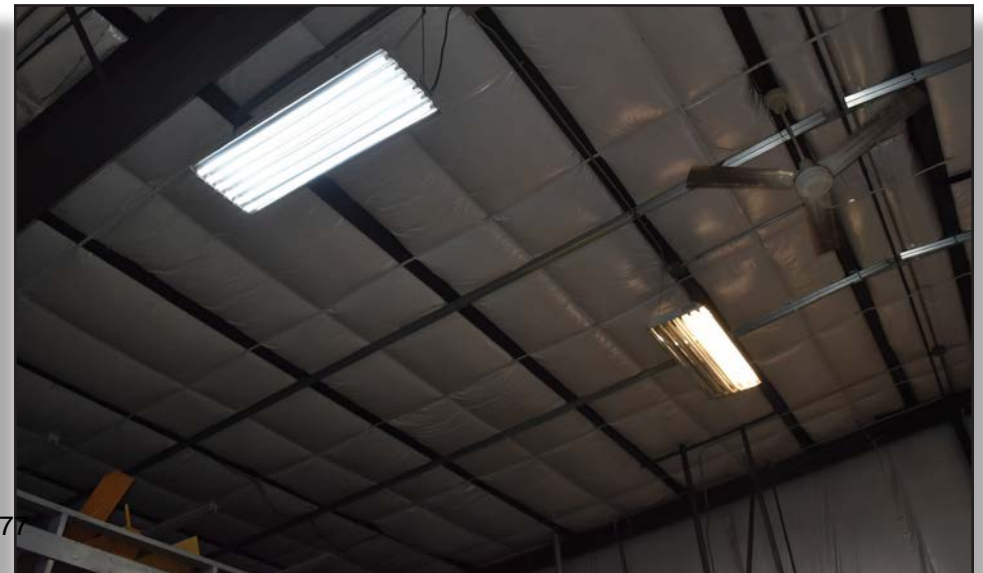
Lighting	The lighting in the bus garage is fluorescent and should be replaced with LED lighting.	While the bus garage is a low priority for lighting replacement, the District will see energy gains by switching to this new technology and installing sensors.	6	6	6	8	26	2	\$75,000
