November Facilities Committee Meeting

Weston Public Schools, Facilities feasibility study and master plan.

BOE Facility Committee
presentation on
11-2-2017

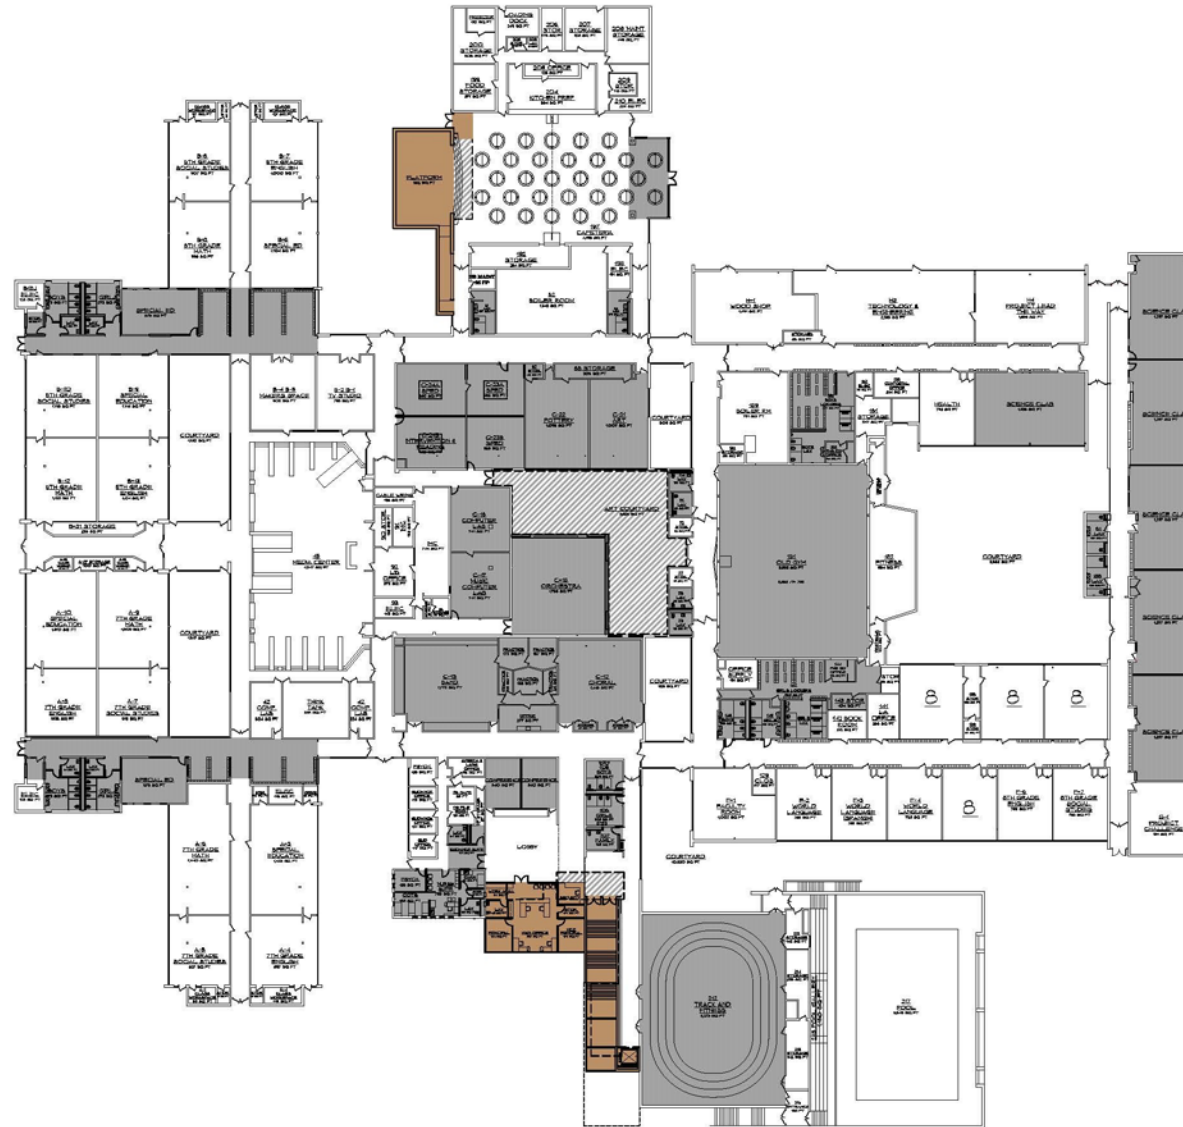
Middle School Design Option 2 - Proposed

DESIGN LEGEND	
■	RENOVATIONS
■	NEW CONSTRUCTION
▨	DEMOLITION

WESTON SCHOOLS FACILITIES FEASIBILITY STUDY WESTON MIDDLE SCHOOL - DESIGN OPTION 2 ESTIMATE				
Design Option Projects	Area	Cost Per Sq ft.	Subtotal	Totals
BUILDING INFRASTRUCTURE (Facility Conditions)				
HVAC			\$ 4,165,000	
Electrical - to support HVAC, improve emergency power, new lighting throughout			\$ 935,625	
Ceilings & devices throughout	96,909	\$ 15	\$ 1,453,635	
Restroom Renovations throughout			\$ 875,000	\$ 7,429,260
STUDENT LOCKERS & A-WING				
Hallway reconfigurations, restrooms & lockers	6,916	\$ 400	\$ 2,766,400	\$ 2,766,400
SCIENCE				
Science demolition	3,325	\$ 50	\$ 166,250	
G-wing Science Club Conversion	8,026	\$ 400	\$ 3,210,400	
C-wing (science) Special Education Conversion	2,552	\$ 300	\$ 765,600	\$ 3,376,650
ART & MUSIC				
Music Renovations	6,651	\$ 300	\$ 1,995,300	
Art Renovations	2,633	\$ 300	\$ 789,900	
Cafeteria - stage demolition	644	\$ 20	\$ 12,880	
Cafeteria - Northwest demolition	539	\$ 20	\$ 10,780

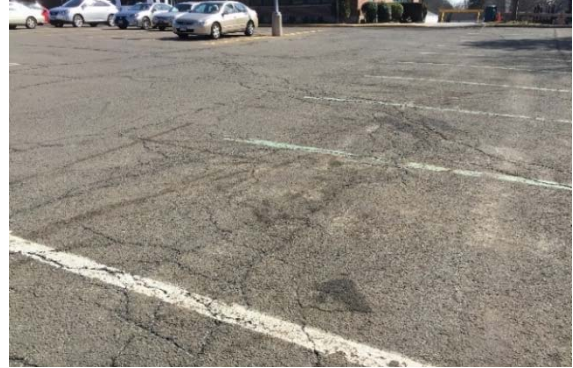
Figure 3: Typical parking lot cracks at front

Both concrete and bituminous pathways allow for pedestrian connections from all of the houses around the site. The entire front parking lot has significant cracks throughout the asphalt and should be completely repaved. The teacher parking lot near North House is currently not paved nor does it have any connecting sidewalks to the existing sidewalks and does not meet handicap accessibility. The pathways are in good condition. The surrounding fields appear to be compacted and should be addressed as spring arrives.

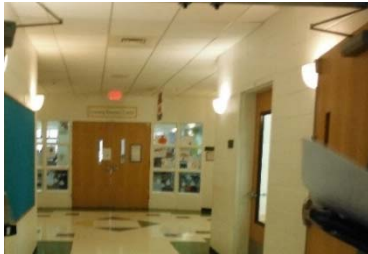
Figure 4: Center House hallway

The interior of the building is well maintained based on the existing conditions and existing systems. A visual inspection of the walls, floor and ceiling were reviewed during the building walkthrough. The interior walls are a variety of concrete masonry units or block (CMU), plaster and sheetrock. Each House has its 'own interior identity. Paint color begins to designate each house making it easy for children to find their way around the school. Center House consists of painted white 8x8 concrete block. East House appears to consist mostly of plaster. The lower portion of interior walls are painted yellow. However, the cafeteria is painted with blue accents. South House too is plaster but with green accent paint. North House consists mostly of standard concrete block interior walls. It was noted in the basement along the stair the paint is significantly peeling and water infiltration is present. There were also some cracks noted in the CMU of the gymnasium. A few areas throughout the entire facility could use some touch up paint but most appear to be in reasonable condition. Ceramic tile at the toilet rooms are in fairly good condition.

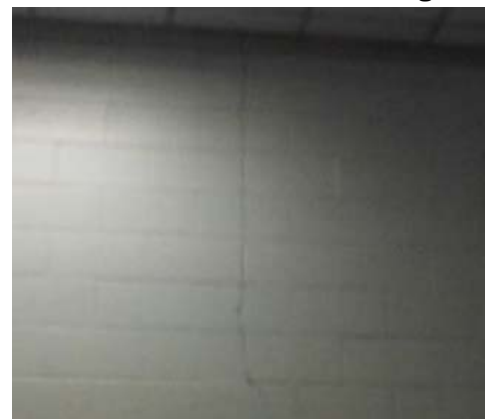
Figure 8: Crack at east wall of gym

baseboards are in fair condition with some areas beginning to wear. The sheet flooring in the North House gymnasium looks fair although it was indicated that its beginning to bubble. Overall the interior walls, floor and ceiling are in good condition.

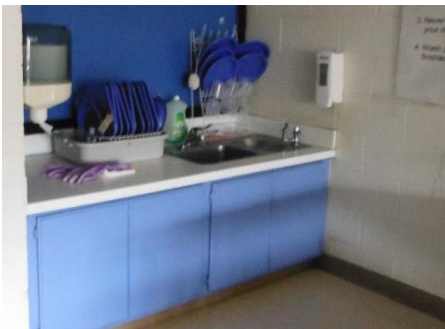
Figure 10: Casework in North House

Most casework and built-in shelving throughout the school is dated. Most notably the dated casework is in the East House as they appear to be original. South House has been updated however the plumbing interferes with the knee space clearance. The Center House has newer plastic laminate casework and those appear to be in good condition. The casework in North House is not quite as dated but some are in tough shape and they do not have a knee space at the sinks and drinking fountains. Most casework throughout does not meet the required height or have the required knee spaces. Most of the sinks within the casework are also not accessible.

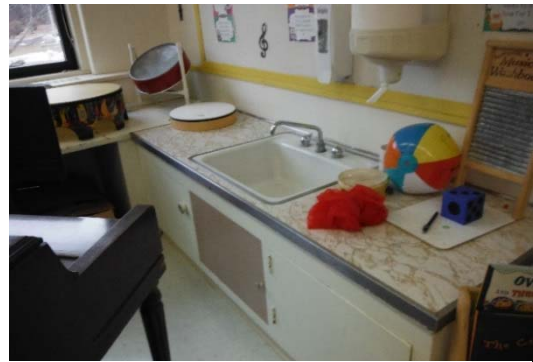
Figure 11: Casework at East House

Many ADA accessibility issues were noted at this facility. This is a common occurrence given the age of the building and its renovations. These items should be included in the long term capital plan. All of the required grab bars do not exist in any of the handicap areas. Most of the single toilet rooms do not have the required clearances. The toilet rooms within classrooms are noncompliant due to lacking the required room dimensions along with lacking the required grab bars. As previously mentioned in addition to the toilet rooms other ADA noncompliance items with the casework, sinks and door hardware. Some doors also do not have the required push pull clearances.

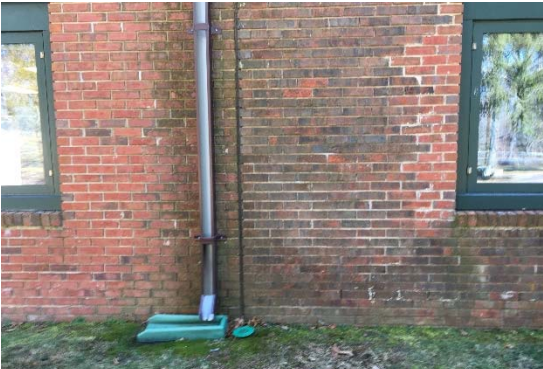
Figure 12: North House masonry conditions

As previously discussed all of the houses were built at a different time and therefore have a different construction and a varying age or need. One consistent component to the exterior is the material, all are brick. The brick walls of the school are generally in good condition, with areas of settling and spalling. The original building is constructed with brick “veneer” and concrete masonry unit interior or plaster interior. The energy efficiency of the original construction is very low, and typical in the 1950s (“pre energy crisis”), and not one that is easily corrected. The 1997 addition, Center House has a CMU interior and likely includes insulation and air space which improves the energy efficiency.

Overall, the mortar is in fair condition with limited areas in need of repointing. Certain areas are in need of more attention. For instance, the base of some of the facades and areas around gutters have mildew and some spalling is present. Most notably this occurs at North House. These areas should be cleaned, repointed and sealed to prevent any further damage. Other areas such as the chimneys may need additional repointing. Some of the exposed foundation walls parging is flaking and may need to be repaired. The through wall base flashing on the east side of North House is deteriorating. This type of repair is rather costly, but this could be allowing water to enter the cavity. It may be the culprit of the water infiltration in the basement elevator machine room below. North House seems to have masonry in most need. Center, East and South have limited areas in need of maintenance. Overall the masonry appears to be in good condition.

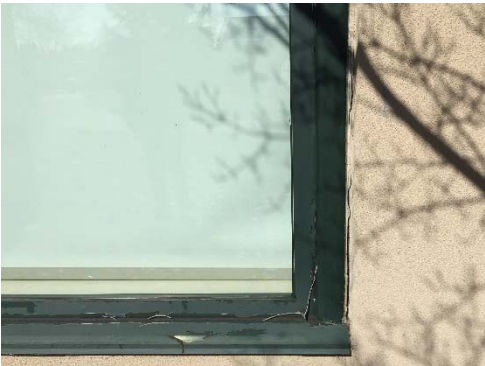
Figure 14: Window at lower level of North House

When evaluating the energy efficiency of a building, it is known that nearly 25–40% of all heat energy is lost through windows. The windows were replaced when the addition was constructed with double-glazed aluminum frame windows. They appear to be in good condition. Caulk is beginning to fail and in need of replacement. Many door frames, mullions and thresholds are beginning to show signs of rust. The ballast roof is in great shape. The EPDM roof also appears in good shape. The wood fascia throughout are in fair condition with some areas in need of more attention. They should be scraped, primed and painted to continue their lifespan.

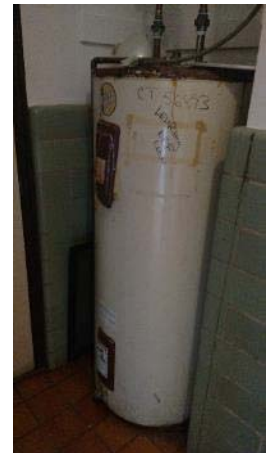
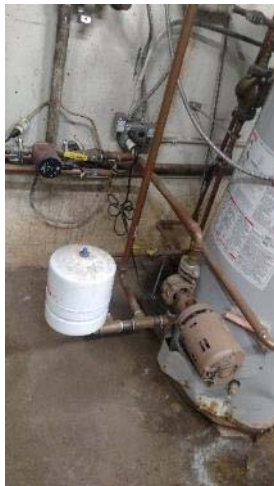
The boiler room in the basement of East House contains 2 domestic hot water heaters. One of the water heaters is a gas-fired water heater having an input rating of 199,900 BTUH and a storage volume of 76 gallons. The system is approximately 14 years old. The system should have an average life expectancy of approximately 15-20 years and remaining life expectancy it about 1-6 years. The boiler room of East House also contained a Bosch tankless water heater that was not plugged in and is assumed to be out of service. This water heater is connected to a 119-gallon storage tank. On the main level of East House, in the kitchen area, is an abandoned water heater that says "LEAKING - OFF LINE" on the outside of it. The gas water heater should be replaced within the next 5 years. The tankless water heater should be checked for serviceability and put back into working order or should be removed. The abandoned water heater in the kitchen area should be removed.

The hot water plant for the Senior Center and the South House is located in the lower level of the Senior Center in the boiler room. There is a gas-fired Bosch tankless water heater rated at 199,000 BTUH and a gas-fired water heater having an input rating of 85,000 BTUH and a storage volume of 100 gallons. The tankless water heater is approximately 7 years old and damaged. The system should have an average life expectancy of approximately 15-20 years and remaining life expectancy it about 8-13 years, however tank needs to be replaced or repaired. The tank style water heater appeared to be taken out of service and is now being used just as a storage tank. The piping in this plant should be tracked and confirm what is being fed by each water heater. The tankless water heater was set to provide water at 140 degrees and no mixing valve was observed. Water delivered at 140 degrees can cause scalding. There were also 3 separate recirculation pumps that were inline on the same piping. All the pumps were running, so the reason for so many pumps should be investigated.

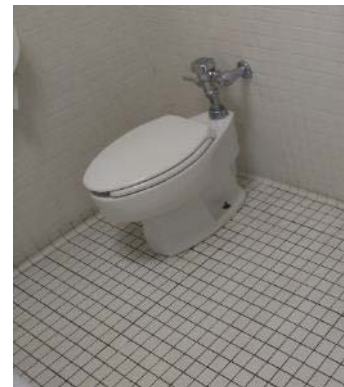
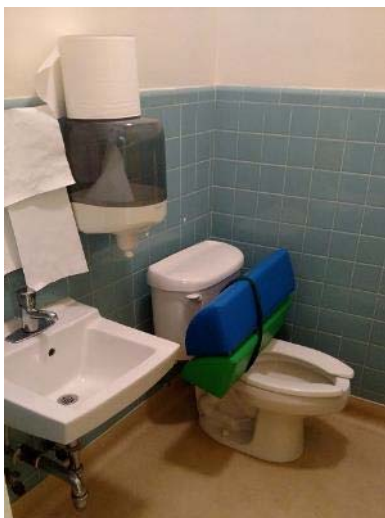
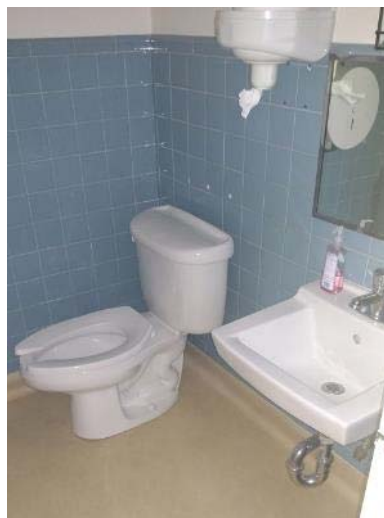
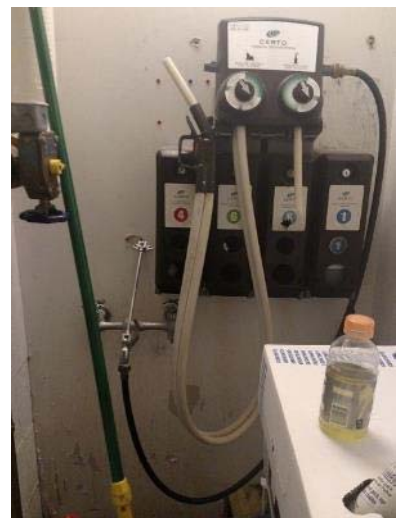
While the overall condition of the fixtures is good, some of the issues noted during the visit are noted below. One of the water closets appears to have had the vacuum breaker portion of the flush valve cut (See photo to right). The manufacturer should be consulted to figure out the location of the "critical line" (typically at least 6" long) for the particular flush valve. If the flush valve has been cut shorter than this, it can create a backflow condition that would allow for contamination of the water supply. Any lavatory or sink that is designed as and ADA accessible fixture needs to have insulation on the piping in the knee space (See photo below). The piping may also need to be reconfigured on additional fixtures. to provide the proper clearances (See photo below). A janitor's sink was observed with hoses connected to the faucet from a chemical feed system without a vacuum breaker to prevent back siphoning in the event of a drop in building water pressure. The condition could result in contamination the domestic water system creating a safety hazard. Recommend installing a vacuum breaker as soon as possible (See photo below).

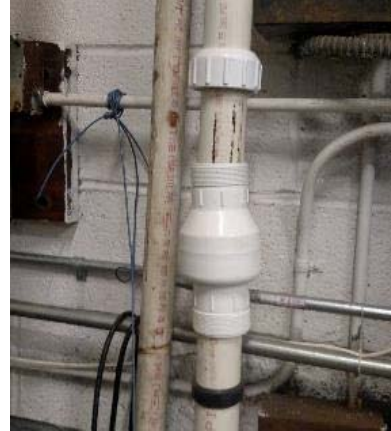
The sanitary for the school is handled by means of a septic tank. None of the fixtures in the kitchens appeared to be connected to an automatic grease recovery unit or grease interceptor. The local health department should be contacted to see if this is a requirement for their district. There is a sump pump located in the basement of the East House. The check valve for the discharge of the pump is not installed correctly. This should be repaired in order to prevent and leaks. There was also another sump pump located in the basement of the North House, but it was inaccessible due to boxes stored in the area. No other sanitary or storm piping issues were observed during the visit. If there are any areas with known issues, it is recommended that the pipes in that area get scoped with a camera to see if the root of the issue can be determined.

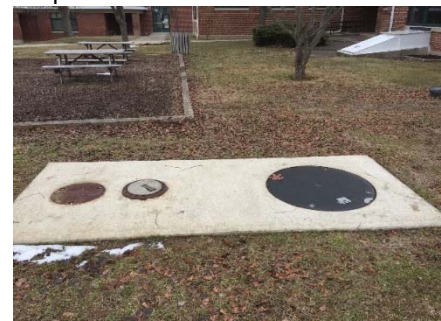
The 6000 gallon USTs serving the North and East Wings were each replaced in 2015 and should not require replacement again for at least 18 years.

The 4000 gallon UST serving the Central Area was installed in 1998, was last tested in 2009, and is due for replacement in 2018.

The 6000 gallon UST serving the South Wing was installed in 1988, was last tested in 2009, and is due for replacement in 2018.

All USTs would have been registered with the State at the time of installation and the Town's registration paperwork should be reviewed for date of installation and warranty and to determine the requirements for tank testing, inspection and replacement.

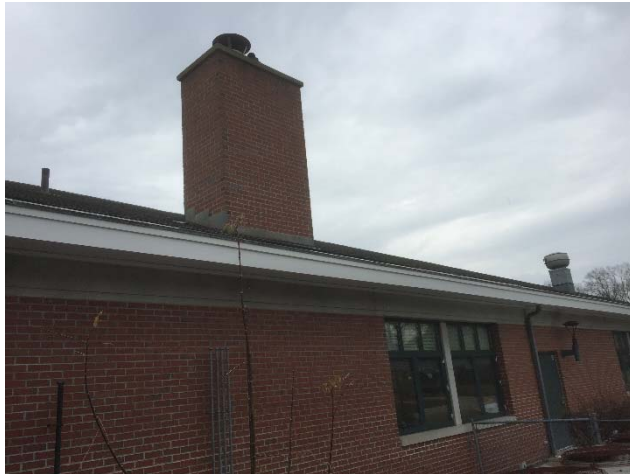
Chimney height for two of the four Boiler Rooms appears to be inadequate. Chimney height for the Central Area and North Wing Boiler Rooms appears to be code compliant but may be inadequate to prevent introduction of flue gasses into the building. The Central Area chimney is below the height of the outside air intakes, making it likely that flue gasses will be drawn into the air intakes under certain wind conditions. The North Wing chimney does not appear to be high enough to prevent introduction of flue gasses under all conditions, especially if new rooftop equipment or air intakes are provided as part of future HVAC upgrades. Consideration should be given to

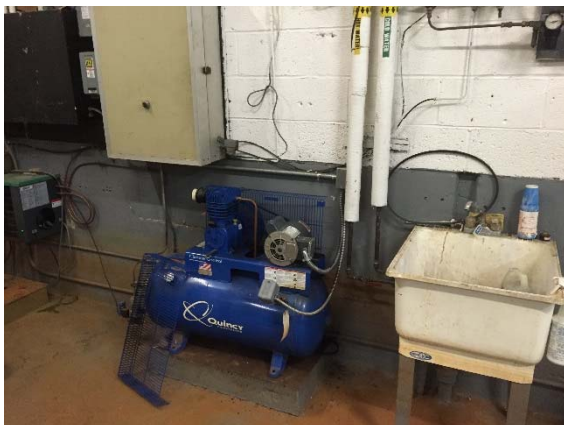
Corridors of the three academic wings lack proper ventilation as required by the Building Code. Corridors ventilation should be provided as part of any future HVAC improvements.

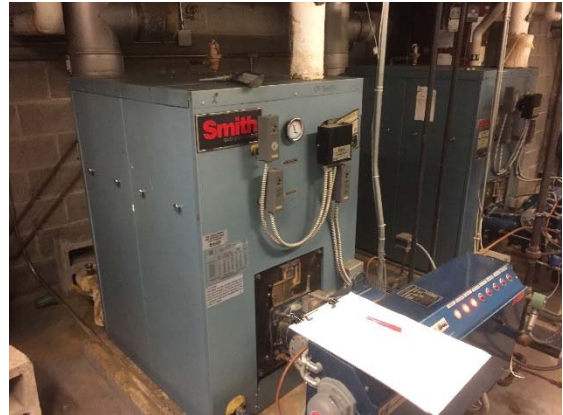
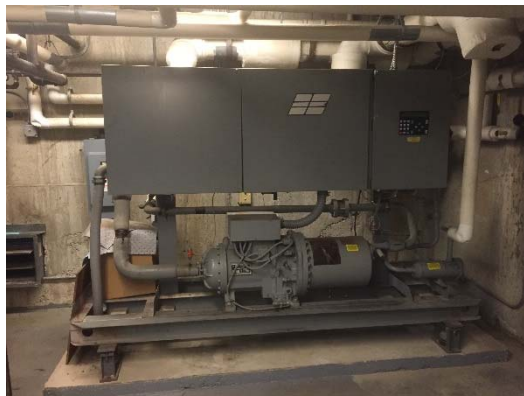
Heating for the Central Area is provided by two Smith model 19-W-6 Boilers with Power-Flame dual fuel burners capable of firing #2 Fuel Oil or Natural Gas. The Boilers are believed to have been installed as part of the 1997 renovation and appear to have been well maintained, likely having a minimum of 10 years useful life remaining. Hot Water Pumps appear to be in serviceable condition but are showing some surface rust. Boiler Room floor was dry at the time of our visit however, there are signs of previous leakage including the noted rusting of the pumps. Two combustion air openings have been provided which meet the requirements of the Mechanical Code.

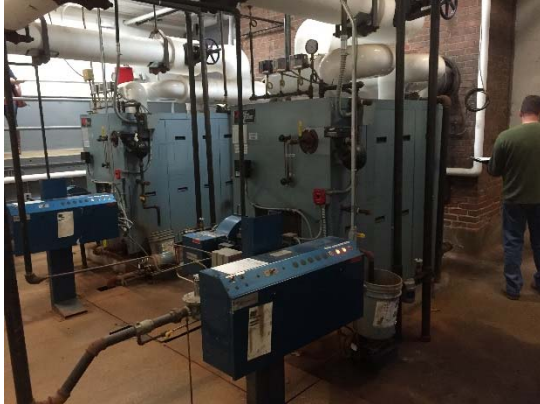
The East Wing is served by two Smith model 28HE-S-08 Steam Boilers with Power-Flame dual fuel burners capable of firing #2 Fuel Oil or Natural Gas. The Boiler Room is neat and well organized and the Boilers, Boiler Fed Unit and related piping and equipment in the Boiler Room appear to be well maintained and in good condition, likely having a remaining useful life of 10 years or more. Combustion air is provided by a louver which is ducted down to within 12 inches of the floor. A second louver appears to have been closed off and the provisions for combustion air do not appear to be compliant with the code.

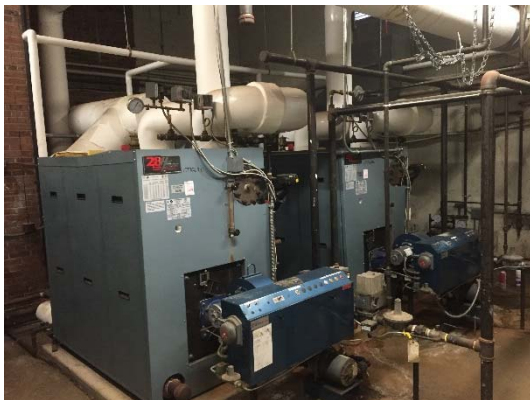
Heating for the West Wing and Senior Center is provided by two Smith model 28HE-S-08 Steam Boilers with Power-Flame dual fuel burners capable of firing #2 Fuel Oil or Natural Gas. The Boiler Room is neat and well organized and the Boilers appear to be well maintained, in good condition, likely having a remaining useful life of 10 years or more. Boiler Room piping and equipment appears to be in mostly good condition except for the Boiler Feed Unit which is badly corroded from leakage and appears to be at the end of its useful life. The leak appears to have been repaired and the life of the unit may be extended by performing maintenance including cleaning and painting.

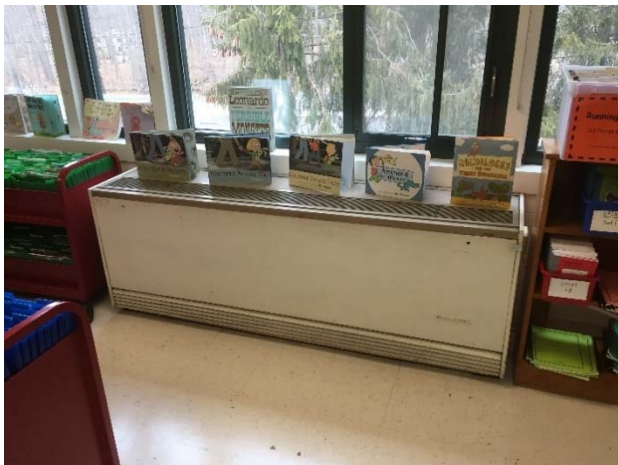
Heating and Ventilation the original Classrooms of the North Wing is provided by Unit Ventilators which appear to be at the end of their useful lives. Unit Ventilators generally do not meet the State's requirements for classroom noise levels so replacement equipment will likely be rooftop HVAC equipment.

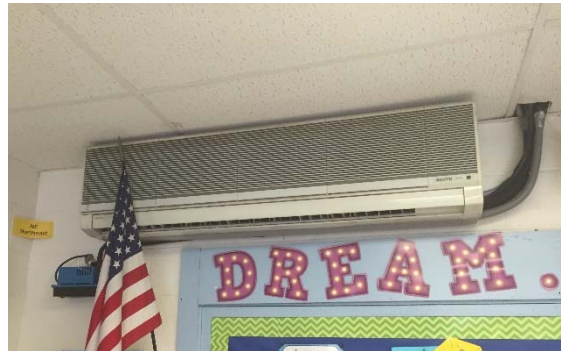
Five classrooms have been provided with Ductless Split System Air Conditioning. The equipment is relatively new and appears to be in good condition but will become obsolete with the installation of central Air Conditioning equipment.

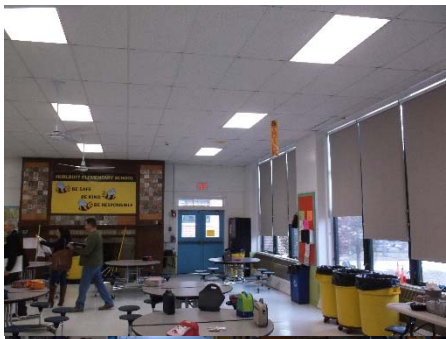
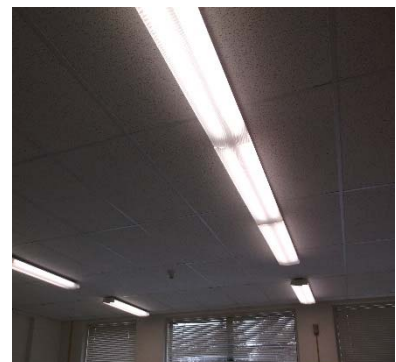
The Central House existing luminaires are mostly made up of recessed 2'x2' and 2'x4' parabolic fluorescent fixtures with some incandescent track lights in the corridor outside of the Art room. The media center has pendant mounted direct/indirect fluorescent "bowl" fixtures and direct/indirect linear fluorescent fixtures in the center of the room. With recessed 2'x2' parabolic fluorescent fixtures on both sides. The Computer Lab had rows of pendant mounted indirect linear fluorescent fixtures. The lower level mechanical/electrical rooms have pendant mounted industrial fluorescent fixtures with wire guards while the corridor and stairwells leading to these rooms have surface and pendant

mounted "wraparound" fluorescent fixtures. The lights in this building are controlled by wall switches at the door(s), except the individual offices which had ceiling mounted occupancy sensors in conjunction with a wall switch. The East House existing luminaires are made up of recessed lensed fluorescent fixtures and surfaced mounted "wraparound" fluorescent fixtures. The lower level Boiler room and Storage/Electrical room have surface and pendant mounted industrial fluorescent fixtures with wire guards. All lighting in this building is controlled by wall mounted switches door(s), no occupancy sensors were observed. The South House existing luminaires are mostly made up of recessed lensed fluorescent fixtures, except in the Kitchen & Cafeteria where they are surface

The light fixtures in the Core Building are the newest and are in good condition along with the parabolic fixtures in the other buildings. Some of the surface mounted "wraparound" fixtures are in good condition, while a large number are at or beyond their useful life. Most of the surface mounted and recessed lensed fluorescent fixtures are also at or beyond their useful life. These fixtures should be replaced with new efficient LED fixtures. Additional energy savings could be had by installing occupancy sensors all classrooms that do not have them to turn lights off automatically when the rooms are not in use. Also, any classroom that has new LED fixtures installed should have a day light sensor installed for additional control of the fixtures along the windows.

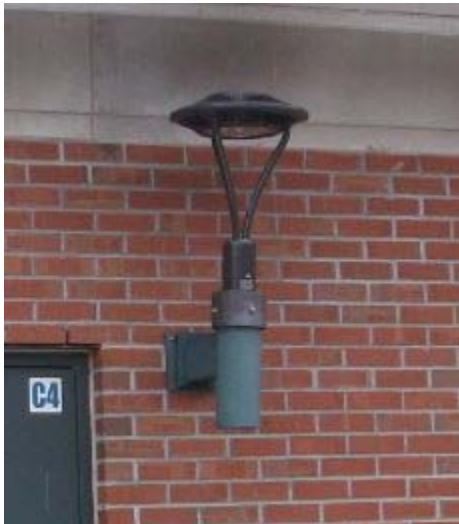
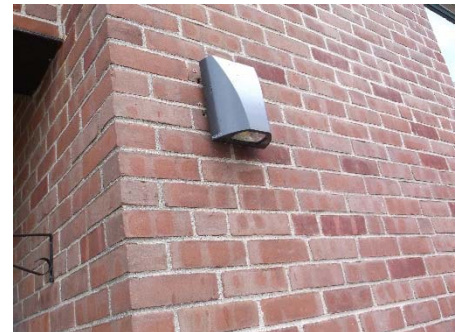
The existing luminaires throughout the exterior consist of new building mounted post top LED fixtures, wall mounted full cutoff LED sconce fixtures, surface mounted canopy light fixtures and pole mounted post top and "shoe box" LED fixtures. The pole mounted "shoe box" fixtures are installed only in the parking area of the senior center on new matching square poles. The building mounted and pole mounted post top LED fixtures are mounted to the existing pole and building mounted arms. The fixtures are all in good condition and should not need to be replaced or upgraded. The lights were not on at the time of the walk through since it was late morning early afternoon, so their operation could not be verified. Without a

photometric report with all the existing normal & emergency exterior fixtures, we cannot determine if the code required light levels are met. Also, it does not appear that all exterior egress doors have an emergency fixture and/or second normal fixture, so that failure of a fixture will not leave the area without light.

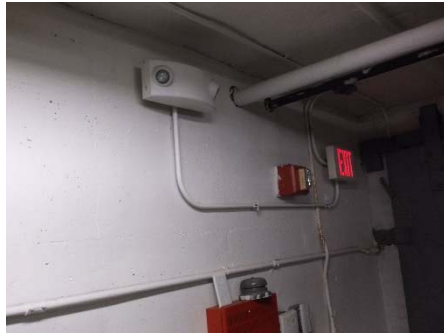
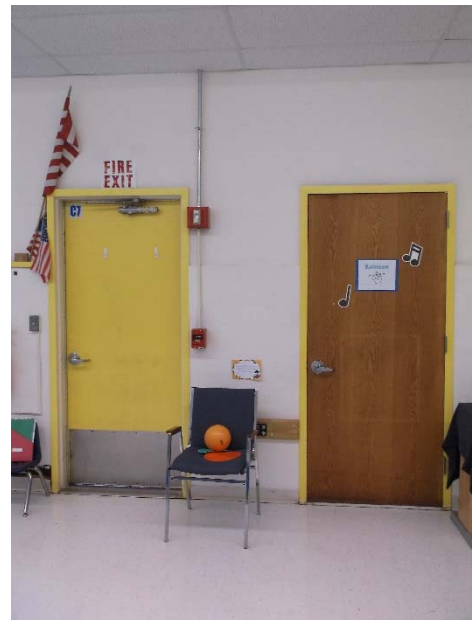
There are existing emergency lights throughout the buildings, we are not sure the design meets the code and should be reviewed with the AHJ. There are old central DC battery systems in multiple buildings with “dead light” incandescent fixtures which we were told are no longer operational. These systems should be removed to avoid confusion on whether these lights or this system is not working. There are self-contained twin head emergency light fixtures in some of the utility areas, these fixtures appear to be in good operating condition. We were not able to test all fixtures at the time of our walk through. The

There are existing exit signs located throughout the facility, there are signs with thermoplastic housings and LED lamps. These signs appear to be in good condition and most were operating properly in the public spaces. There are also many non-illuminated exit signs, mostly located in classrooms with exterior egress doors. These signs do not meet the current code, and we recommend they be replaced with new illuminated LED signs.

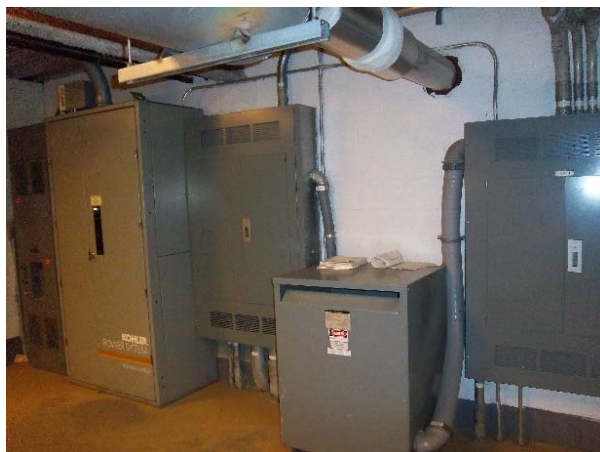
The existing electrical service originates from a pad mounted utility transformer located to the east side of the Central House. From the utility transformer, the secondary feeder runs underground to a 1200 amp, 480Y/277V – 3 phase service rated switch. The service switch intern feeds a generator transfer switch, we could not determine the size of the transfer switch but assume it is 1200 amps. The transfer switch feeds a distribution panel “MDP-1”, this panel feeds the four houses (Central, North, East & South/Senior Center) via a 150 KVA transformer located in each house. Also in this room is a 265 KW diesel generator and day tank that feeds the standby side of the transfer switch.

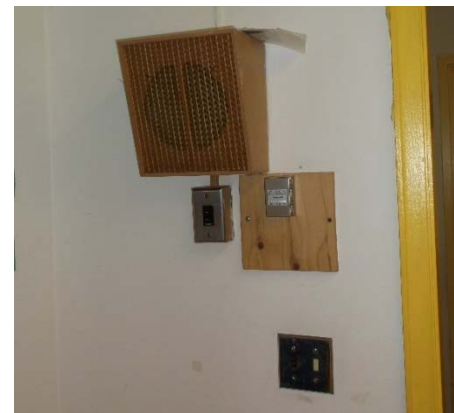
The existing data outlets are located throughout in the classrooms and the Administration Offices. There is a network cabinet (Multicom-2000) in the main office with the Franklin Time System master clock, CD & DVD player. There are wall mounted phones in all the classrooms, along with a wall mounted clocks and speakers. There are speakers in all the hallways and utility rooms. Some of the classrooms in the East House have older wall mounted speakers that should be upgraded to a newer ceiling mounted speaker. There are desk phones in the Offices of Central House.

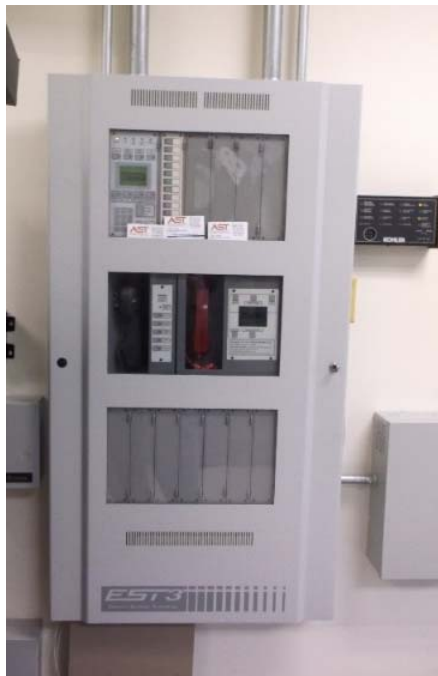
Fire Alarm

The existing fire alarm system is an addressable Edwards (EST3) system, with the control panel located in the main office. There are additional power panels and transponders located in the other houses. There are manual pull stations at the egress doors along with audio/visual devices throughout the complex. There appears to be a voice evacuation system, we could not determine if it is throughout the entire school or only in the assembly spaces. The devices throughout appear to be in good operating condition.

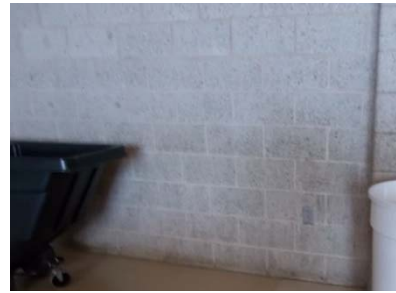
Figure 4: Cafetorium CMU wall

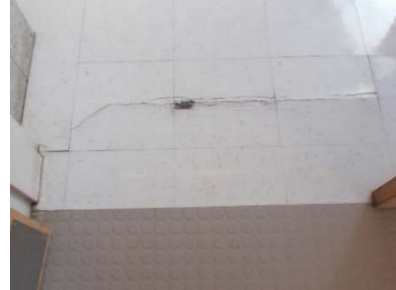
Figure 5: VCT cracking near stair

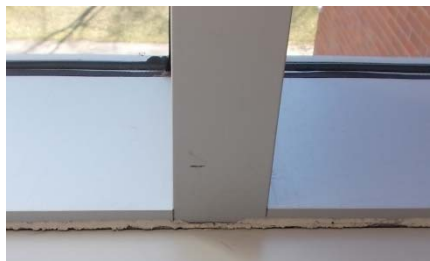
Figure 6: Window caulk cracking

The facility consists of a similar doors, frames and hardware. Most doors are wood doors, some with a glazing opening within the leaf. Hardware are hand levers and panic devices that meet today's code requirements. Frames are painted. Overall the interior doors are in good condition. It is recommended to continue painting frames as required. The interior of the windows are in good condition although caulk is beginning to crack in some locations. Typically caulk should be replaced every 10-15 years.

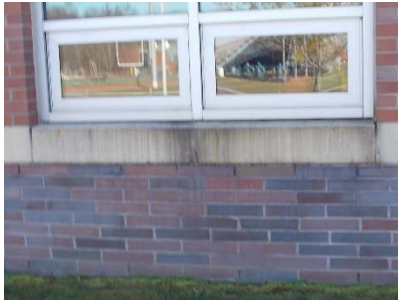
Figure 7: Precast sill

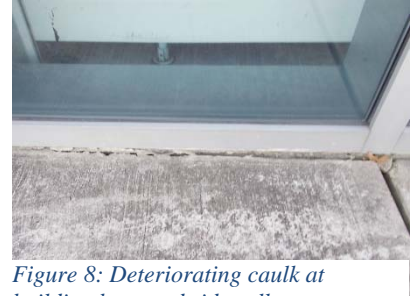
Figure 8: Deteriorating caulk at building base and sidewalk

A3	Areas at base of masonry and parapet are dirty with mildew and vegetation			3				Clean and seal	\$ 8,000	
A4	Caulk where building meets sidewalk caulk is deteriorating			3				Recaulk as required	\$ 2,000	
A5	Caulk and mortar around precast parapet cap and masonry have mildew			3				Recaulk as required	\$ 3,000	
A6	Control joint caulk is showing early signs of wear and cracking			3				Recaulk as required	\$ 5,000	
A7	Knee wall at gymnasium					1		Rebuild parapet, portion of roof and add external gutters - at \$800 per linear foot	\$ 264,000	
EXTERIOR SUBTOTAL									\$ 298,000

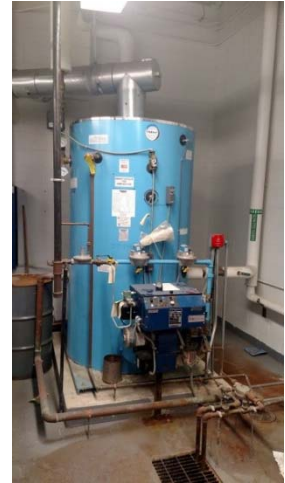
Water temperature was designed to be maintained by the use of heat trace cable on the hot water piping. At the time of the site visit, the controllers for the heat trace system were off and we were told that they had been off for years. No one was able to tell us the reason they were off. They just knew that they had always been off since they worked there and that there are issues with having to wait an extended period of time to get hot water at the further area of the building. At an additional visit to the building with a manufacturer's representative for the company that manufactures the heat trace system, the units were powered up and the controllers were reprogrammed.

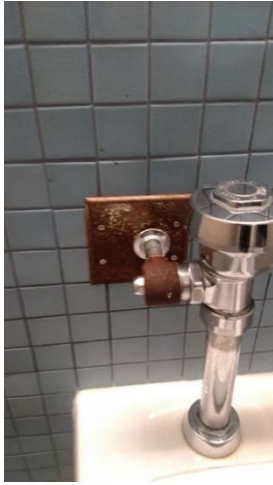
While the overall condition of the fixtures is good, some of the issues noted during the visit are noted below. Some of the chrome trim on the flush valves is severely corroded and should be replaced. The reason for the corrosion is unknown and difficult to determine since it only seems to be effecting certain trim pieces and only on certain valves (See photo below left). A janitor's sink was observed with

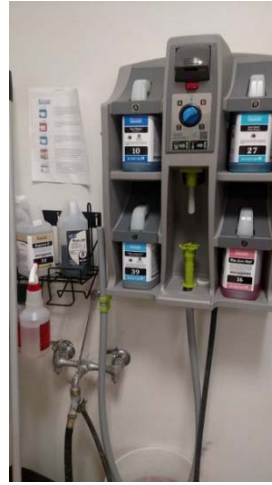
hoses connected to the faucet from a chemical feed system without a vacuum breaker to prevent back siphoning in the event of a drop in building water pressure (See photo below right). The condition could result in contamination the domestic water system creating a safety hazard. Recommend installing a vacuum breaker as soon as possible.

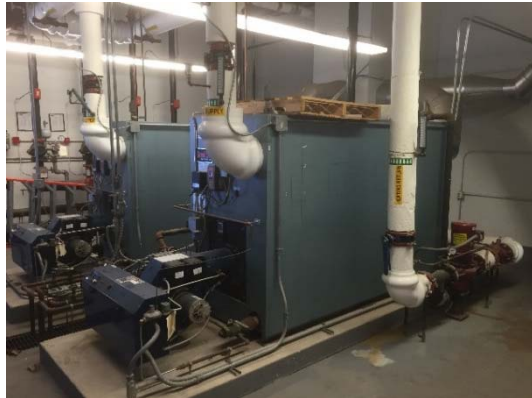
Heat for the school is provided by two Smith Model 28A Hot Water Boilers, each with a heating capacity of approximately 3200 MBH. The Boilers are equipped with Power-Flame Dual Fuel Burners which were firing on natural gas at the time of our visit. The Boilers appear to be in good condition and well maintained. The Boiler Room is neat and well organized. The equipment, piping and insulation all appear to be in good condition with no visible signs of leakage.

Since Boiler life can be affected by poor water quality and inconsistent maintenance, it is recommended that the boiler water be periodically tested. Regular preventive maintenance should be performed to maximize the service life of Boilers and related equipment.

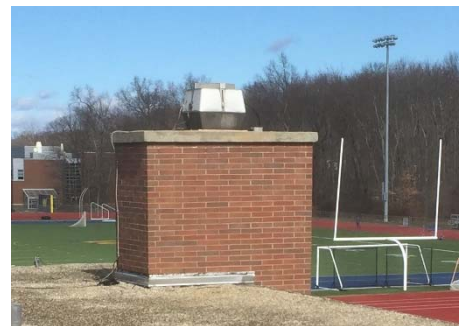
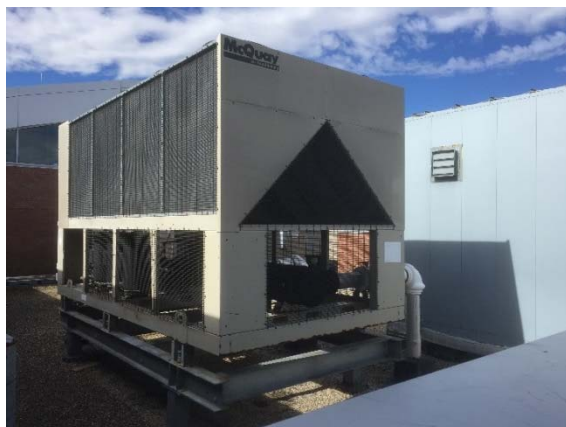
Draft Inducer is located at the top of the Chimney. Chimney height does not appear adequate to prevent flue gases from being introduced to the building through the rooftop air intakes under certain wind conditions. If odors of burning fuel are present within the building, the chimney height may be increased to address the situation. The Chimney and Draft Inducer should be cleaned and inspected as part of normal preventative maintenance.

M2	Chimney and Draft Inducer require regular service				2		Clean and Inspect chimney annually. Inspect and test Draft Inducer.	\$ 1,300	Annual Cost
M3	Combustion Air is provided by Fan in Boiler Room				2		Check for proper operation regularly. Replace drive belts, damper actuators and motors as required.	\$ 100	Annual Cost
M4	Two Chillers should receive continued preventative maintenance			3			Perform Chiller service including testing of compressors, fans, controls and refrigerant charge, and cleaning heat exchangers.	\$ 2,400	Total annual cost for 2 Chillers
M5	Hot Water and Chilled Water Pump life may be extended by regular service			3			Inspect and service pumps annually. Provide repairs as required.	\$ 1,600	Total annual Cost for 8 Pumps
M6	Air Handling Units require regular service			3			Replace filters and fan belts, lubricate bearings and damper linkages, check damper and valve operation, clean coils, condensate pans and drains.	\$ 3,500	Total annual Cost for 7 AHUs

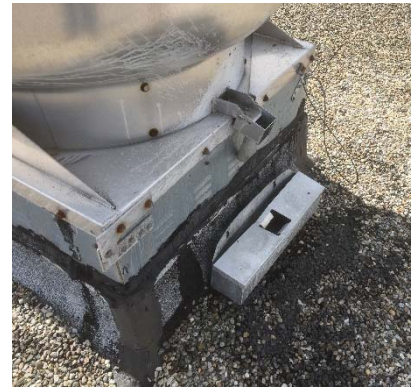
The Grease Exhaust Fan appears to be in serviceable condition but the grease trough has come loose from the fan. Recommend reattaching the grease trough to the fan to prevent the cooking grease from damaging the roof.

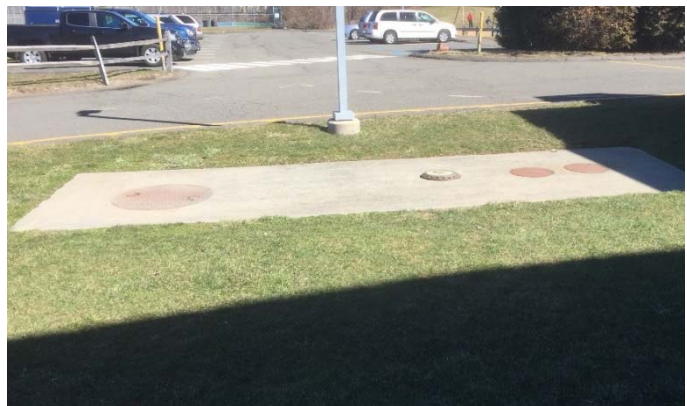
The Underground Fuel Storage Tank (UST) was installed in 2004 and is scheduled for removal in 2034.

The Tank Inventory and Leak Detection System should be periodically checked for proper operation.

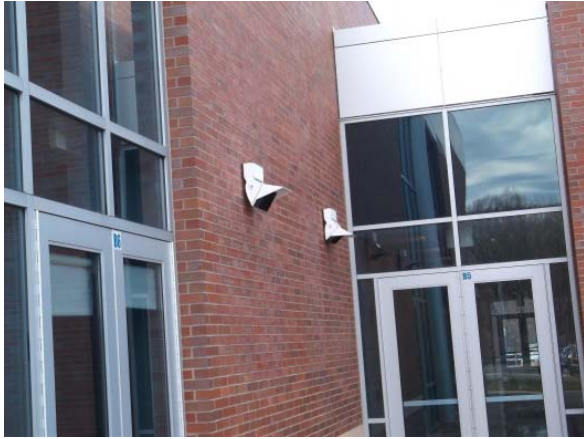
Exterior Lighting

The existing luminaires throughout the exterior consist of recessed down light fixtures in the canopies. Building mounted white adjustable fluorescent fixtures with black louvers and a white shroud. The shroud is meant to provide the fixture with a full cutoff design to meet the code. The problem is the fixture can be adjusted where the fixture is no longer full cutoff. We propose these fixtures be replaced with new LED full cutoff fixtures; this will save energy and meet the code. The parking lot lighting is provided by pole mounted (approximately 20' high) LED low profile full cutoff fixtures. The pole mounted fixtures are all in good condition and should not need to be replaced or

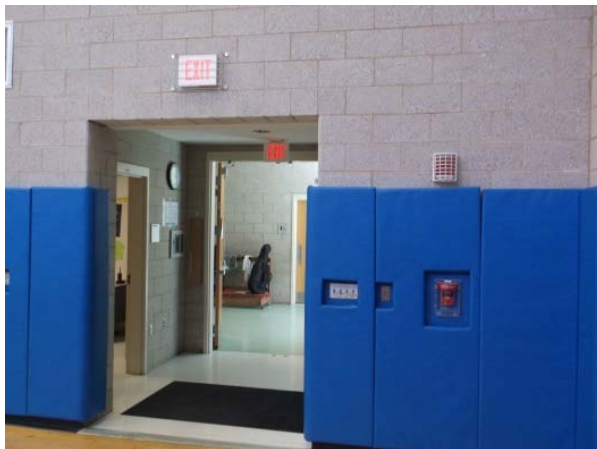
Exit signs & Emergency Lighting

The existing emergency lighting is provided by general building light fixtures wired to the generator distribution system and a few battery powered (normally off) fixtures. The current code does not allow a single transfer switch to serve both emergency and standby loads from the same switch. The standby loads (ie: HVAC equipment, kitchen refrigeration, misc. power, etc.) should be moved to a second transfer switch. We were not able to determine the extent of lighting on the generator to determine if proper light levels are provided during an emergency condition to meet the current code. This should be reviewed further, to determine if any area requires more emergency

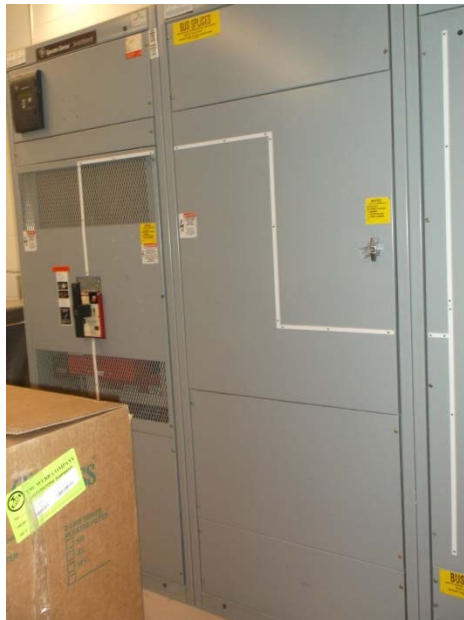
Power

The existing electrical service originates from a pad mounted utility transformer located to the north-east side of the building. From the utility transformer, the secondary feeder runs underground to a 2500 amp, 480Y/277V – 3 phase service rated switch in the Main Electric Room. The service switch intern feeds a distribution section via bus splice section. The distribution section of the switchboard feeds panels in the Main Electric Room and throughout the building. There are seven other “normal” panels in the room (both 480/277V & 208/120V) along with three transformers. There is an automatic transfer switch fed from a 125 KW diesel generator outside next to the pad mounted utility transformer. The transfer switch feeds a 480/277V panel, step down transformer and a 208/120V panel. The two generator panels serve some interior lighting, exterior lighting, paging system, security system, fire alarm system, kitchen refrigeration, misc. power and some HVAC equipment (heating). Also in the Main

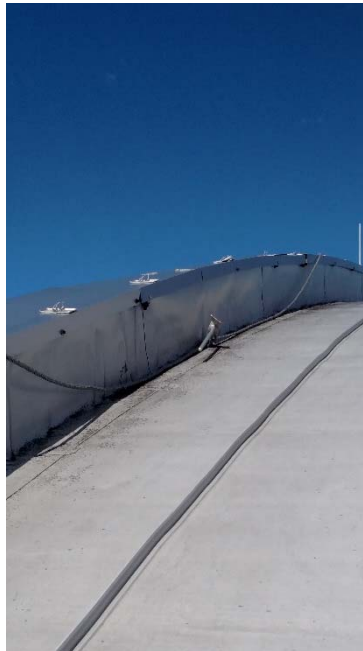
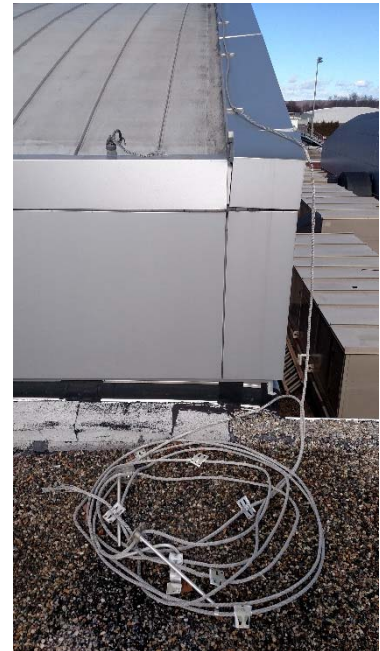
There is a lightning protection system installed on the roof of the building, with air terminals and cables. There is damage to both the air terminals and the cable along the south side of the Gymnasium roof. There are cables that are broken apart, air terminals damaged or pull off the roof and a section of cables and terminals just sitting coiled up on the roof.

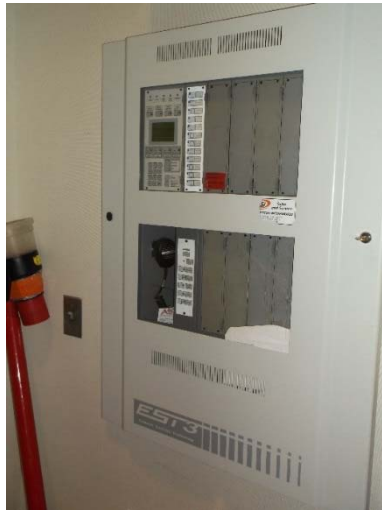
Fire Alarm

The existing fire alarm system is an addressable Edwards (EST3) system, with the control panel located in the corridor behind the Main Office and the batteries are on the wall in the room behind the control panel. There is a remote panel in the Cafeteria with voice capability and a second remote panel in the main lobby across from the elevator outside the Main Office. There are additional power panels located throughout the school. There are manual pull stations with “stopper” covers at the egress doors along with audio/visual devices throughout the complex. There are visual devices in all the Classrooms. There are carbon monoxide detectors in the mechanical room where there is fuel burning equipment. There are smoke detectors throughout the school, in the corridors, classrooms, stairs, etc. The system appears to have voice capabilities throughout the school and not just in the assembly spaces. The devices throughout appear to be in good operating condition.

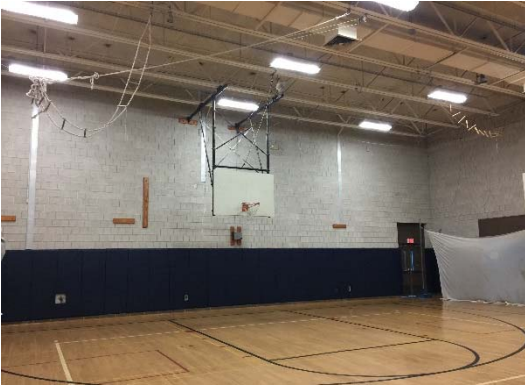
The interior of the building is maintained based on the existing conditions and existing systems. A visual inspection of the walls, floor and ceiling were reviewed during the building walkthrough. The interior walls consist mostly of concrete masonry units (CMU) or block. There are also some areas with sheetrock and paneled walls in between some of the classrooms. Most walls appear to be in fair condition. However, some of the block walls throughout the school have significant vertical cracks. Specifically, with the 8x8 CMU. This most notably occurs in the New Gym where numerous cracks are evident. Metal plates have been added to help remedy this issue. It is recommended to provide further evaluation by a structural engineer.

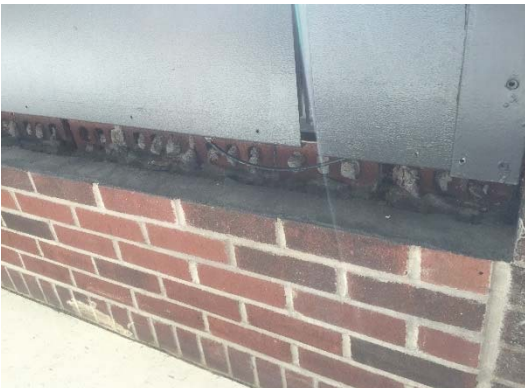
Figure 5: Below window wall missing brick course

Secondly, during the window renovations the removal of brick (likely due to PCBs) had taken place. The interior brick under the sills had never been infilled leaving the wall cavity open and unfinished. This is an aesthetically unpleasing look and it negatively impacts the thermal qualities of these walls. This should be infilled with brick or block. Additionally, rubber baseboard throughout the school is in need of replacement, specifically noted at the built out base of the lockers. These bases are also too large for the lockers and could result in a tripping hazard.

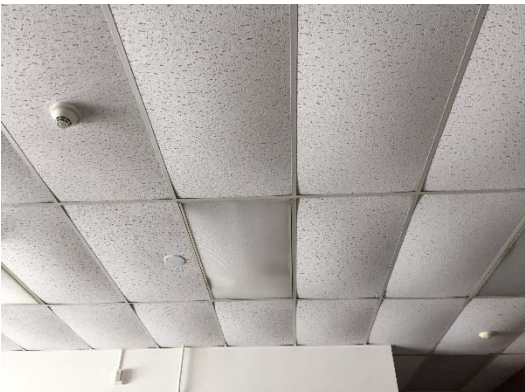
Figure 6: Typical sagging ceiling

The majority of the ceilings throughout the school are 2x2 or 2x4 dropped acoustical ceilings. There are also some areas with old spline ceilings. The remainder of the building is exposed structure and deck. This occurs in areas such as the gymnasiums, the Media Center, the newly painted decks in the technology rooms, and the original wood at the main entrance and admin spaces. Some corridors are exposed with low ductwork. Most of the acoustical tiles are old and sagging and they should be replaced. Spline ceilings should also be replaced. Some of the exposed ceilings could use a fresh coat of paint and the wood ceilings should be refinished to maintain their lifespan.

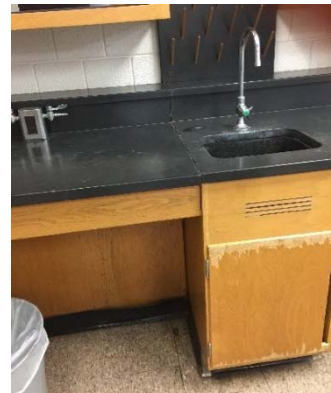
Figure 8: Science casework

Most casework and built-in shelving appear to be original to the school. Most are dated and nearing the end of their useful life. Some built-in bookcases in classrooms don't even have shelves. Most casework does not have knee spaces. The ones with sinks do not have the required knee space and therefore are not considered accessible. Science and Art classrooms have casework that is very dated, peeling and inefficient. These specific areas need more efficient and usable casework. There are some newer areas with blue plastic laminate casework that does appear to be in good condition. Additionally, lockers throughout the school are in disrepair. Student lockers in corridors are mangled and do not lock properly. Locker rooms are also not in the greatest condition. Lockers and the bases in the corridors should be replaced throughout the school.

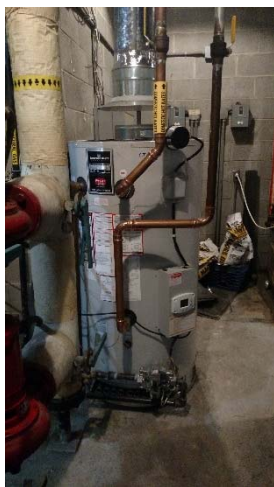
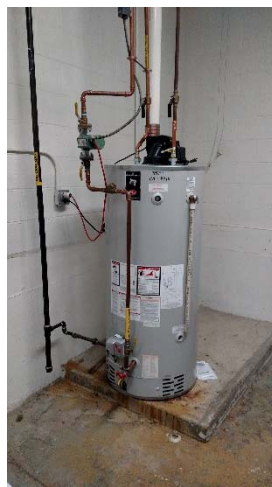
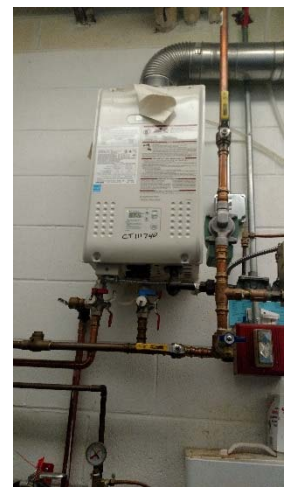
Domestic hot water is produced by three gas-fired water heaters. The first water heater, located in one of the boiler rooms, has an input rating of 450,000 BTUH and a storage volume of 80 gallons. The system is approximately 1-year-old. The system should have an average life expectancy of approximately 20-25 years and remaining life expectancy it about 19-24 years. The second water heater, located in the other boiler room, has an input rating of 76,000 BTUH and a storage volume of 75 gallons. The system is approximately 1-year-old. The system should have an average life expectancy of approximately 20-25 years and remaining life expectancy it about 19-24 years. The third water heater is a tankless water heater located in the office area of the kitchen. This water heater has an input rating of 199,000 BTUH and it appears that the old water heater is being used as a storage tank. The system is approximately 8 years old. The system should have an average life expectancy of approximately 15-20 years and remaining life expectancy it about 7-12 years.

To maximize service life, the Water Heater should be regularly serviced per the manufacturer's maintenance recommendations including, but not limited to, draining and flushing, testing relief valve, and inspecting/replacing anode. Refer to manufacturer's O&M literature.
