November Facilities Committee Meeting

Weston Public Schools, Facilities feasibility study and master plan.

BOE Facility Committee
presentation on
11-2-2017

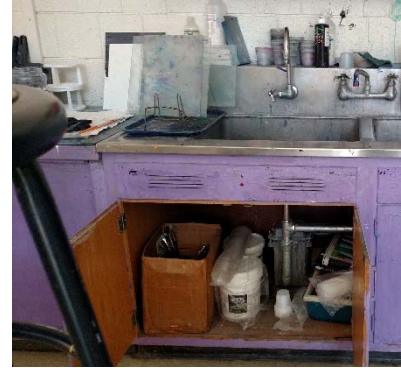
Plumbing fixtures for the building appear to be good condition. The urinals are a combination of wall mount and floor mount, both with manual flush valves. The building has some water closets that are wall mounted and some that are floor mounted, both with manual flush valves. The lavatories are a combination of wall hung lavatories with single or double controls metered faucets. The sinks in the art classrooms have solids interceptors on their drainage piping. The interceptors should be checked periodically and cleared of any solids that have been collected in them. Various styles of electric water coolers are provided throughout the building. The science sink drains are piped correctly with acid waste piping. It is unknown where the neutralization tank is that this piping is running into.

While the overall condition of the fixtures is good, one of the issues noted during the visit was that one of the floor drains in the locker room appeared clogged as there was standing water near the drain.

All of the fixtures in the kitchen are connected to a grease interceptor. No sanitary or storm piping issues were observed during the visit. If there are any areas with known issues, it is recommended that the pipes in that area get scoped with a camera to see if the root of the issue can be determined.

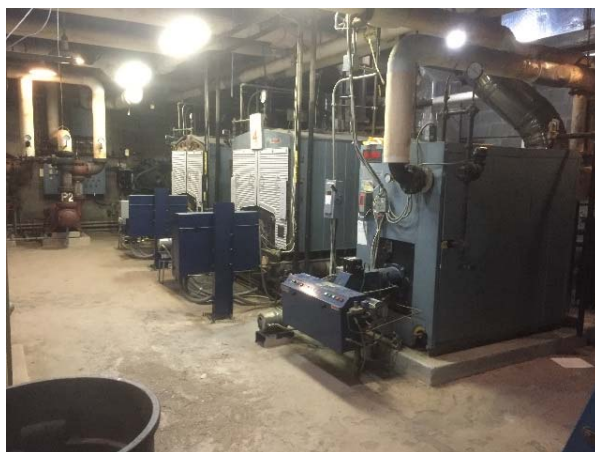
Heat for the facility is provided by two separate Hot Water Boiler Plants. The 1970 addition is served by the two original HB Smith 450 Mills Boilers which have been retrofit with Power-Flame dual fuel burners. The Boilers appear to be well maintained and in serviceable condition but at nearly 50 years old they are approaching the end of their useful life expectancy, are inefficient by current standards, and will become costlier to maintain. Hot Water Pumps and Fuel Oil Transfer Pump Set are at, or near, the end of their useful lives. Recommend planning for eventual replacement of Boilers, Pumps and related accessories and controls.

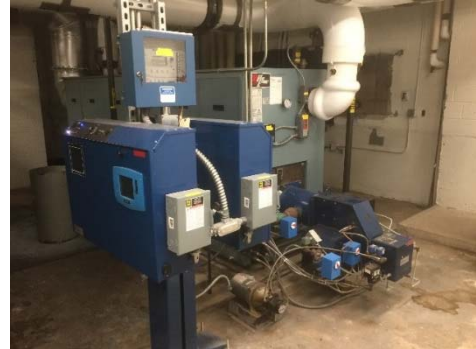
The 1960 Boiler Plant was renovated around 2010 at which time two Smith Model 28-HE-18 Dual Fuel Boilers were installed along with new Hot Water Pumps, Boiler Room Piping, Hydronic Accessories, and Fuel Oil Transfer Pump Set and piping. The Boilers and equipment appear to be in good condition with 20 to 30 years of useful life remaining. The equipment, piping and insulation all appear to be in good condition with no visible signs of leakage. Combustion air is provided by two roof mounted gravity vents ducted into the Boiler Room which appear to be adequate.

Since Boiler life can be affected by poor water quality and inconsistent maintenance, it is recommended that the boiler water be periodically tested. Regular preventive maintenance should be performed to maximize the service life of Boilers and related equipment.

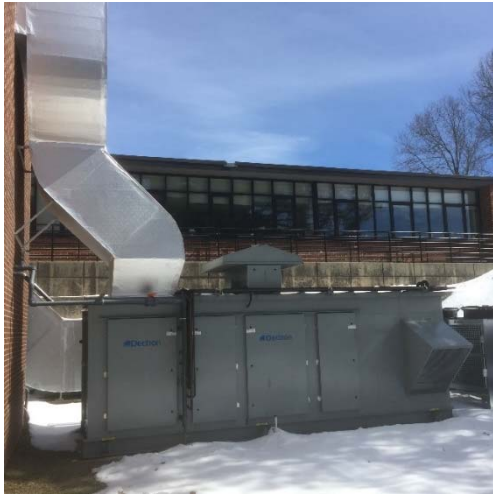
A new Pool Dehumidification System has been installed but final commissioning has not yet been completed. The system consists of a Dectron Dry-O-Tron unit located on grade and ducted into the Natatorium. Once online, the existing system serving the Natatorium will be abandoned and the new system will provide temperature and humidity control of the space.

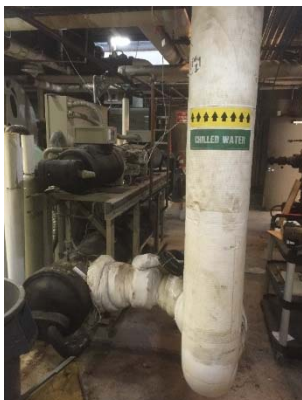
The Chiller supplies chilled Water to various Air Handling Units and Fan Coil Units serving the 1970 portion of the facility. The Chiller and Condensing Unit were manufactured in 2003, installed in 2004, and appear to be in serviceable condition with 10 to 15 years of useful life remaining. Chillers should be serviced annually by an HVAC Service Company in accordance with the manufacturer's Operation & Maintenance requirements.

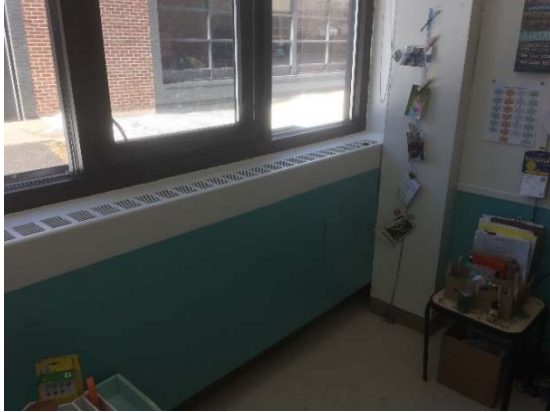
Perimeter Classrooms and miscellaneous spaces are served by Hot Water Fined Tube Radiation installed at the time of original construction. The enclosures are showing signs of age and the heating elements are likely providing diminished heating capacity having exceeded their useful life expectancy. Recommend planning for replacement as part of any major HVAC improvements.

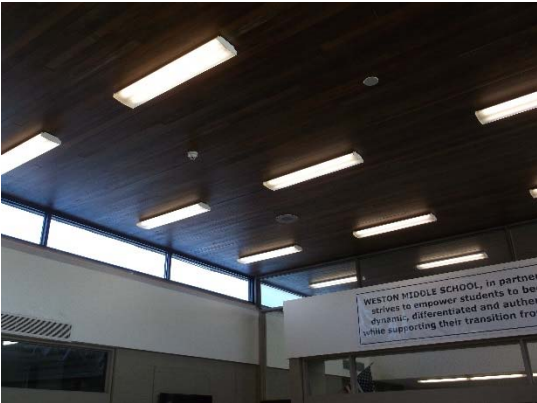
The existing luminaires are mostly made up of recessed 2’x4’ parabolic fluorescent fixtures, recessed lensed 2’x4’ fluorescent fixtures and some down light fixtures. In the Main Office and Lobby there are surface mounted fluorescent wraparound fixtures on a wood ceiling. The Classrooms are a mix of recessed lensed 2’x4’ fluorescent fixtures and surface mounted fluorescent wraparound fixtures, except the new Tech. Ed. Rooms have pendant mounted LED wraparound fixtures. The Corridors have both recessed lensed 2’x4’ fluorescent fixtures and recessed 2’x4’ parabolic fixtures. The Cafeteria has recessed 2’x4’ parabolic fixtures and the Stage has pendant mounted incandescent “RLM”

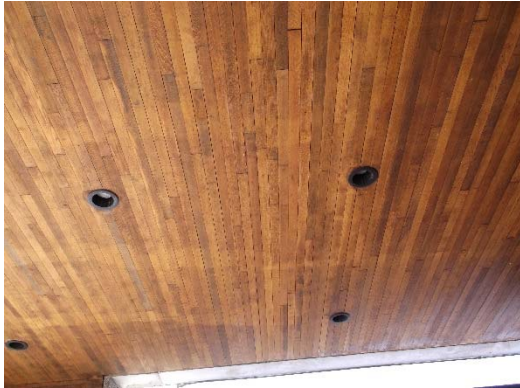
The existing luminaires throughout the exterior consist of recessed down light fixtures in the canopies. Building mounted “full cutoff” LED sconce type fixtures, round surface mounted fixtures (fluorescent or LED) and building mounted LED flood lights. The parking lot lighting is provided by pole mounted (approximately 20’ high) LED low profile full cutoff fixtures. There are also pole mounted fixtures, both low profile full cutoff and flood light type along the access driveway around the back of the school. The pole mounted fixtures are all in good condition and should not need to be replaced or upgraded. The lights

were not on at the time of the walk through since it was late morning early afternoon, so their operation could not be verified. It appears that all the exterior egress doors have both normal and emergency light fixtures installed at them, but without more information we cannot determine if the minimum light levels required are meeting the current code to allow for proper egress away from the building.

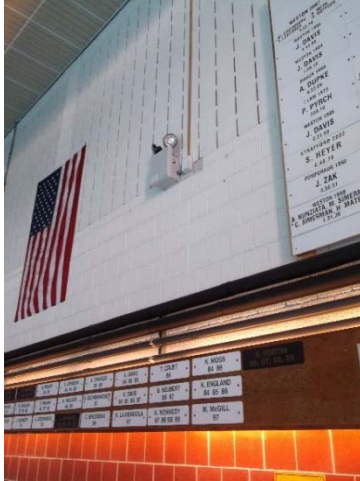
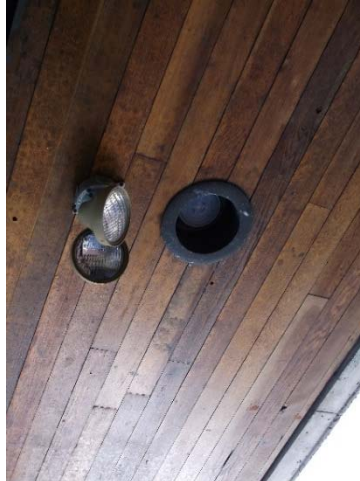
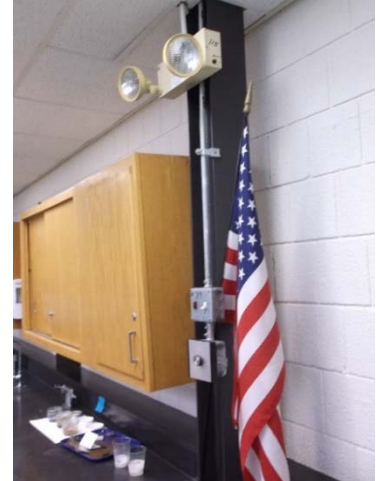
The existing emergency lighting is provided by self-contained battery powered normally off fixtures (twin heads, squares & recessed round fixtures). There are also normal building fixtures on the generator distribution that appear to be used for emergency lighting. The current code does not allow a single transfer switch to serve both emergency and standby loads from the same switch. The standby loads (ie: HVAC equipment, kitchen refrigeration, misc. power, etc.) should be moved to a second transfer switch. We were not able to determine the extent of lighting on the generator to determine if proper light levels are provided during an emergency condition to meet the current code. This should be reviewed further, to determine if any area requires more emergency fixtures, in addition to providing a “pure” emergency system. There are remote mounted normally off single & twin head emergency fixtures in the Courtyard, these do not appear to be able to provide the required emergency light levels to properly exit the courtyard. Additional emergency light fixtures should be installed to meet the current code requirements. We were not able to determine if there are enough normal or emergency fixtures to properly illuminate all the egress paths from the building to meet the current code.

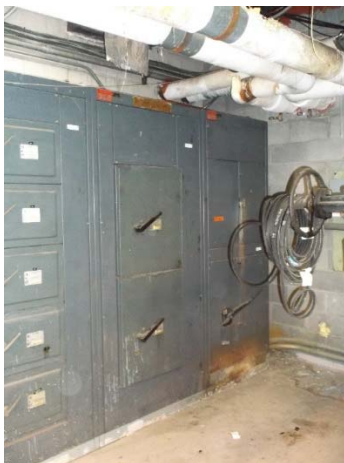
The existing electrical service originates from a pad mounted utility transformer located to the north-east side of the building. From the utility transformer, the secondary feeder runs underground to a 2500 amp, 480Y/277V – 3 phase service rated switch in the Boiler Room. The service switch intern feeds two distribution sections. The distribution sections of the switchboard feed panels throughout the building in local electrical closets and directly in rooms. There are two motor control centers in this room also, one “normal” and one “emergency” (both 480/277V). There is an Emergency Electric room adjacent to the Boiler room with an automatic transfer switch fed from a 275 KW diesel generator outside next to the pad mounted utility transformer. The transfer switch feeds a 480/277V panel, 150KVA step down transformer and a 208/120V panel. The two generator panels serve some interior lighting, exterior lighting, paging system, security system,

fire alarm system, kitchen refrigeration, misc. power and some HVAC equipment (heating). The main electrical equipment is older and nearing the end of its useful life and will need to be replaced in the near future, also the location of the equipment does not meet current code. This room only has one door in or out of the room, which would require double the working clearances in front of the equipment or an unobstructed path to the door which it does not have. When the equipment is going to be replaced, careful planning and coordination will be required to locate the new equipment and be code compliant.

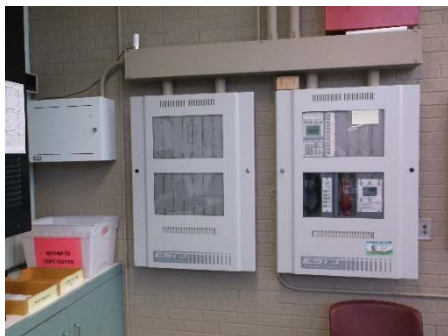
The existing fire alarm system is an addressable Edwards (EST3) system, with the control panel located in the Main Office on the south wall. There is a remote alarm panel along with multiple power supply panels (NAC panels) throughout and emergency phones in the Gymnasiums. There are manual pull stations at all egress doors and in the Gymnasium. The pull stations in the Gym have “stopper” covers. There are audio/visual devices throughout the building including all the Classrooms, the Pool, the Locker Rooms, the Gymnasiums and the Cafeteria. There are carbon monoxide detectors in the mechanical rooms where there is fuel burning equipment.

There are smoke detectors throughout the school, in the corridors, classrooms, stairs, etc. There is a beam detector transponder and receiver wall mounted on the east and west walls of the Pool. The system appears to have voice capabilities throughout the school and not just in the assembly spaces. The devices throughout appear to be in good operating condition.

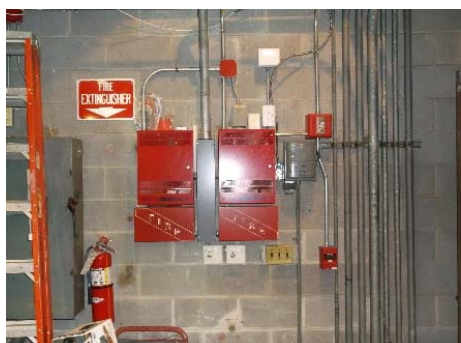
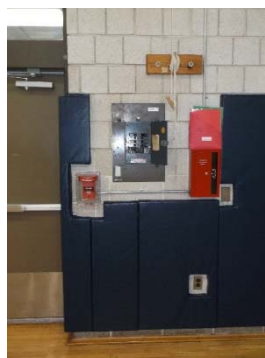
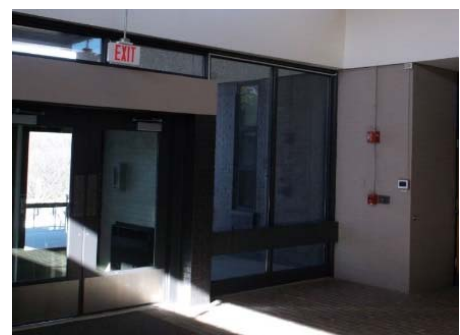
There is **not** “area of rescue” system for the stair at the new Gymnasium & Pool. This is code requirement, both landings of the stairwell should have a two-way communication system installed. The systems headend unit should be located either in the Main Office or the Security desk. In addition to the communication system, illuminated signs should be installed at each stair door. |

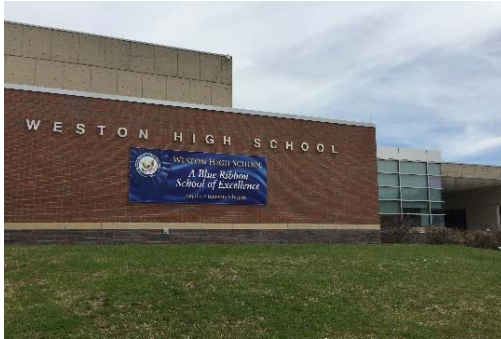
Figure 1: View of High School main entrance

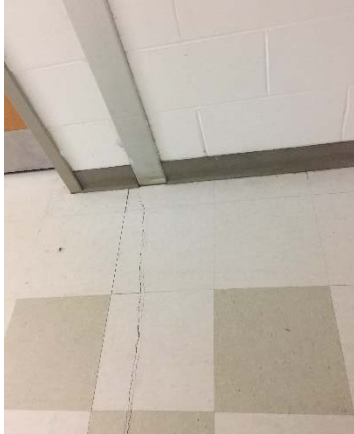
Figure 4: Cracked VCT where expansion joint is needed

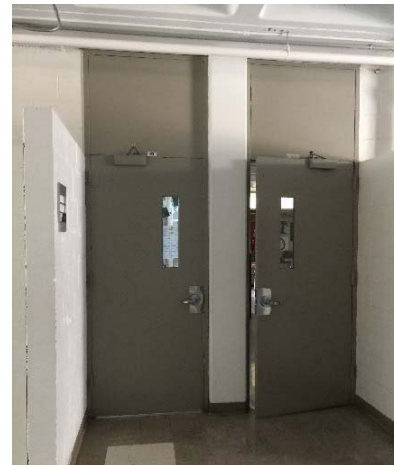
Figure 5: Original classroom doors without required push pull clearance

Many ADA accessibility and code issues were noted at this facility. This is a common occurrence given the age of the building and its renovations. These items should be included in the long term capital plan. Many of the doors within the original structure do not have the required push and pull clearances. All of the courtyards do not appear to meet the required egress as dictated by the code. All of the required grab bars do not exist in any of the handicap restrooms as they are all missing the vertical grab bar. Some gang toilet rooms are missing a handicap stall all together. As previously mentioned, in addition to these toilet rooms other ADA noncompliance items there is also the noncompliant casework.

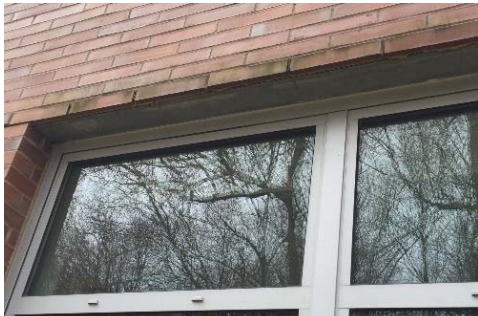
Figure 7: Window head condition

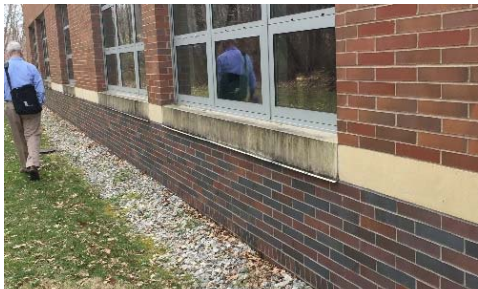
Figure 6: Window sill condition

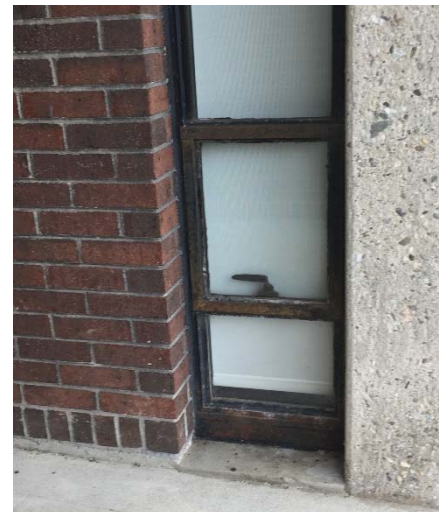
When evaluating the energy efficiency of a building, it is known that nearly 25–40% of all heat energy is lost through windows. The new additions have received new double-glazed aluminum frame windows. They appear to be in good condition. However, many of the old windows are still in place today. These older steel windows with a single pane of glass are not efficient at all. Many go all the way to the floor. There are also clearstory windows throughout the school too. Many of these windows are deteriorating and should be replaced with new energy efficient systems. The exterior doors seemed to have all be replaced. A few utility doors may still be existing from the original construction and should be replaced. There are a variety of roofs at this school. Ballast roofs are on the additions and a variety of EPDM roofs are on the existing building. The ballast roof appears to be in good shape. The roof was believed to be replaced in 2000 so it is approaching the end of its warranty period.

Figure 8: Original Window condition

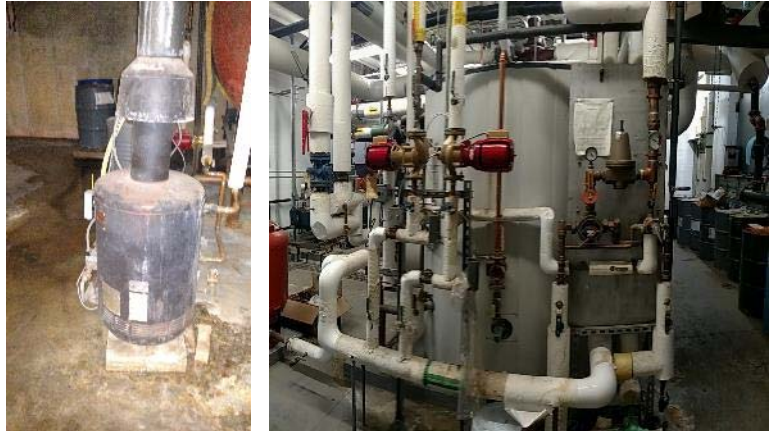
Domestic hot water is produced by two gas-fired water heaters. The first water heater, located in one of the boiler rooms, has an input rating of 199,000 BTUH and feeds two large storage tanks with unknown volumes. The water heater was manufactured in 1985 and is 32 years old. The system should have an average life expectancy of approximately 20-25 years, so this system has reached the end of its useful life. The second water heater, located in the other boiler room, has an input rating of 1,010,000 BTUH and a storage volume of 750 gallons. The system is approximately 12 years old. The system should have an average life expectancy of approximately 20-25 years and remaining life expectancy it about 10 years, however, there is some severe corrosion on some of the piping and this should be repaired/replaced.

To maximize service life, the Water Heater should be regularly serviced per the manufacturer's maintenance recommendations including, but not limited to, draining and flushing, testing relief valve, and inspecting/replacing anode. Refer to manufacturer's O&M literature.

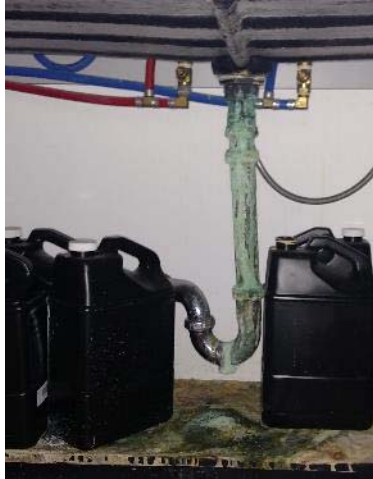
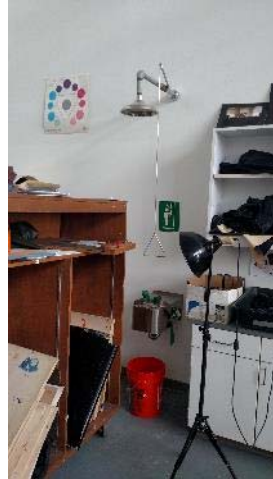
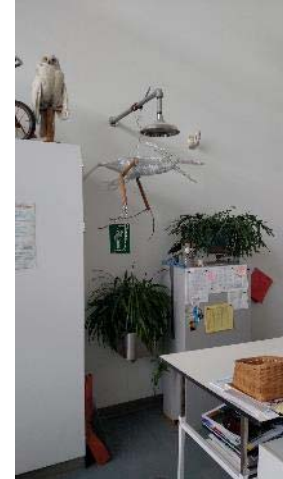
While the overall condition of the fixtures is good, there are a few issues noted during the visit. The drain for the sink in the darkroom has severe corrosion and should be replaced or repaired (See photo below left). Some of the emergency showers that are installed are not accessible or in working order due to items being stored in the area that should be clear for the shower or in one case, the handle for the emergency shower has been removed (See photos below center and right).

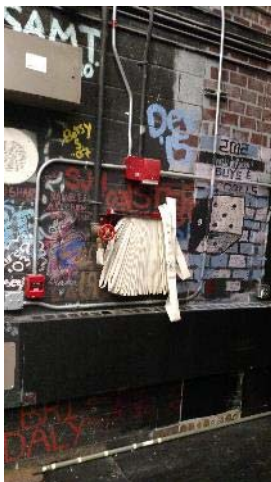
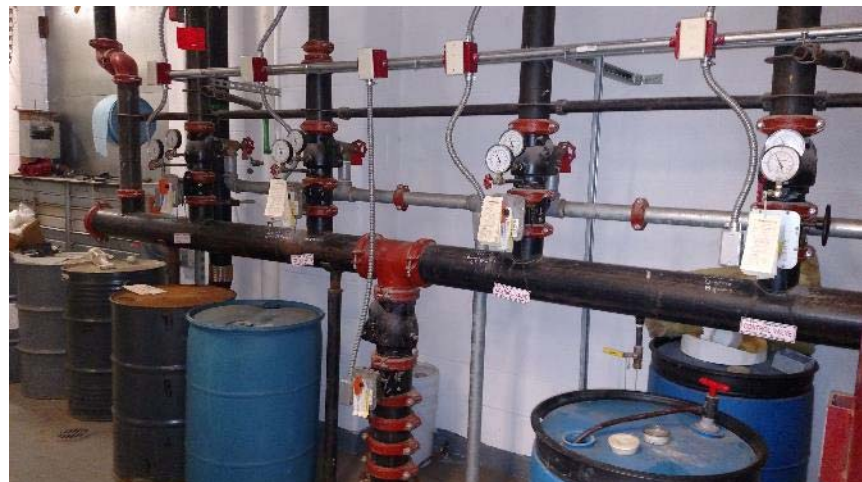
The facility is fully sprinklered. The sprinkler piping and components appear to be in good condition. There is a check valve and flow switch on the supply. This feeds 5 alarm valve risers that provide multi-zoned sprinkler coverage for the building. This main is fed from a pump house on the campus that serves multiple buildings. It is not known if the stage platform is wood-framed, as there was no visible way to access the area below the stage. Due to this, it is unknown if sprinkler protection has been provided under the stage or if it is required due to the type of construction materials used. The stage has been provided with standpipes. Overall, the sprinkler system for the school appears to be in good condition.

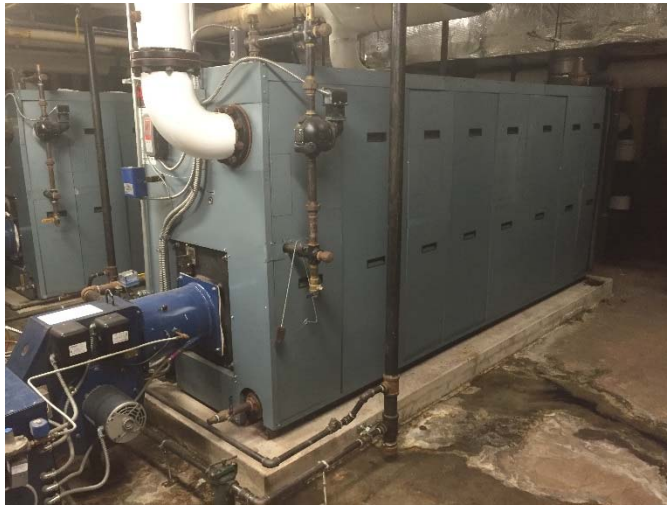
Heat for the facility is provided by two separate Hot Water Boiler Plants. The 1968 portion is served by two Smith Model 28HE-W-18 Boilers installed in 2011. The boilers are fitted with Power-Flame dual fuel burners. The Boilers appear to be well maintained and in good condition with likely 25 to 30 years of useful life remaining. The Hot Water Pumps, system valves and accessories appear to date back to the original 1968 construction. The pumps should be considered near the end of useful life but appear to be serviceable and may remain in service with continued Maintenance. Recommend planning for eventual replacement. Provision for combustion air appears adequate.

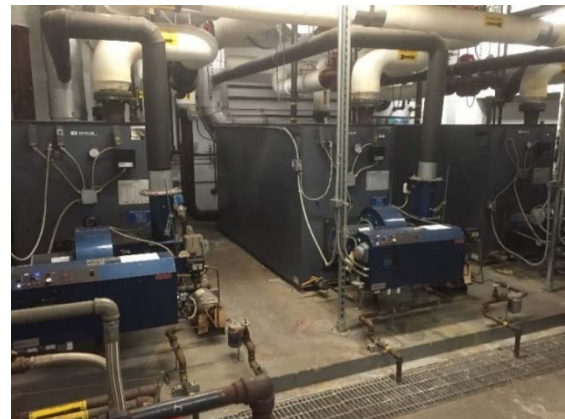
The 2005 addition is served by three Weil-McLain model 1488 Hot Water Boilers equipped with Power Flame Dual Fuel Burners. The Boilers appear to be well maintained and in good condition with likely 20 to 25 years of useful life remaining. Provision for combustion air appears adequate.

Since Boiler life can be affected by poor water quality and inconsistent maintenance, it is recommended that the boiler water be periodically tested. Regular preventive maintenance should be performed to maximize the service life of Boilers and related equipment.

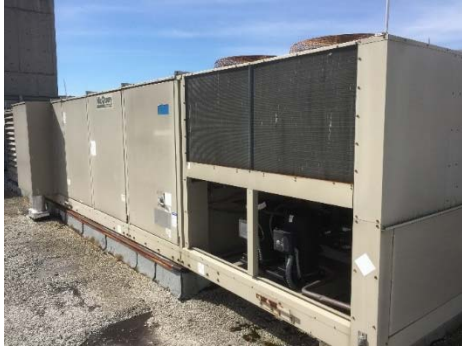
Packaged Rooftop Air Conditioning Units installed as part of the 2005 project serve interior spaces and the 2005 Additions. The units appear to be in good condition with 10 to 15 years of useful life likely remaining.

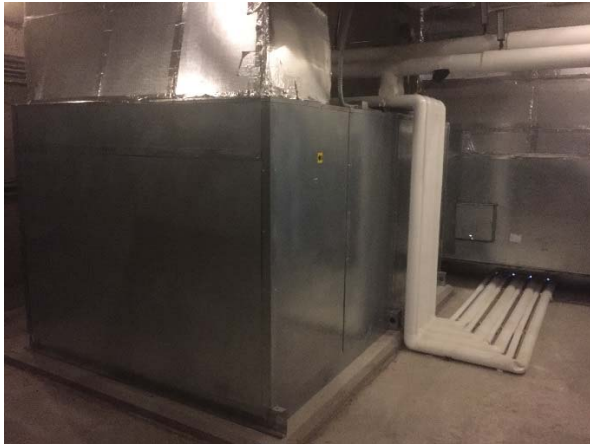
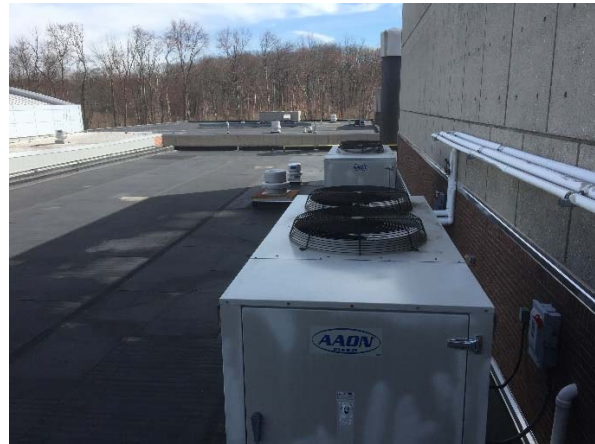
The Auditorium is served by an Air Handling Unit located in the Mezzanine Mechanical Room with a pair of roof mounted Condensing Units. The Unit was installed as part of the 2005 renovations and appears to be in good condition with 10 to 15 years of useful life remaining.

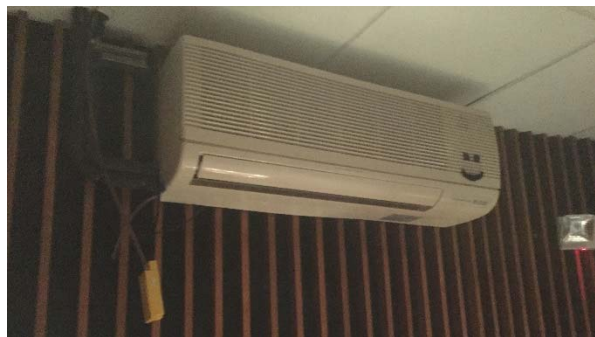
Auditorium Control Booths are provided with Air Conditioning by Ductless Split Systems. The units appear to be in good condition with 10 to 15 years of useful life remaining.

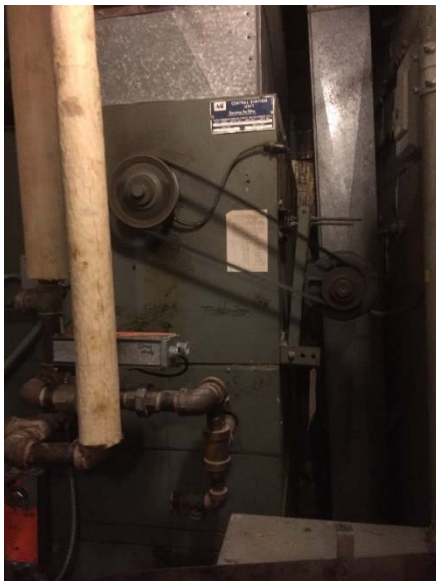
An original 1968 Air Handling Unit serves a portion of C-Wing. The unit is at the end of its useful life and should be budgeted for replacement. The unit is currently running with an exposed drive and no belt guard which is a hazard to personnel.

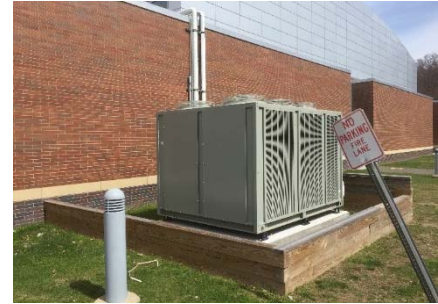
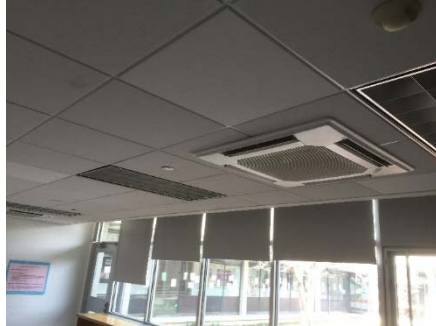
The New Gymnasium is served by a roof mounted Air Handling Unit installed at the time of construction in 2005. A 60 Ton Chiller was added to serve the Gym Air Handling Unit in 2015. The Air Handling Unit is in good condition with 15 to 20 years of useful life remaining. The chiller likely has 25 or more years of useful life remaining.

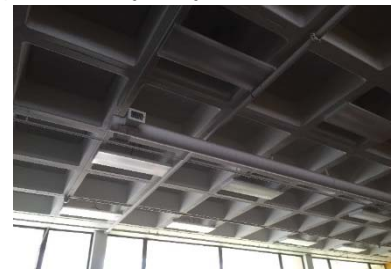
The Weight Room and Dance Studio are served by a Packaged Rooftop Unit serving other spaces of the Athletic Department. The Weight Room and Dance Studio are at the end of the duct run, the supply duct appears to be small for the space and ventilation of the spaces is not adequate. Recommend installing a unit dedicated to the Weight Room and Dance Studio.

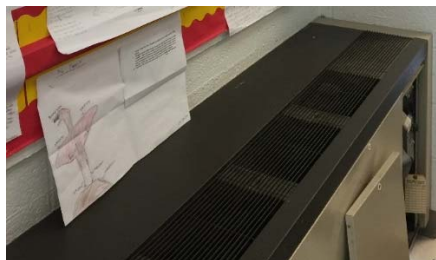
Classrooms B-6 thru B-9 of the 2005 B-Wing addition are served by a Packaged Rooftop Air Conditioning Unit. The Classrooms have large north facing windows and there have been complaints of poor heating in those spaces. Recommend further investigation and possible installation of supplemental heating.

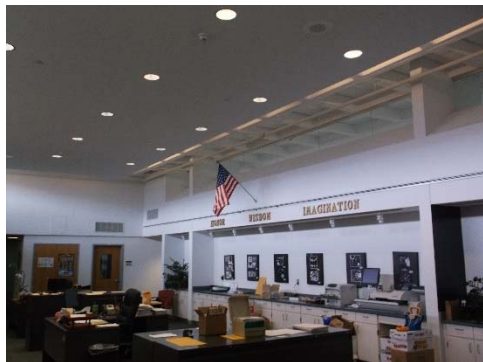
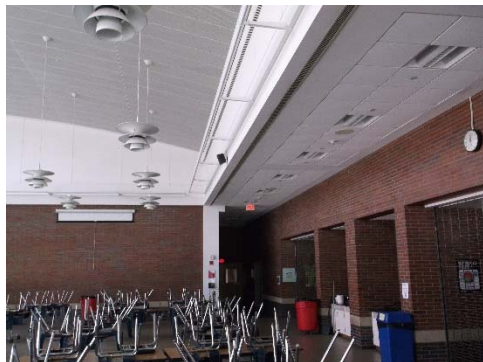
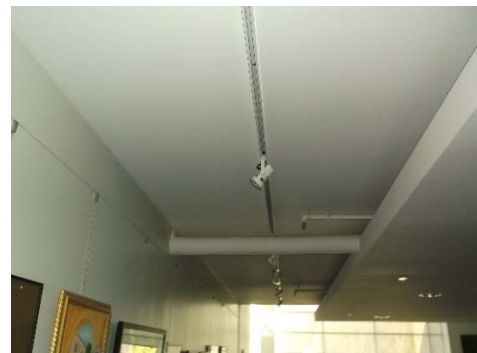
The existing luminaires are a mix of recessed, surface and pendant mounted fixtures, mostly fluorescent with some LED and metal Halide lamps. In the Main Office, Guidance and Lobby there are recessed 2'x2' & 2'x4' parabolic fixtures, recessed 2'x2' & 2'x4' center basket fixtures, surface mounted cylinder fixtures, recessed down lights, surface mounted track light fixtures and recessed down lights with decorative drop concentric metal rings. The Classrooms are a mix of recessed 2'x4' 18 cell parabolic fluorescent fixtures, surface mounted lensed 2'x2' fixtures, pendant mounted round direct/indirect fluorescent tube fixtures and some pendant mounted lensed LED 2'x2' fixtures. The Corridors have both recessed 2'x4' center basket fixtures and recessed 2'x4' 18 cell parabolic fixtures. The Cafeteria has pendant mounted decorative spherical metal halide fixtures and linear fluorescent wall wash fixtures and recessed 2'x2' center basket fixtures. The Auditorium has recessed down lights as the main "house light" fixtures with 4' industrial

fluorescent fixtures with wire guards on the stage. There are also theatrical lights installed on the Stage, three rows on motorized rails along with fixed mounted lights on pipes at the sides of the auditorium. The Kitchen and Serving area has recessed mounted lensed 2'x4' fixtures and pendant mounted

direct/indirect light fixtures. The Corridor running along the Gymnasiums and the Cafeteria has recessed linear wall wash pointed up along the length of the sky light. Both Gymnasiums have pendant mounted industrial high bay 3/4-lamp fluorescent fixtures with wire guards. The Media Center/Library has pendant mounted decorative spherical metal halide fixtures and linear fluorescent wall wash fixtures and recessed down light fixtures. The Science classrooms have recessed 2'x4' 18 cell parabolic fixtures. The main Courtyard has three frosted sphere fixtures mounted on 8' poles along with a few lights up under the canopies the other courtyards do not have lighting in them. The Computer Labs have pendant mounted round direct/indirect tube fixtures installed. The Locker rooms for both Gymnasiums have recessed 1'x4' & 2'x4' lensed fluorescent fixtures along with recessed fluorescent cove light fixtures in the bath rooms and wall mounted "jelly jar" fixtures in the showers. The utility spaces are typically illuminated by pendant mounted fluorescent wraparound or industrial fluorescent fixtures with wire guards. Most fixtures were working at the time of the walk through, but some of the fluorescent fixtures are near the end of their useful life and should be replaced with new efficient LED fixtures.

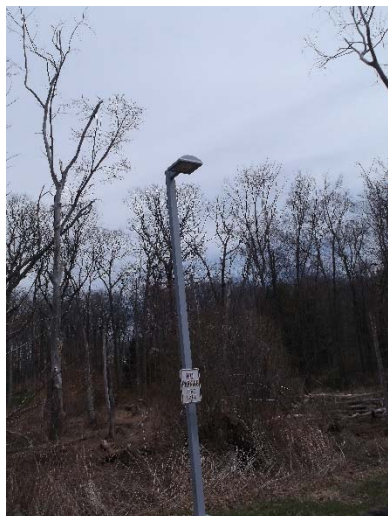
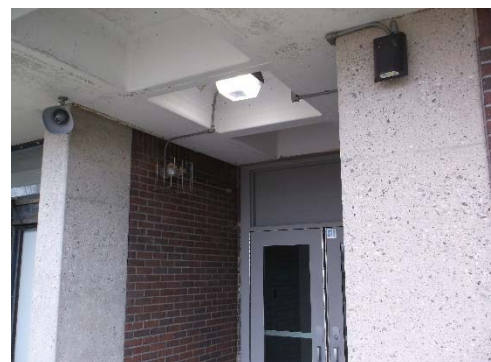
The existing luminaires throughout the exterior consist of surface mounted square metal halide/LED light fixtures and surface mounted round cylinder fixtures in the canopies. Building mounted "full cutoff" compact fluorescent/LED sconce type fixtures, two sizes, small and large. There are also ground mounted small LED flood lights aimed at the exterior of the building in some areas. The courtyards have frosted spherical fixtures on an 8ft. pole with some incandescent sockets. The parking lot lighting is provided by pole mounted

(approximately 20' high) LED low profile full cutoff fixtures. There are also bollard fixtures around the building, illuminating walkways. The pole mounted fixtures are all in good condition and should not need to be replaced or upgraded. The lights were not on at the time of the walk through since it was late morning early afternoon, so their operation could not be verified. It appears that all the exterior egress doors have both normal and emergency light fixtures installed at them, but without more information we cannot determine if the minimum light levels required are meeting the current code to allow for proper egress away from the building.

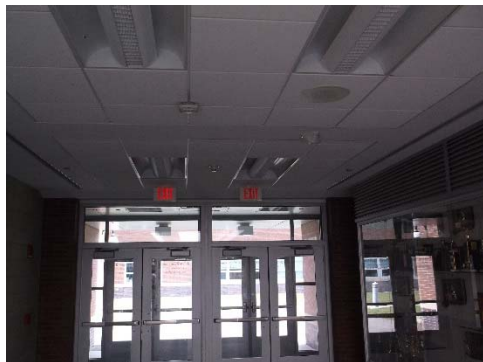
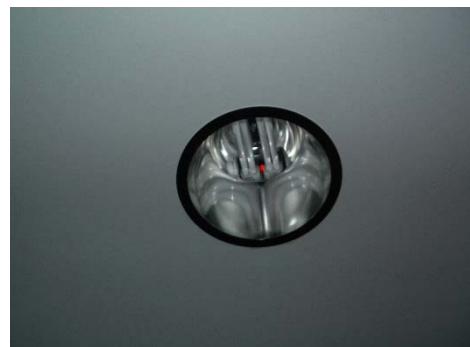
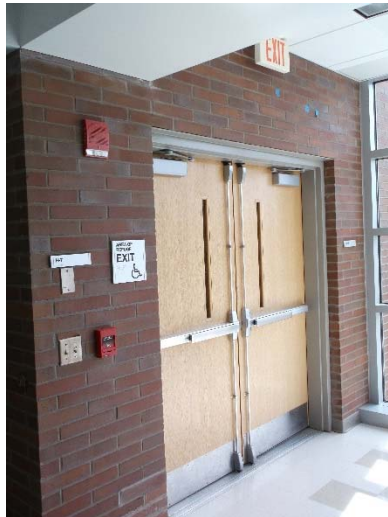
The existing emergency lighting is provided by self-contained battery powered normally off fixtures (twin heads, squares & recessed round fixtures) in addition to emergency battery ballasts in some of the general lighting fixtures. There are also normal building fixtures on the generator distribution; these are areas used for as part of the emergency shelter. This meets the requirements for a standby distribution system. If the school wishes to use the generators for emergency lighting, a second transfer switch will need to be added to each generator, and only code approved emergency systems can be wired to this system. We were not able to

determine the extent of the existing battery emergency lighting system, to determine if it meets the current code required light levels. This should be reviewed further, to determine if any area requires more emergency fixtures or replacement of units not operating. There are remote mounted normally off single & twin head emergency fixtures and exit signs in the Main Courtyard, some of these fixtures appear to be broken and are hanging by their wires. We could not determine if all the exit signs are working and it do not appear that the emergency light fixtures will provide the current code required light levels to properly exit the courtyard. Additional emergency light fixtures

should be installed to meet the current code requirements. The two smaller courtyards did not have emergency lights or exits signs in them, these should be added in order for the area to meet code and continued to be used by students and staff. We were not able to determine if there are enough normal or emergency fixtures to properly illuminate all the egress paths from the building to meet the current code.

WESTON HIGH SCHOOL - FACILITY CONDITIONS ANALYSIS									
TAG NO.	ASSESSMENT	SYSTEM/ CODE REFERENCE	RANKING				CORRECTIVE ACTION	ITIMIZED ESIMATED COST	REMARKS
ELECTRICAL SYSTEMS									
E1	Currently the emergency lighting is provided by stand alone battery units (normally off) & Battery Ballasts in the general light fixtures. There are areas that don't appear to have sufficient emergency lighting to meet the current code and should be reviewed further with the AHJ.					1	Install a code approved emergency lighting system throughout the school, there are a few options to achieve this (new AC inverter system, stand alone battery devices, battery ballast in general light fixtures or generator via emergency transfer switch.	\$ 71,000	\$71K is for a replacing or adding to 60% of the schools existing twin head & battery ballast distribution, it will cost approx. \$130K to modify the existing generator distribution, the third option would fall somewhere in between

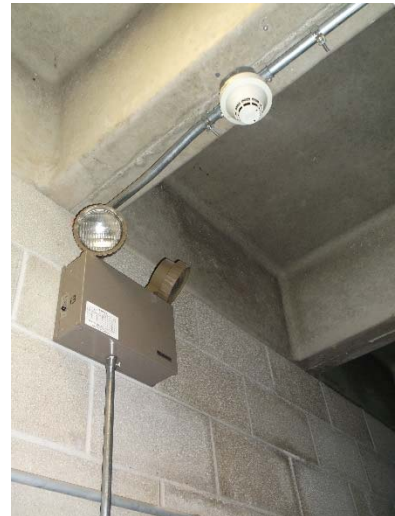
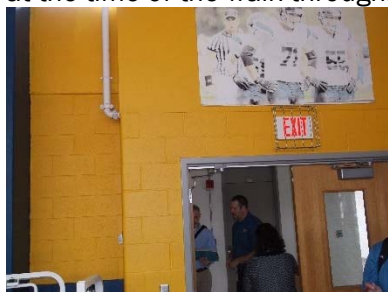
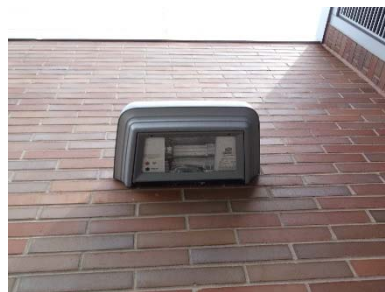
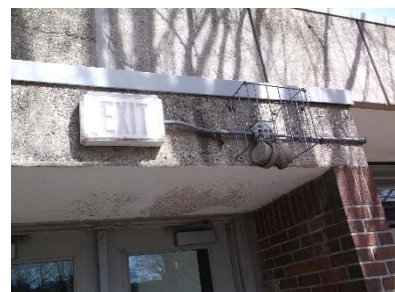
There are existing exit signs located throughout the facility, these signs are white thermoplastic housings with LED lamps and possibly some fluorescent lamps as well. These signs appear to be in good condition and were all operating properly, except for some of the signs in the Auditorium. The two stairs at the new Science addition are missing “area of rescue” signage. There are no low mounted exit signs in three assembly spaces (new Gym., old Gym. & Café.), required under the current code. We recommend added low signs to all doors in the three rooms. There are low exit signs in the Auditorium. There are approximately 20+ Classrooms that require two exits, it does not appear

that these rooms have the required illuminated exit signs and emergency lights installed. Each room over 1K square feet should be confirmed that there is an illuminated sign at the two doors and emergency lighting, if they do not exist add as required to meet the code. The exit signs all appeared to be in good condition and working at the time of the walk through.

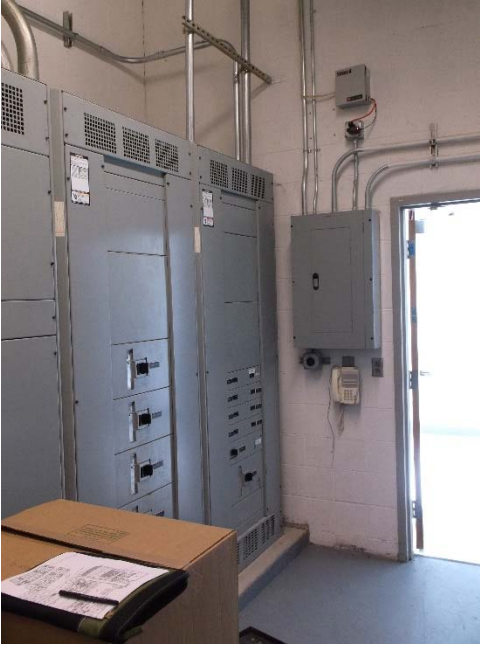
There are two generators, the newest is a 500 KW diesel generator by Caterpillar with base mounted fuel tank located outside of the south side main electric room. The generator has a single output breaker (800 amps) feeding a single automatic transfer switch in the main electric room (south side). The second generator is older and located inside the building near the loading dock on the north side of the building in a room adjacent to the old main electric room. The generator is a 85 KW natural gas unit by Onan with a single output breaker that serves two automatic transfer switches in the room with the generator. The newer transfer switch feeds a 480V disconnect switch and then a 30 KVA step down transformer and then a 208V disconnect switch. The older transfer switch also feeds a step-down transformer then a disconnect switch. The two generator panels serve some interior lighting, exterior lighting,

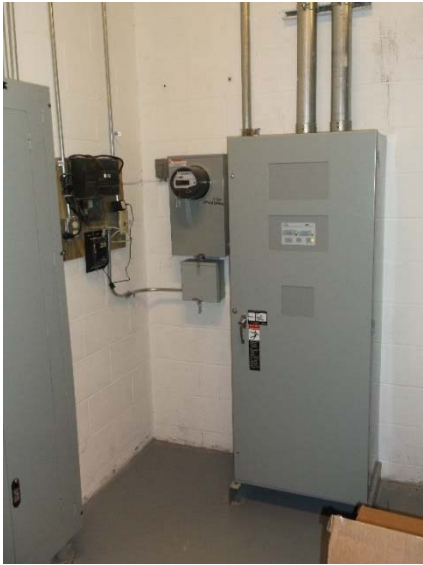
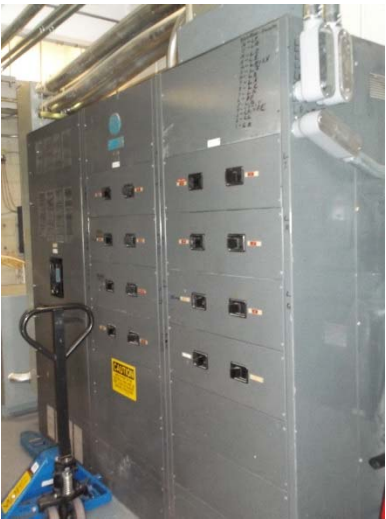
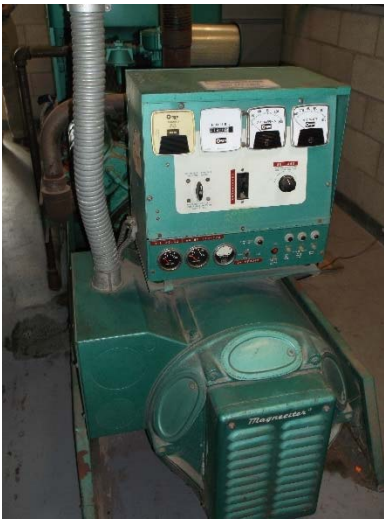
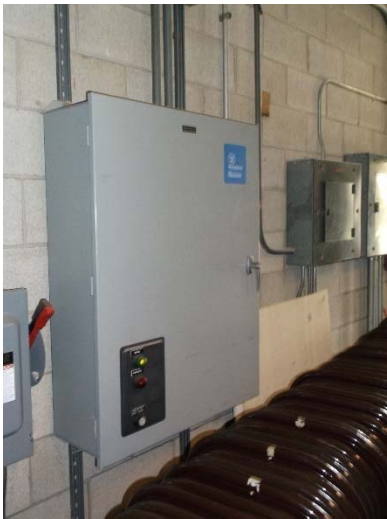
paging system, security system, fire alarm system, kitchen refrigeration, misc. power and some HVAC equipment (heating). The main electrical equipment and panels from the old distribution (north side of building) are nearing the end of its useful life and will need to be replaced in the future, also the location of the existing 2000-amp switchboard does not meet current code. This room only has one door in or out of the room, which would require double the working clearances in front of the equipment or an unobstructed path to the door which it does not have. When the equipment is going to be replaced, careful planning and coordination will be required to locate the new equipment and be code compliant.

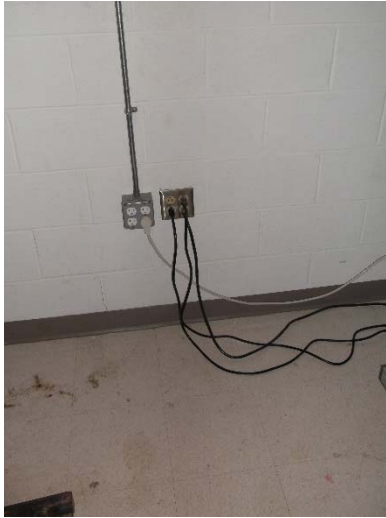
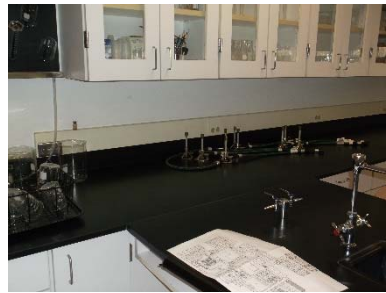
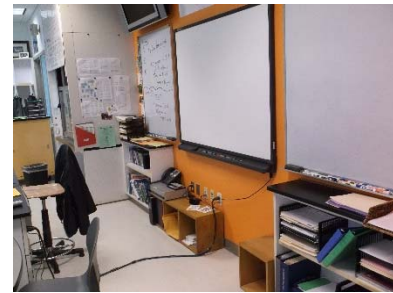
The existing power receptacles throughout the school are mostly recessed mounted duplex and quad receptacles with metal cover plates. There are some surface mounted devices that are fed by either surface mounted conduit or surface mounted raceway (wiremold). The Tech. Woodshop Room has ceiling mounted cord reels with a single receptacle on the end of the retractable cord. The Science Rooms and some other Classrooms have surface mounted dual channel raceway for both power and communication devices. The receptacles for the most part appear to be in good operating condition, there are a few locations that spotted that the devices should be replaced or remounted to the back box.

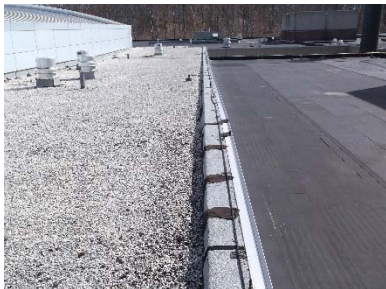
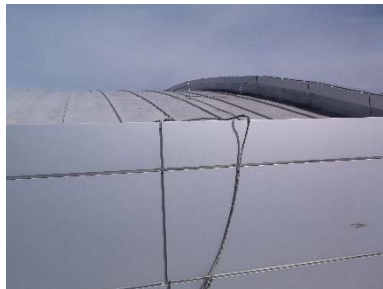
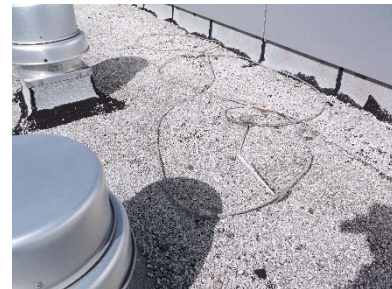
There is a lightning protection system installed on the roof of the building, with air terminals and cables. There is damage to both the air terminals and the cable along the south-east side of the North addition roof. There are cables that are broken apart, air terminals damaged or pull off the roof and a section of cables and terminals just sitting coiled up on the roof.

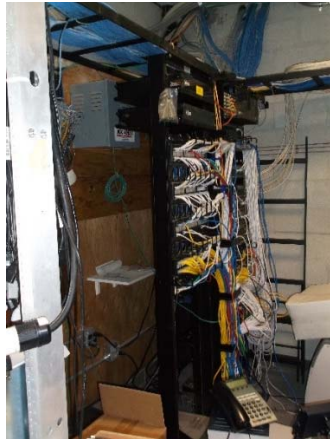
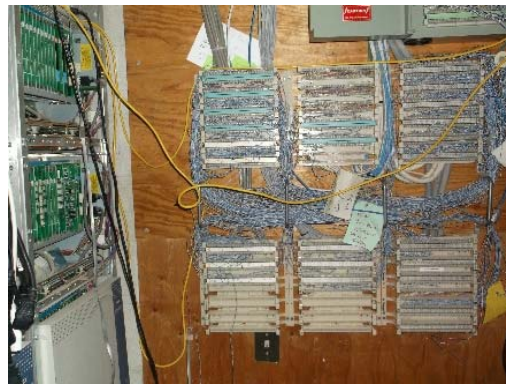
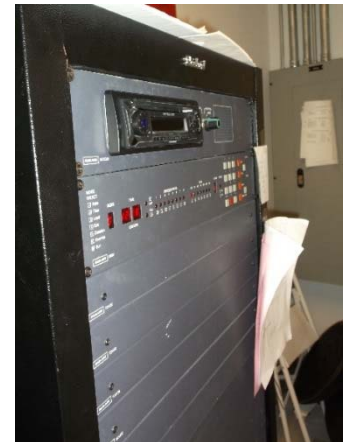
Voice / Data

The existing telephone system demark is in the Data Room located near the loading dock on the north side of the building. There is an open rack, an enclosed cabinet and multiple telephone punch down blocks in the room. There are two other Data closets, one adjacent to the main electric room on the south side of the building and another in the Main Office area. The Rauland master clock headend equipment, and amplifier & cassette deck along with Sonitrol security panels are in the Data closet by the Main Office. The existing data outlets throughout the school are recessed mounted. There are desk mounted phones in all the classrooms, along with a wall mounted clocks and recessed ceiling speakers. There are a few rooms with wall mounted phones like the Gymnasium. There are speakers in all the hallways and utility rooms. There are desk phones in all the Offices. All equipment appears to be operating properly. There are wireless access point devices installed throughout the school. |

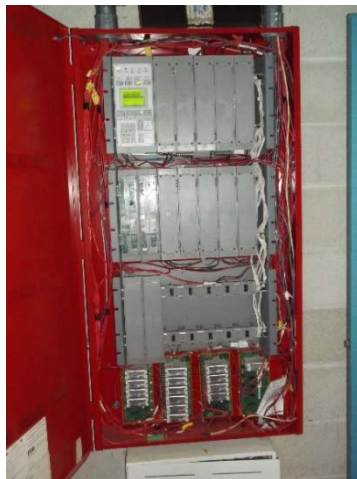
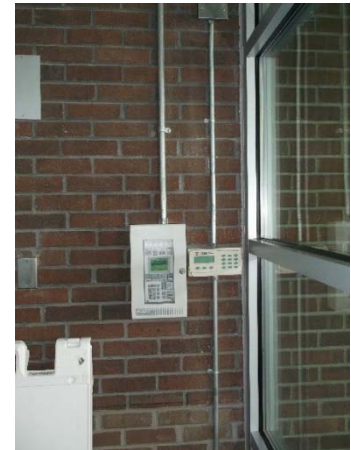
Fire Alarm

The existing fire alarm system is an addressable Edwards (EST3) system, with the control panel located in a room at the lower level Storage area by the elevator near the stair at the east side of the building. There is a remote alarm panel at the front entrance security desk along with multiple power supply panels (NAC panels) throughout.

There are three locations with remote alarm panels with emergency phones, both Gymnasiums and the Cafeteria. There are manual pull stations at all egress doors and in the Gymnasium. The pull stations in the Gym. have “stopper” covers. There are audio/visual devices throughout the building including all the Classrooms, the Locker Rooms, the Gymnasiums and the Cafeteria. There are

carbon monoxide detectors in the mechanical rooms where there is fuel burning equipment. There are smoke detectors throughout the school, in the corridors, classrooms, stairs, etc. The devices throughout appear to be in good operating condition.
