November Facilities Committee Meeting

Weston Public Schools, Facilities feasibility study and master plan.

BOE Facility Committee
presentation on
11-2-2017

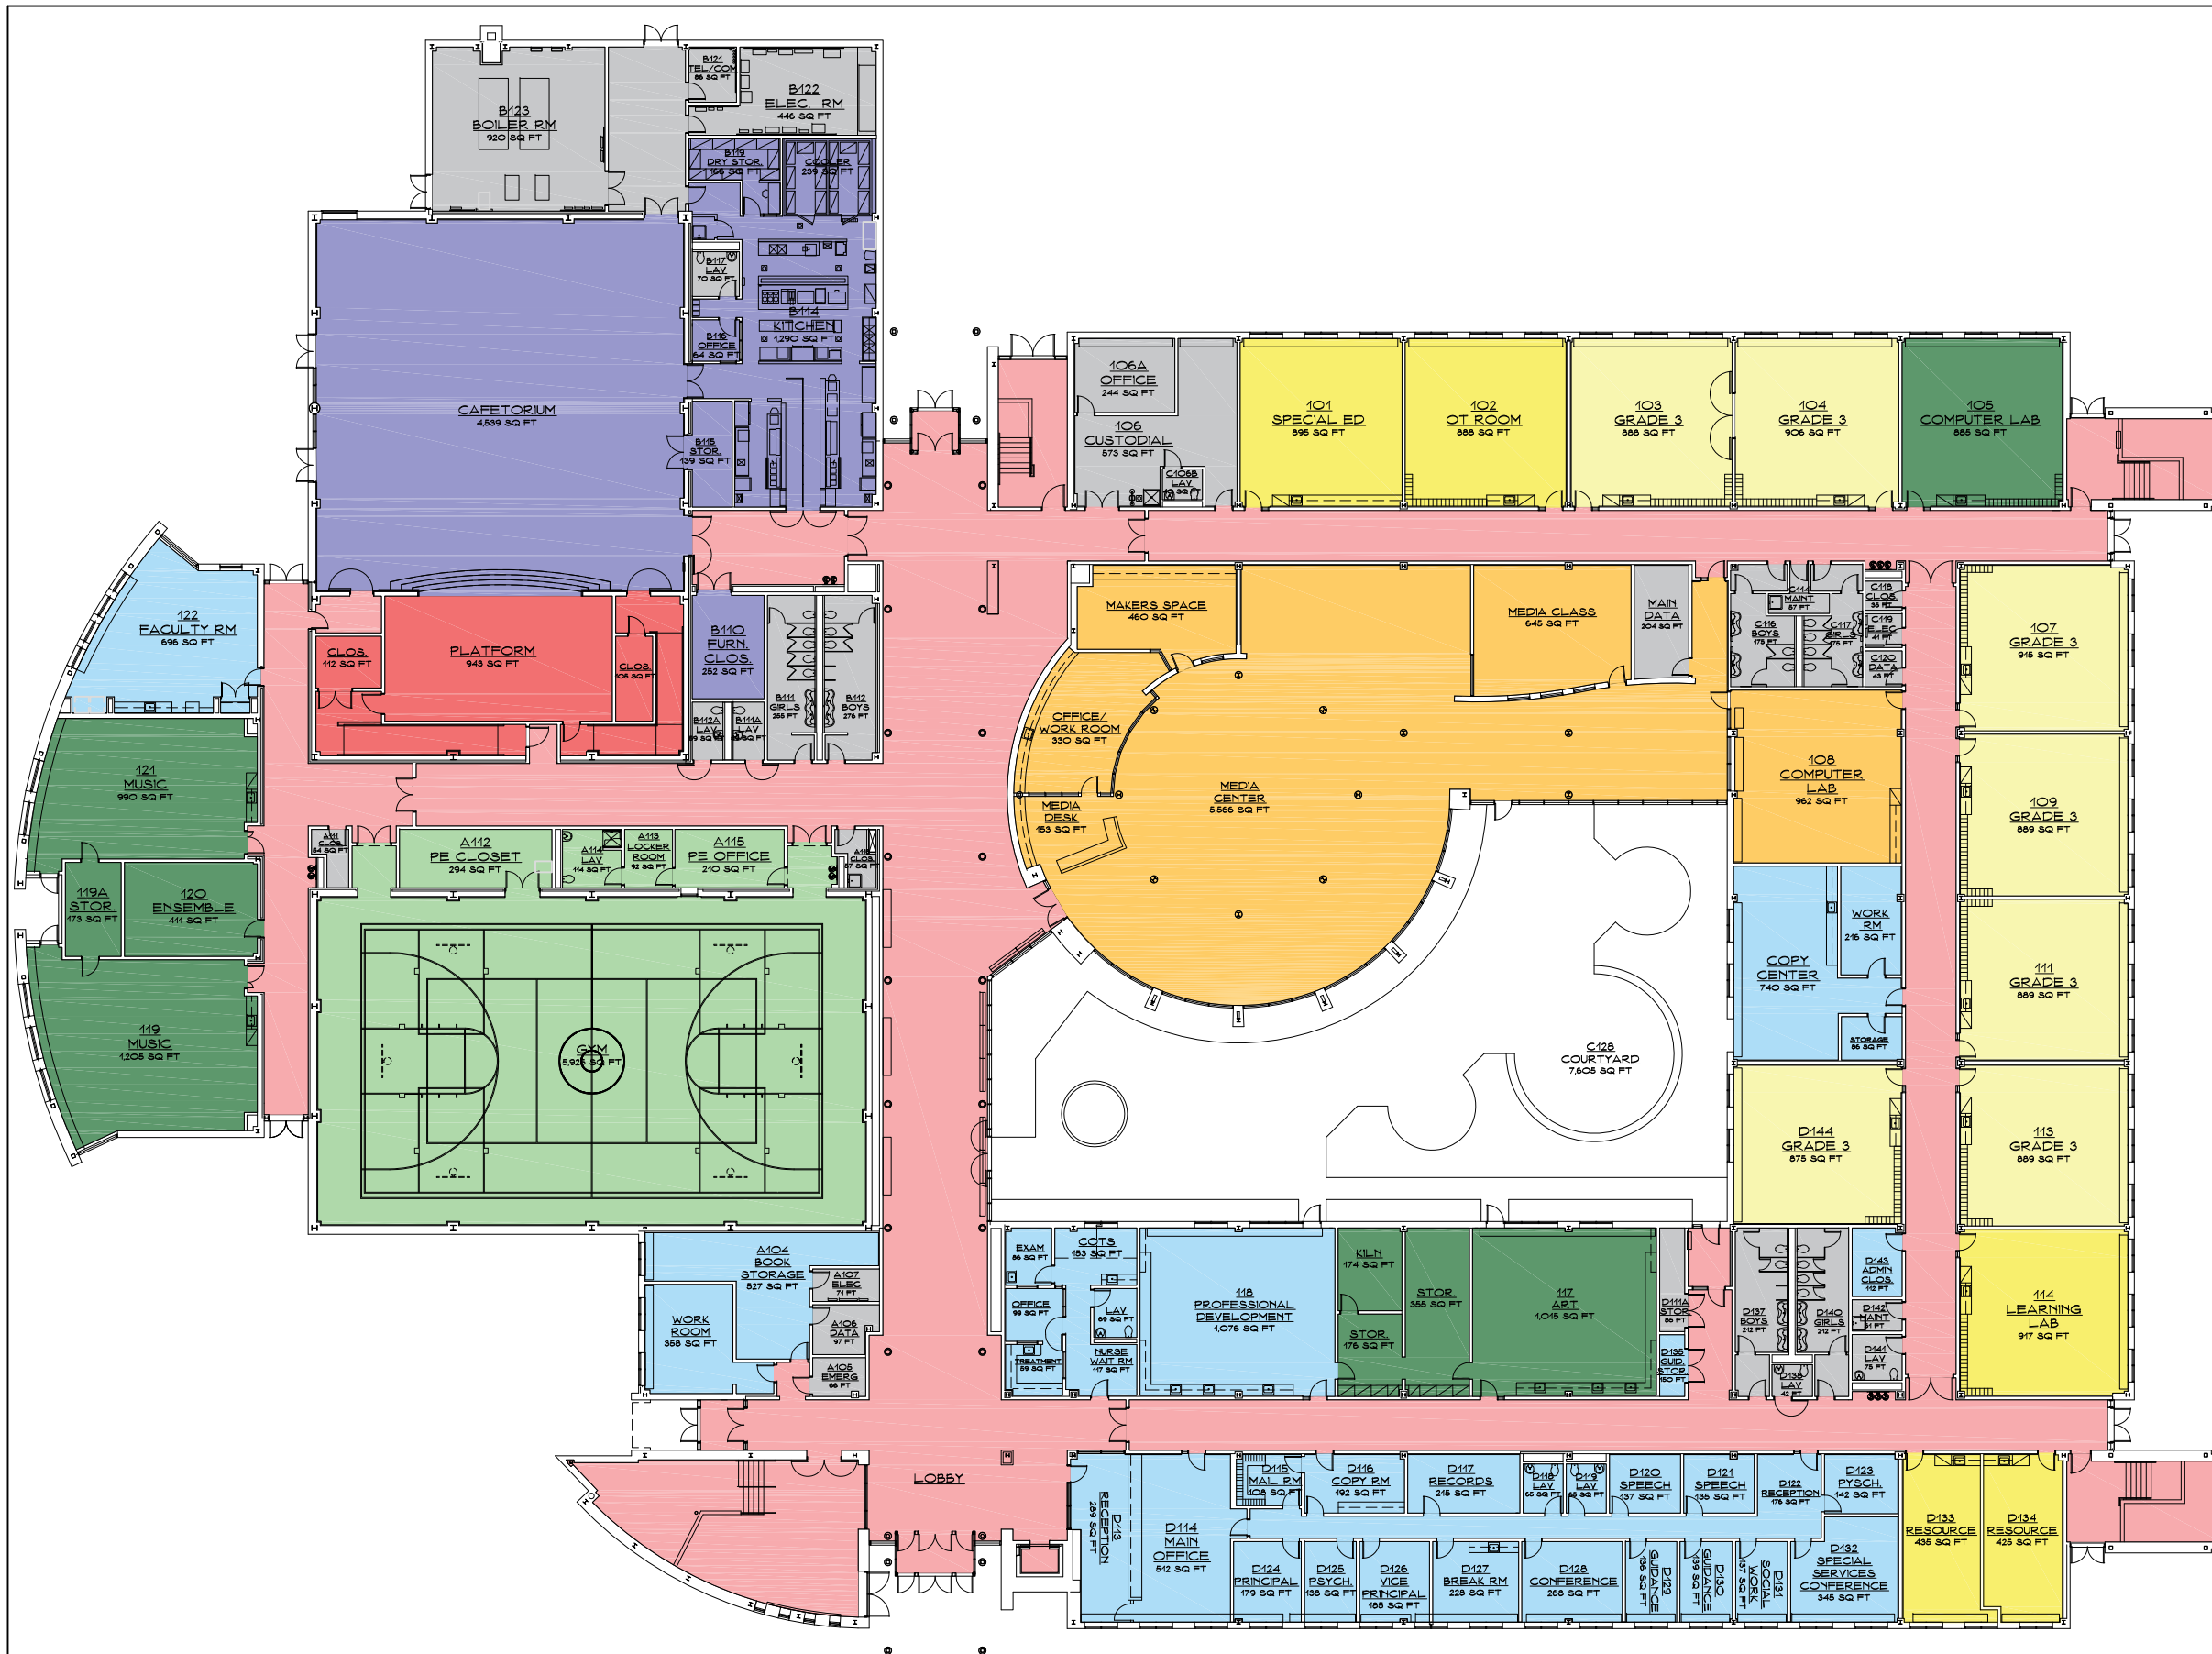
PROGRAM LEGEND	
CLASSROOMS	23,245 NSF
SPECIALS	9,299 NSF
SPECIAL ED.	7,662 NSF
MEDIA CENTER	8,117 NSF
PHYSICAL ED.	6,789 NSF
CAFETERIA	6,912 NSF
AUDITORIUM	1,744 NSF
ADMINISTRATION	8,926 NSF
BUILDING INFRA	7,308 NSF
CIRCULATION	30,448 NSF
SCHOOL TOTAL 110,450 NSF

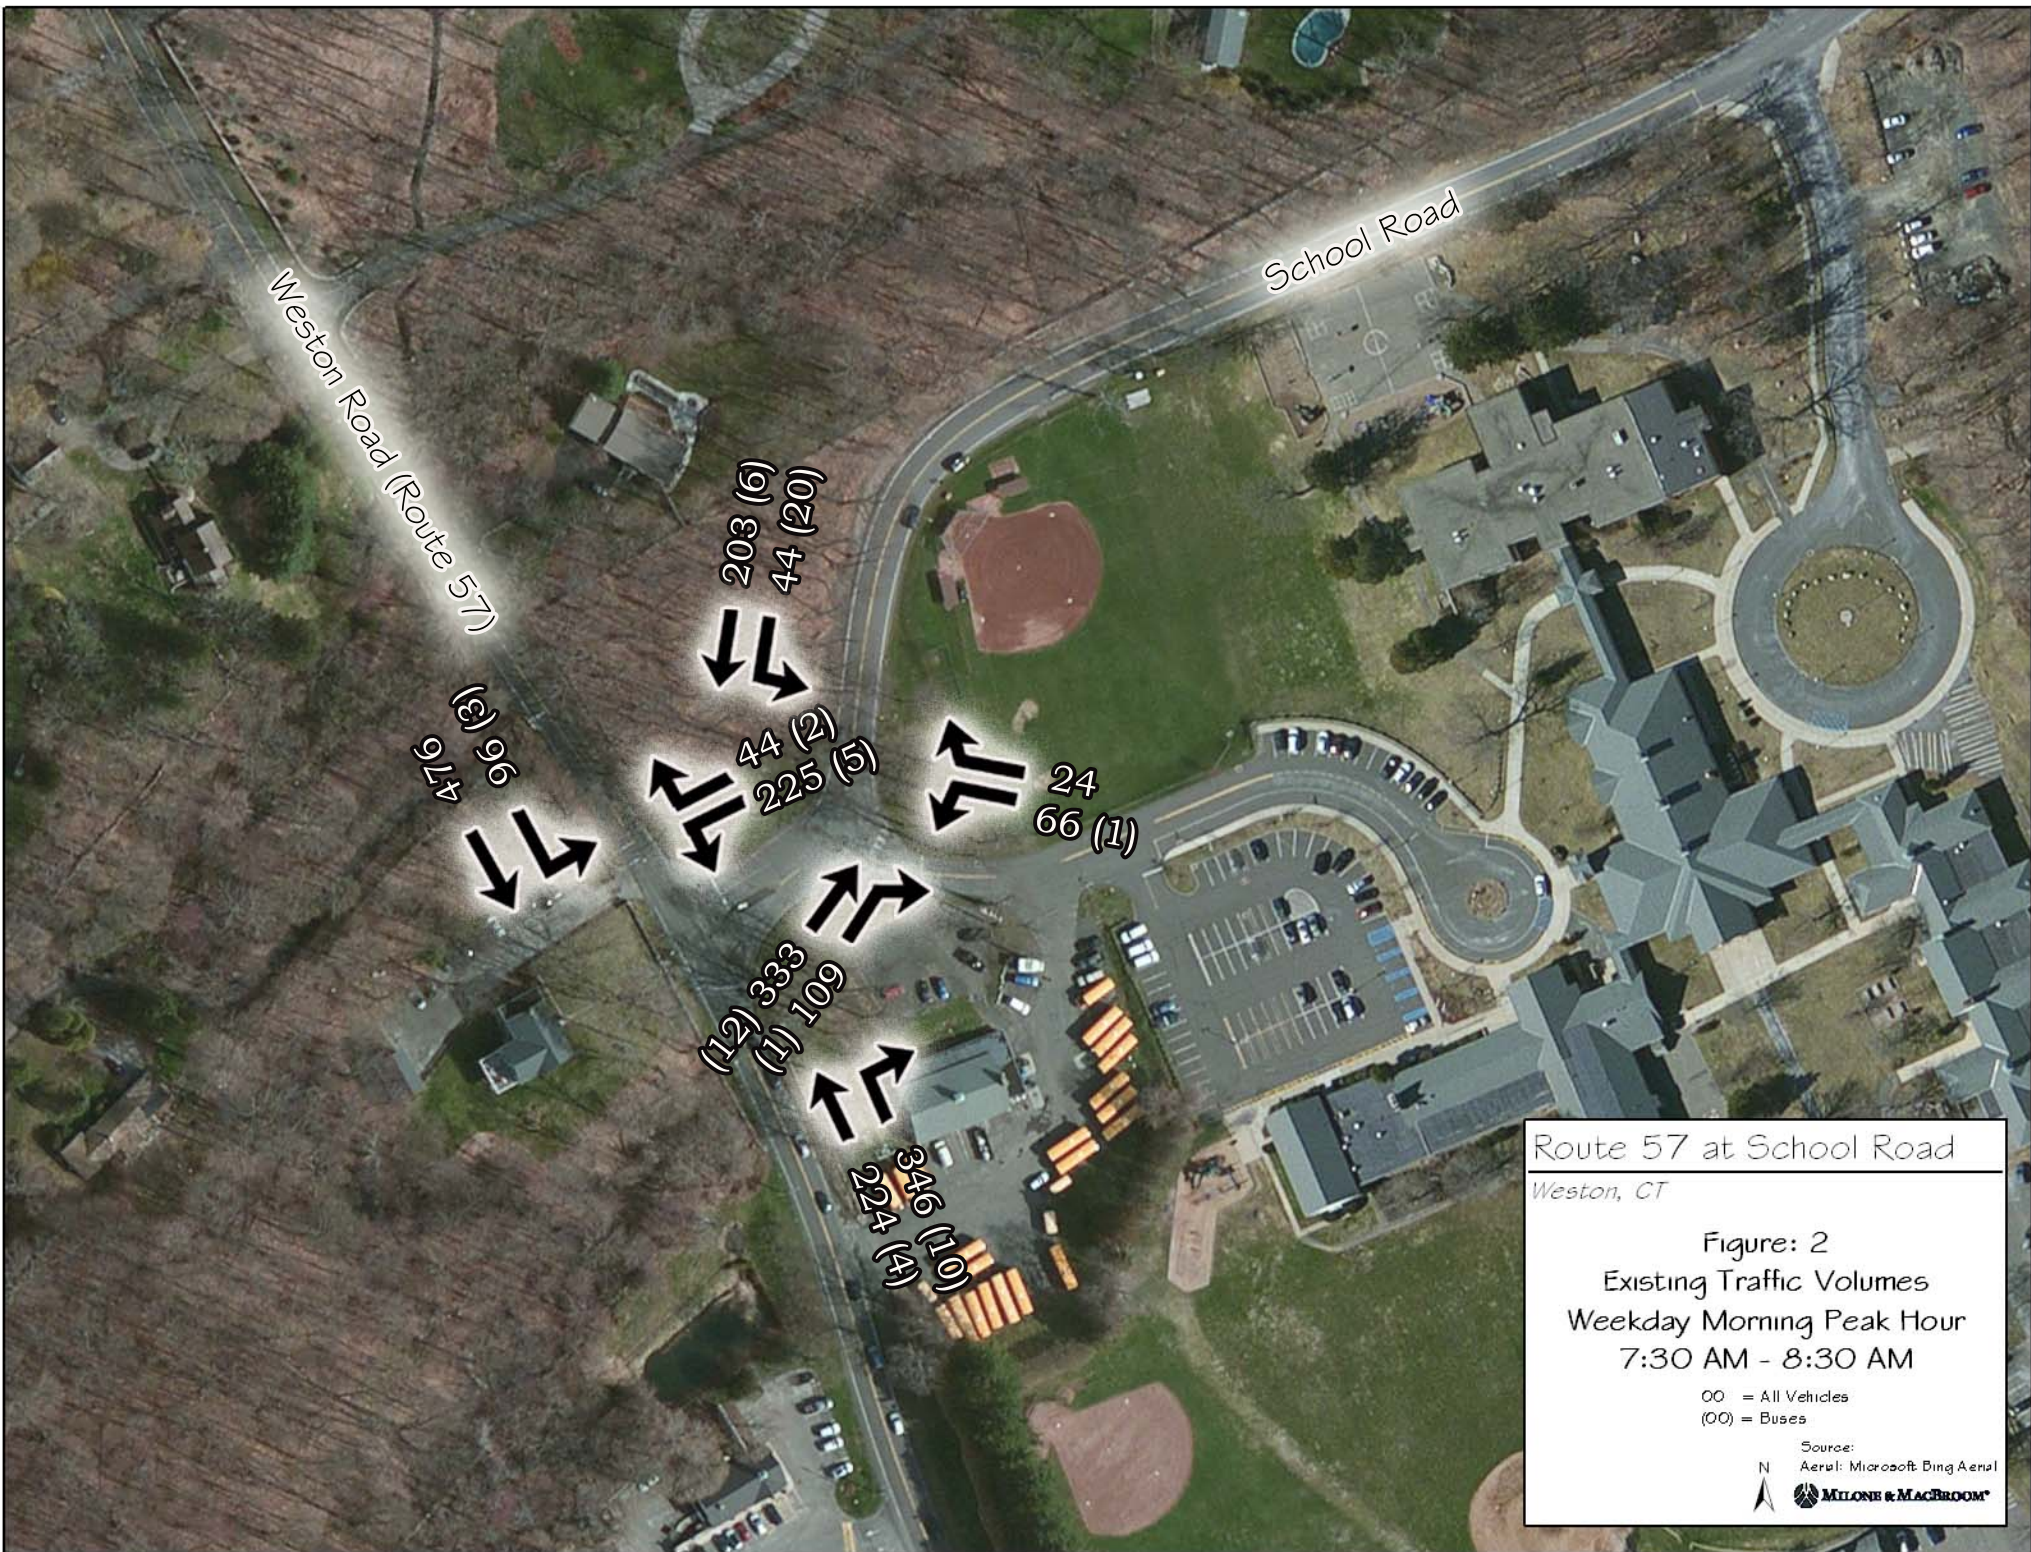
Figure: 2
Existing Traffic Volumes
Weekday Morning Peak Hour
7:30 AM - 8:30 AM

Figures 2 and 3 illustrate the peak hour traffic volumes that were extracted from the counts. The weekday morning peak hour occurred from 7:30 a.m. to 8:30 a.m. while the afternoon peak hour occurred from 2:45 p.m. to 3:45 p.m. These afternoon traffic volumes depict the school dismissal peak. A separate, less noticeable commuter peak did occur later in the afternoon. However, the total volume of traffic through the study area during the later commuter peak was significantly less than during the school dismissal peak. The afternoon commuter peak was not analyzed as a result.

Buses were enumerated during both morning and afternoon count periods. As illustrated in Figures 2 and 3, approximately 42 buses were observed entering and exiting the study intersection during the morning peak period while 32 buses were observed during the afternoon peak period. During the morning peak hour, the majority of buses traveling along Route 57 arrived from the south, turned right onto School Road, and continued through past the elementary school driveway. A notable number of buses also traveled westbound on School Road and turned left into the elementary school driveway during the morning peak hour.

00 = All Vehicles
(00) = Buses

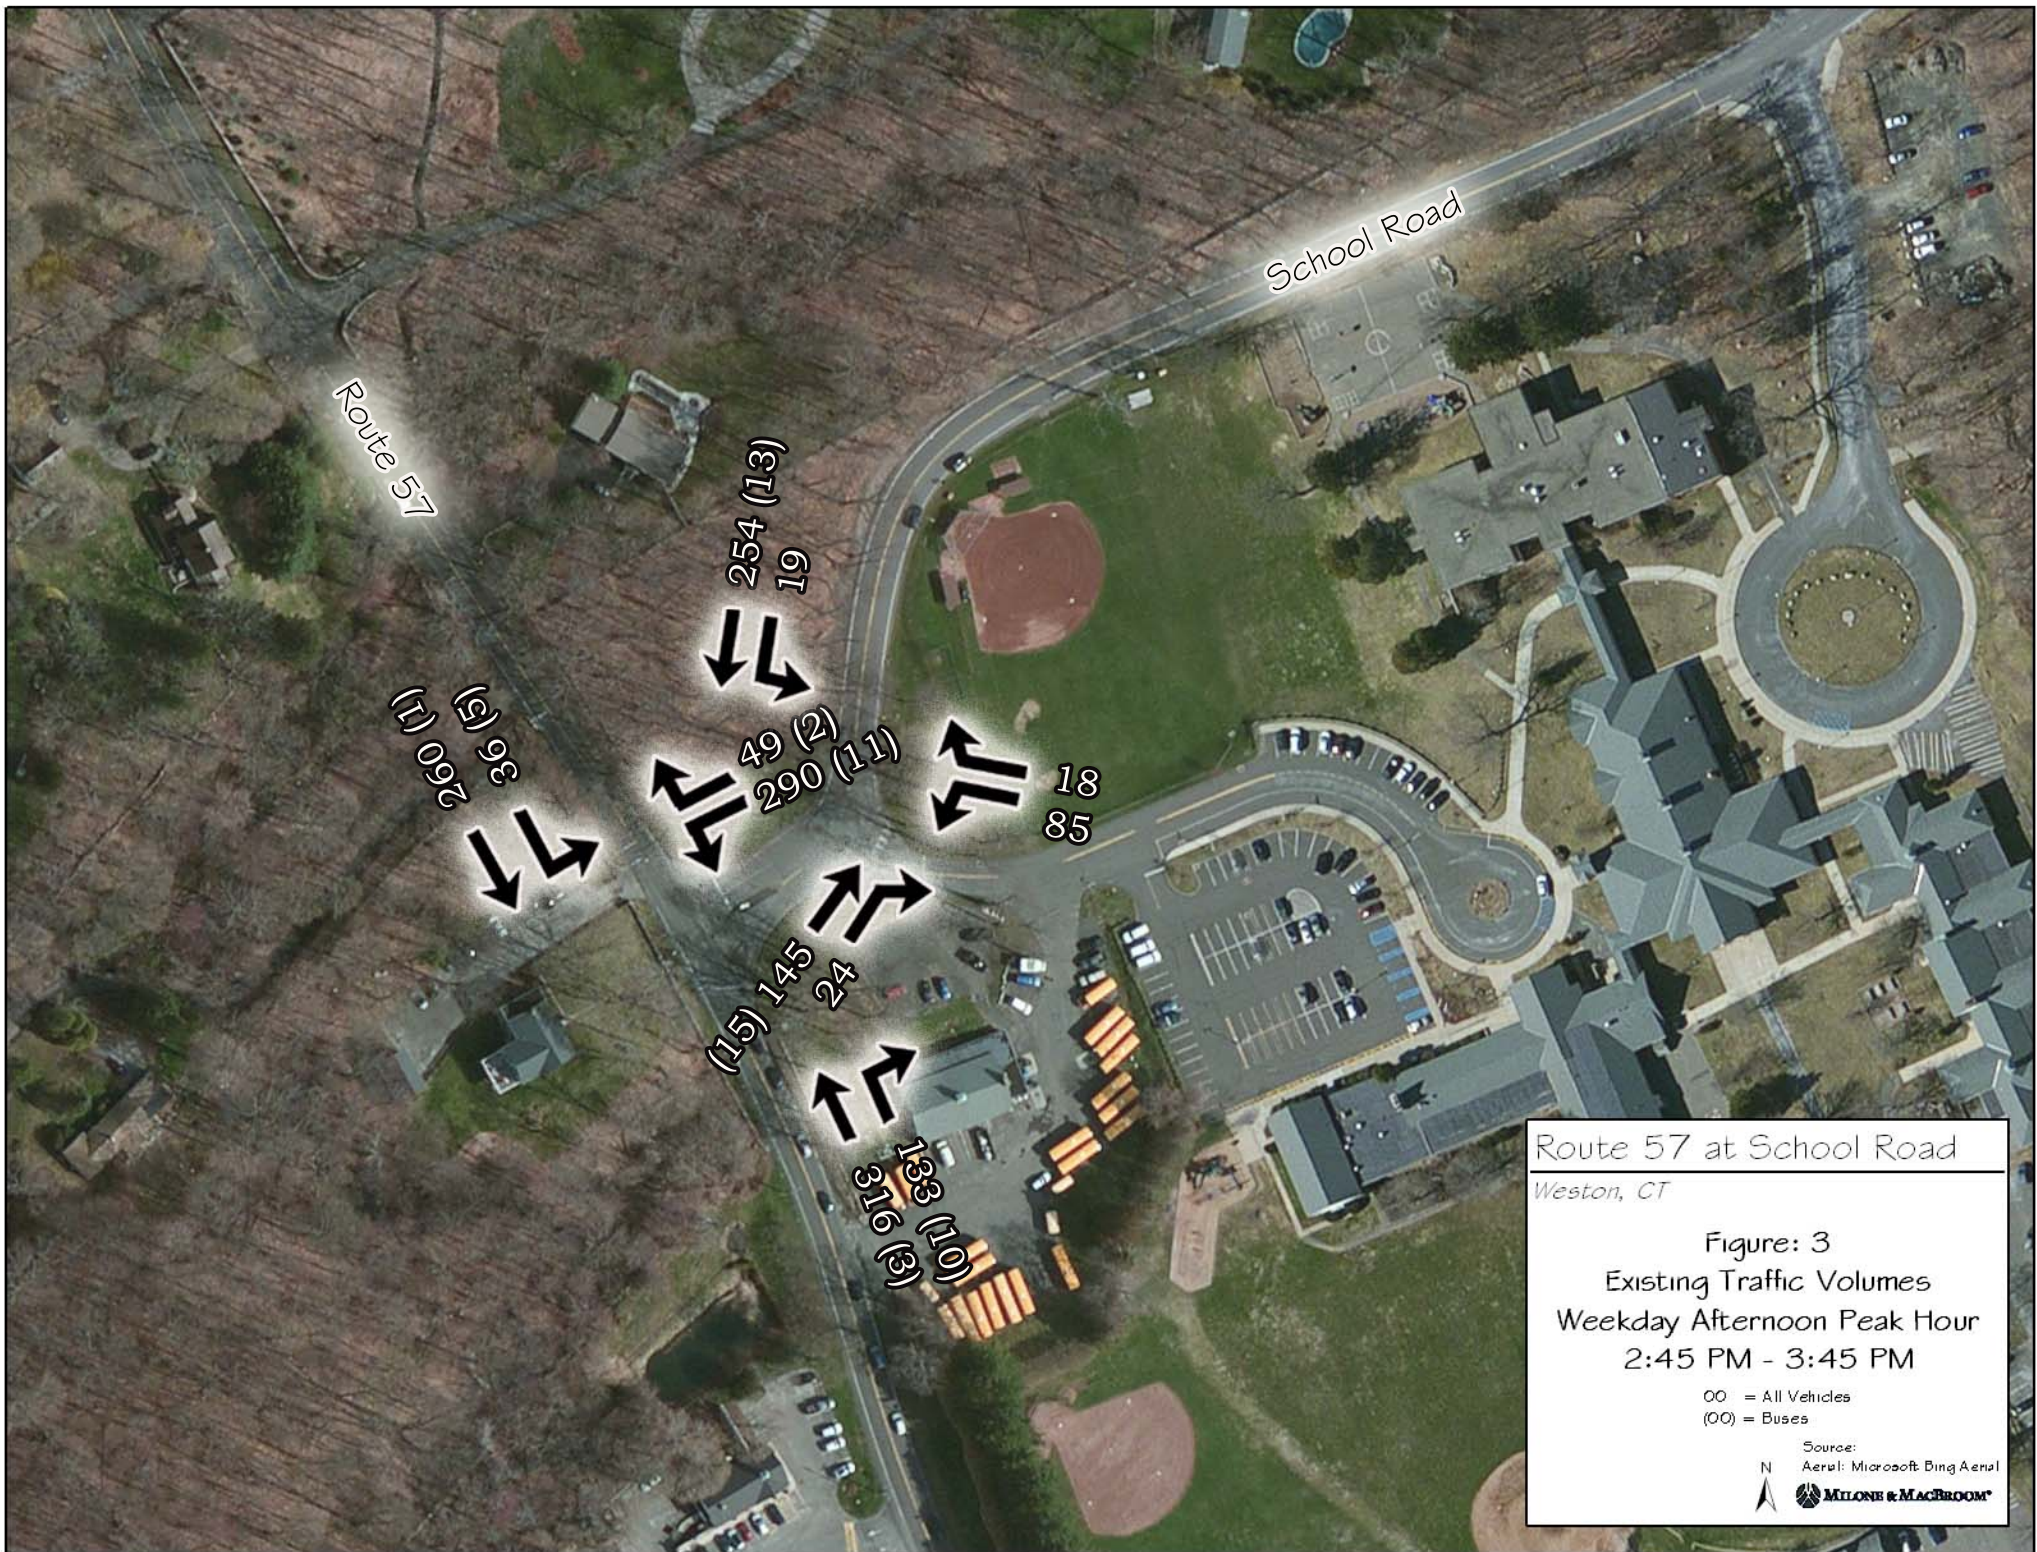
Figure: 3
Existing Traffic Volumes
Weekday Afternoon Peak Hour
2:45 PM - 3:45 PM

The volume of traffic experienced at the intersection was observed to be greater during the morning peak hour than during the afternoon peak hour. This is due to the school arrival period and commuter period coinciding during the morning, whereas during the afternoon the dismissal and commuter peak periods occur separately.

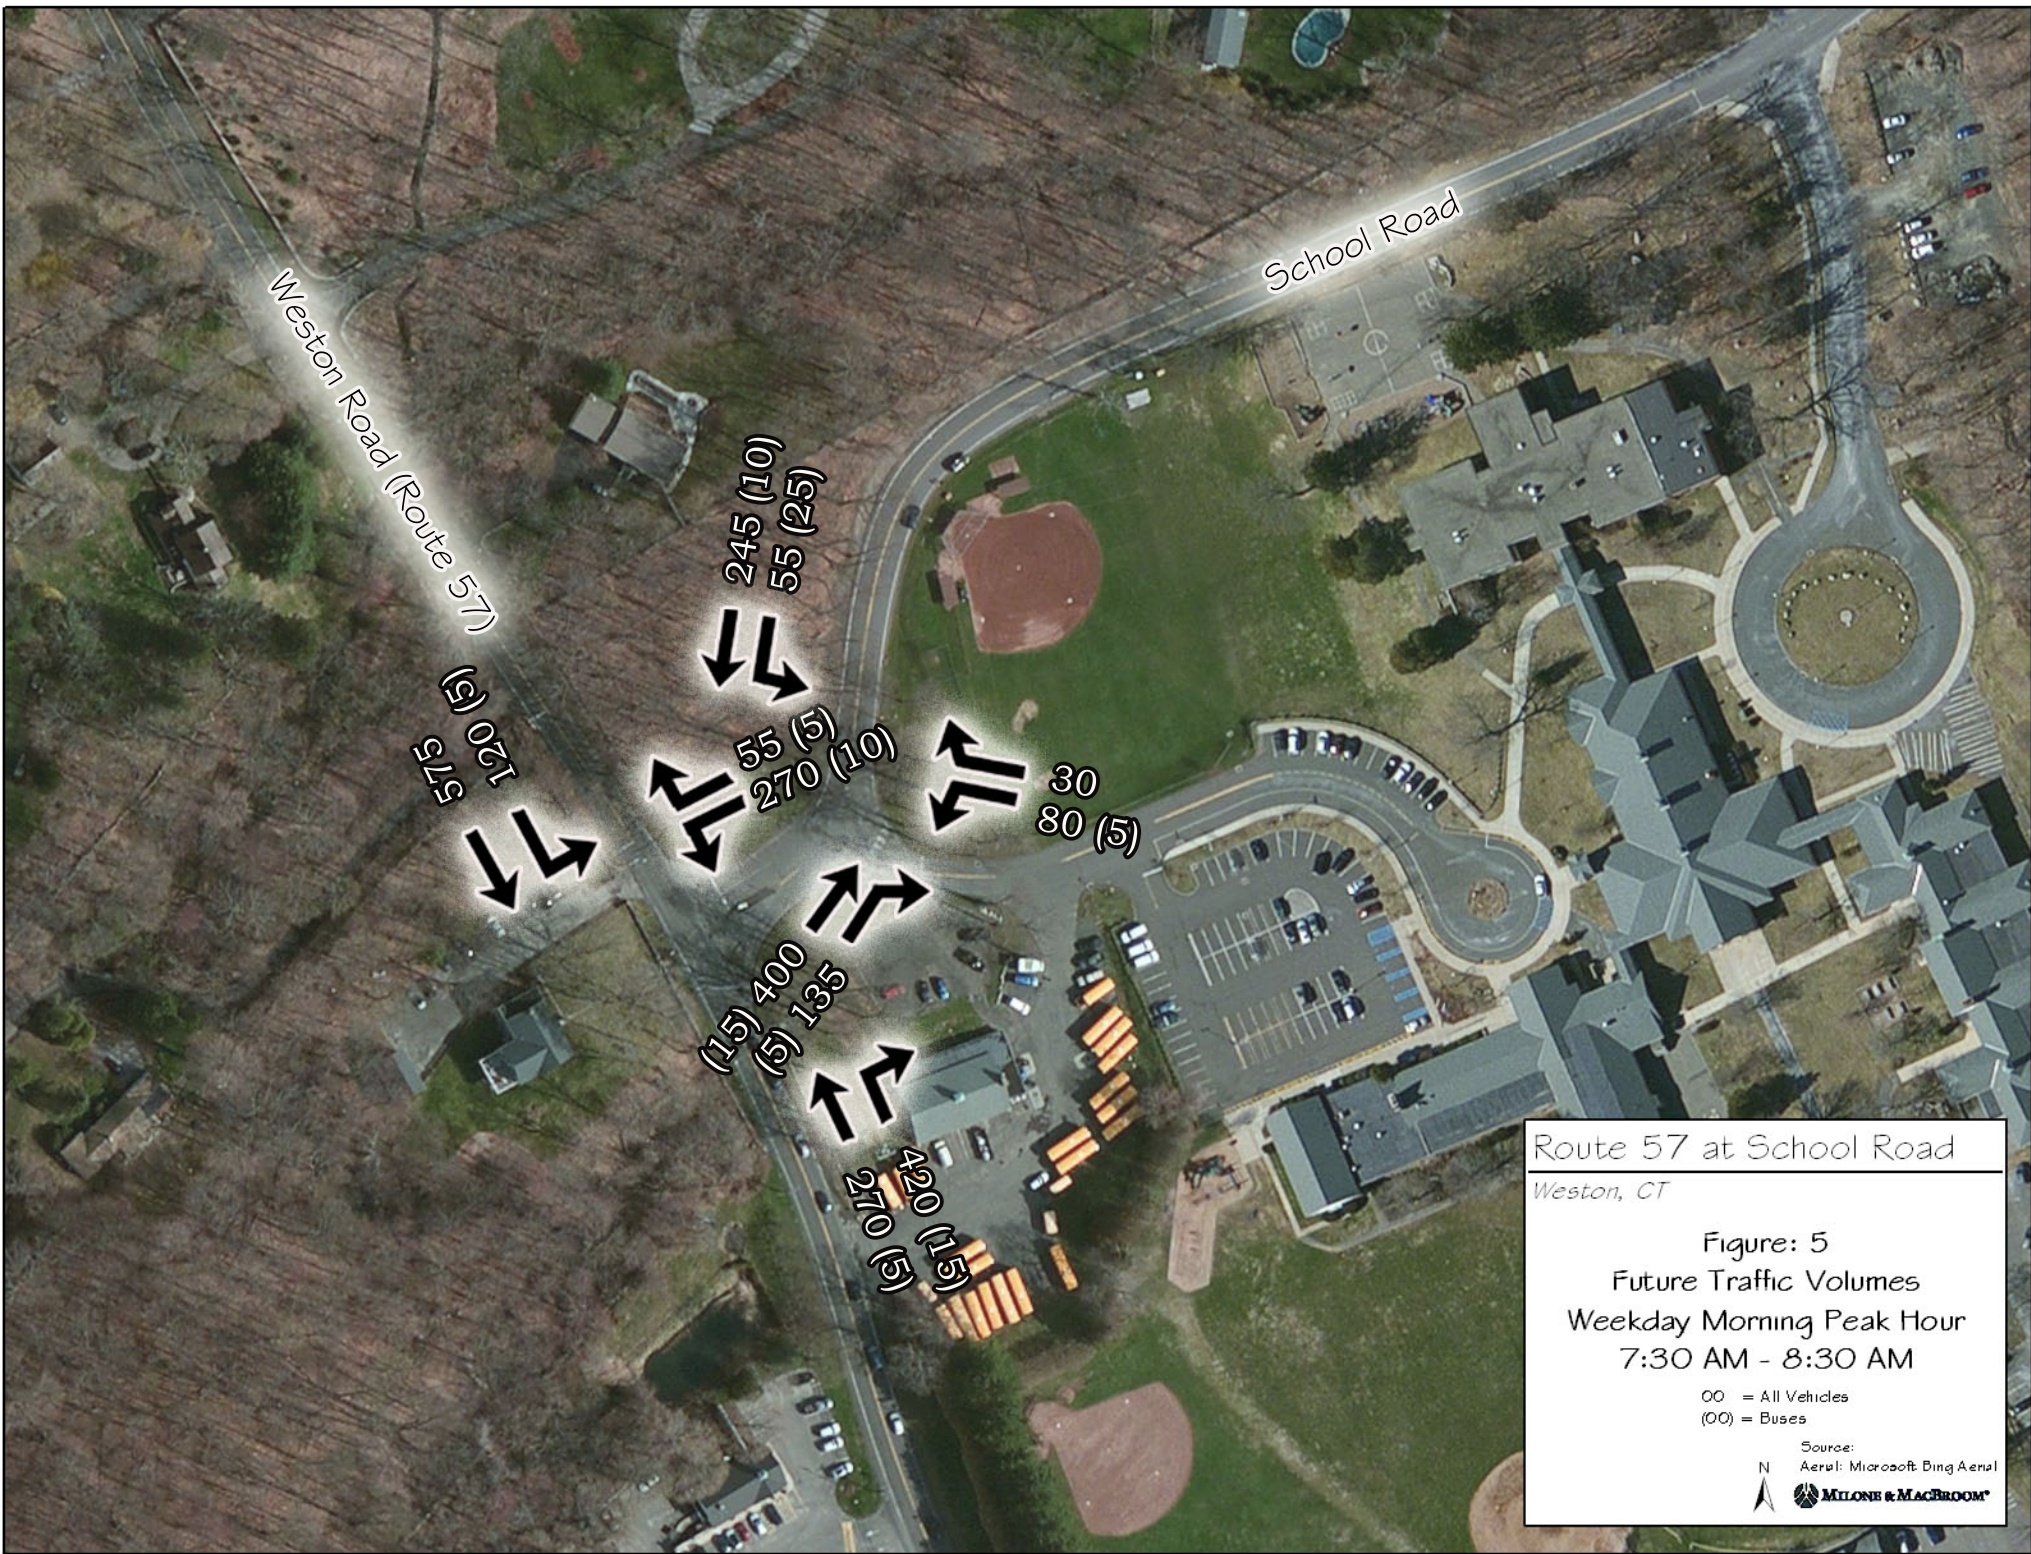
Figure: 5
Future Traffic Volumes
Weekday Morning Peak Hour
7:30 AM - 8:30 AM

CTDOT was also contacted to determine whether there were any approved or yet to be constructed projects in the immediate vicinity of the study intersection to include as part of the future (2030) background traffic. CTDOT determined that there were no such projects to include. **Figures 5 and 6** illustrate the future (2030) weekday morning and afternoon peak hour traffic volumes.

00 = All Vehicles
(00) = Buses

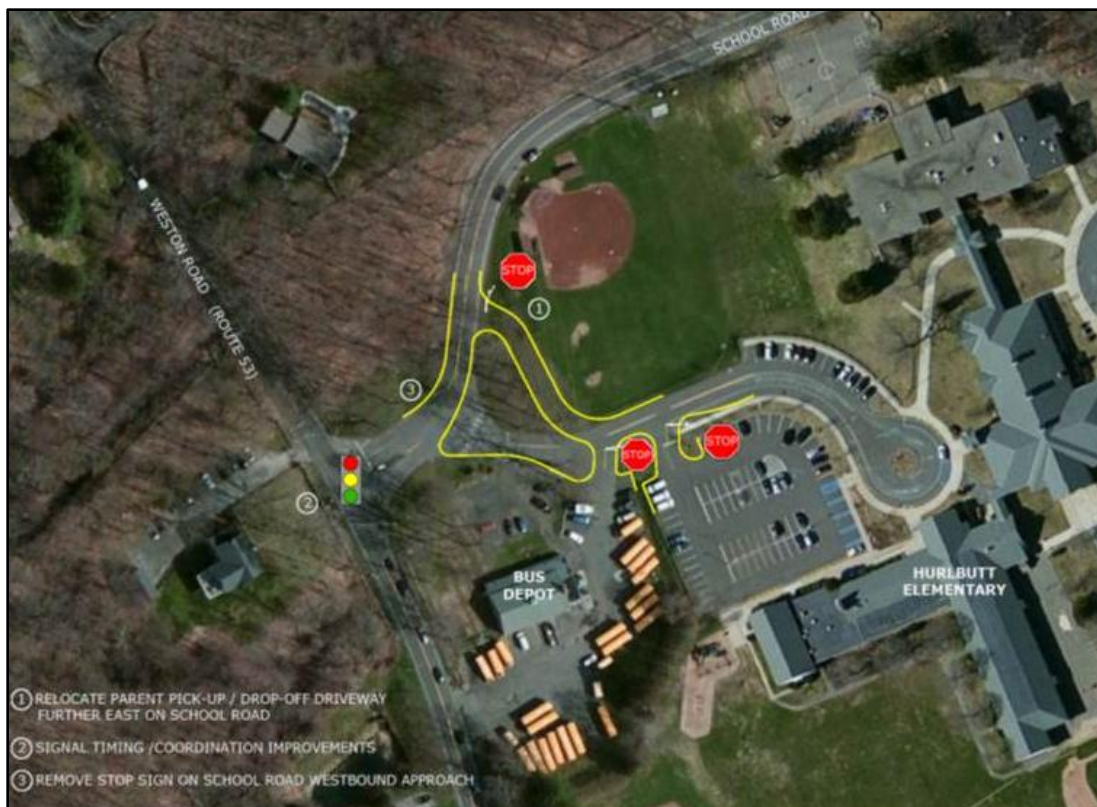
Figure 7: Preliminary Near-Term Alternative 1

This alternative would involve the relocation of the existing parent pickup/drop-off driveway to the Hurlbutt Elementary School further to the east on School Road along the lower western boundary of the baseball field. The relocation would create more separation from the Route 57- School Road intersection and reduce the number of conflict points at that location. A stop control would be installed on the driveway approach while School Road will be free flow. In addition, signal timing improvements and potential coordination with the newly redesigned traffic signal at the intersection of Route 57 and Norfield Road to the south would be implemented.

The proposed improvements would involve impacts to the school property. **Figure 7** presents a conceptual layout of *Preliminary Near-Term Alternative 1*.

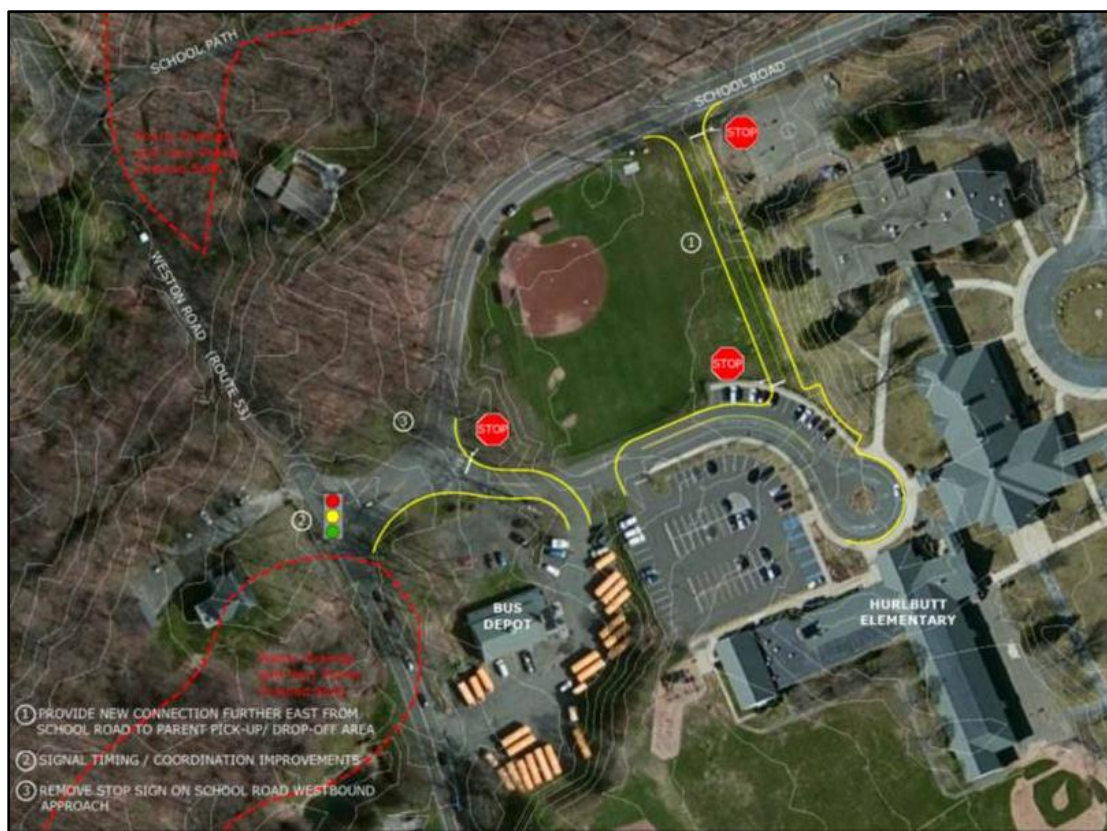
Figure 8: Preliminary Near-Term Alternative 2

Preliminary Near-Term Alternative 2 would involve the construction of a new parent pickup/drop-off driveway to the Hurlbutt Elementary School further to the east on School Road along the eastern boundary of the baseball field, while leaving the existing driveway open for bus access only to the school bus depot. This new configuration would create more separation from the Route 57- School Road intersection and reduce the number of conflict points within the study area. Similar to *Preliminary Near-Term Alternative 1*, signal timing improvements and potential coordination with the newly redesigned traffic signal at the intersection of Route 57 and Norfield Road to the south would be implemented. In addition, the existing stop sign on School Road westbound would be removed making School Road free flow. The proposed improvements would involve impacts to the school property. **Figure 8** presents a conceptual layout of *Preliminary Near-Term Alternative 2*.

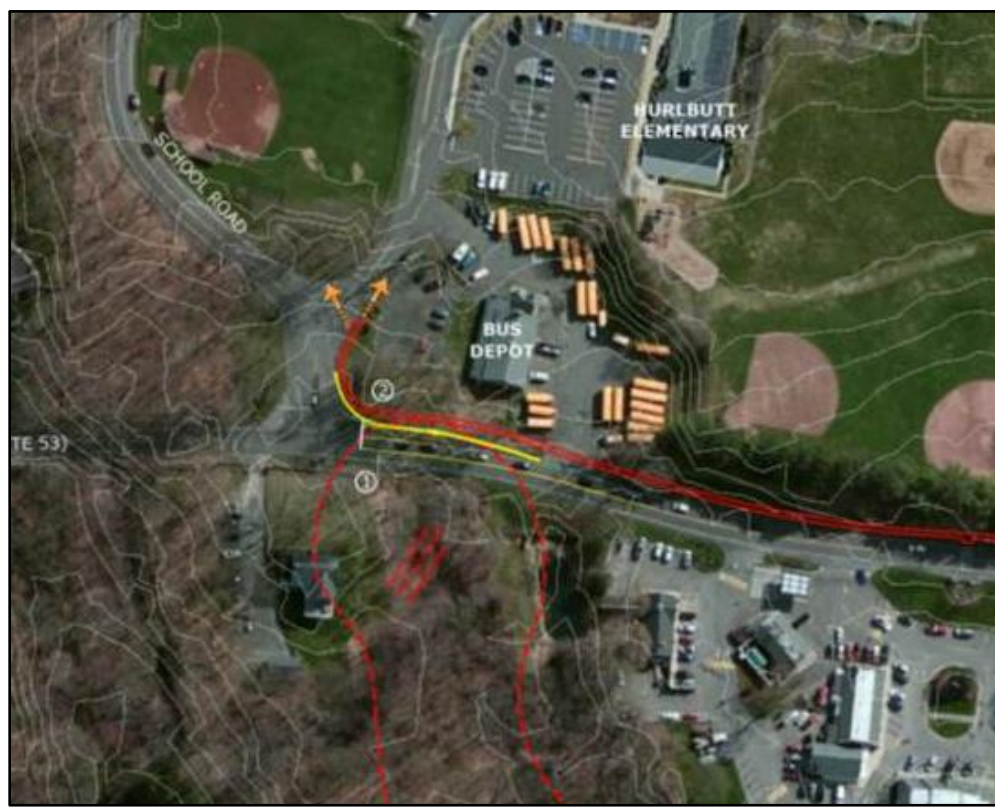
Figure 9: Preliminary Long-Term Alternative 1

Preliminary Long-Term Alternative 1 would involve widening the Route 57 northbound approach along its eastern edge to provide an exclusive right-turn lane and a through lane. This improvement would reduce queuing on the Route 57 northbound approach. A new sidewalk would be installed along the eastern edge of Route 57 from School Road to Norfield Road with a mid-block crosswalk and advance crosswalk signage. The proposed improvements would involve some right-of-way (ROW) impacts. **Figure 9** presents a conceptual layout of *Preliminary Long-Term Alternative 1*.

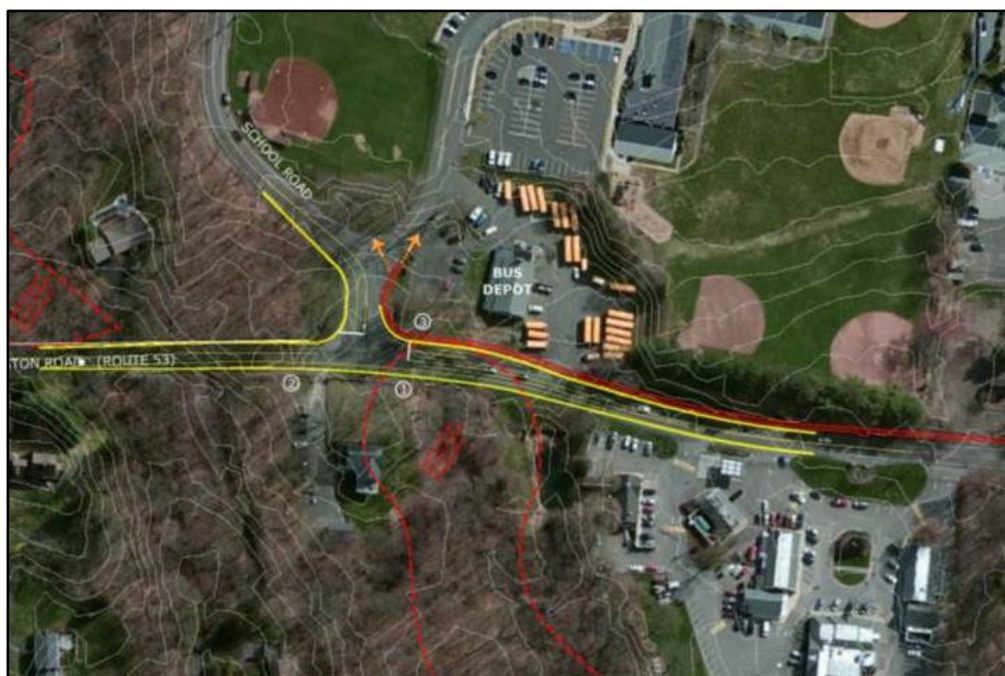
Figure 10: Preliminary Long-Term Alternative 2

Preliminary Long-Term Alternative 2 would involve widening the Route 57 northbound approach along its eastern edge to provide an exclusive right-turn lane and a through lane. The Route 57 southbound approach would also be widened along the eastern edge to provide a 20-foot bypass to help minimize queuing on this approach. Similar to *Preliminary Long-Term Alternative 1*, a new sidewalk would be installed along the eastern edge of Route 57 from School Road to Norfield Road with a mid-block crosswalk and advance crosswalk signage. This alternative would involve some ROW impacts. **Figure 10** presents a conceptual layout of *Preliminary Long-Term Alternative 2*.
