Community Engagement Meeting #2  
Wednesday, August 19, 2026 7:00 PM Central

**BVH**  
ARCHITECTURE

Community Meeting  
05/06/2026

# Facilities Audit Results

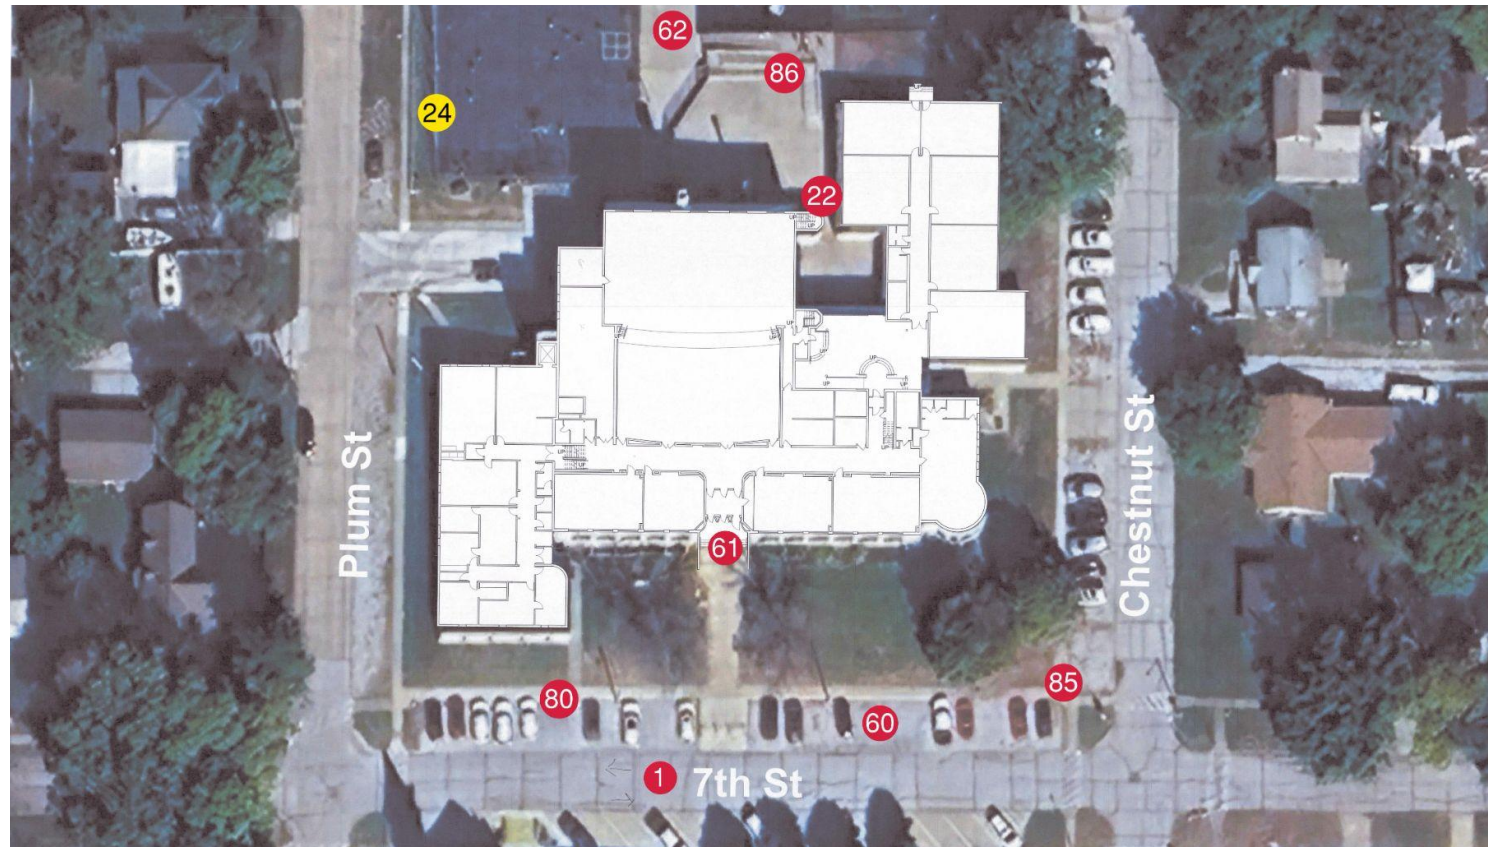
## Site Heat Map

# ELEMENTARY SCHOOL
