BOX BUTTE COUNTY SCHOOL DISTRICT #07-0010
HEMINGFORD PUBLIC SCHOOLS
BOARD OF EDUCATION MEETING AGENDA
Tuesday, September 10, 2024
South Campus

FACILITY ASSESSMENT & ENERGY AUDIT

MECHANICAL, ELECTRICAL, PLUMBING, FIRE
PROTECTION & TECHNOLOGY SYSTEMS

Hemingford High School (7th – 12th)

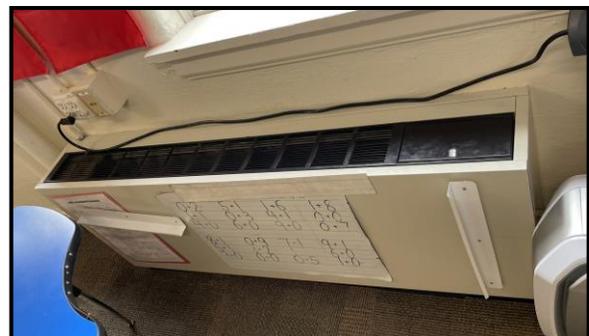
1. 1926 Elementary: This area is served by 2-pipe floor console style fan coil units (FCUs). The FCUs are relatively simple and reliable. However, they do not provide uniform air distribution through the space served which results in poor occupant thermal

comfort. Additionally, floor console style FCUs generally output higher noise levels which can interrupt teaching activities as compared to traditional ducted HVAC systems.

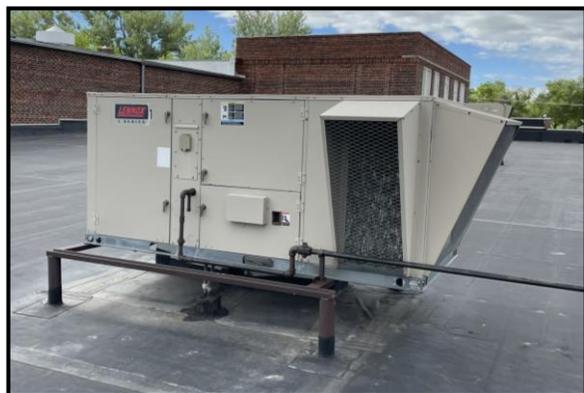
7. 2014 Commons: This area is served by two (2) packaged rooftop units (RTUs) with direct expansion (DX) cooling and natural gas heat exchangers. The RTUs were installed in 2014 and appear to be in acceptable condition.

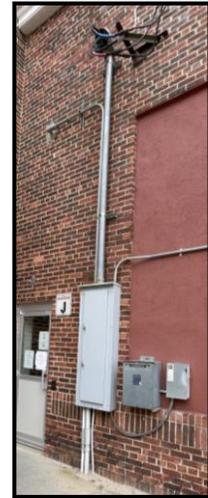
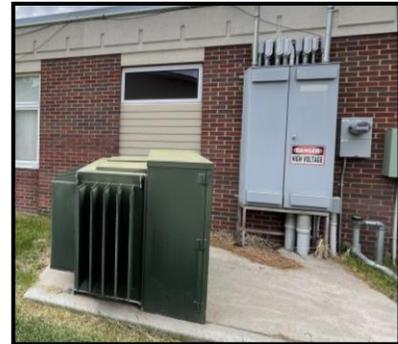
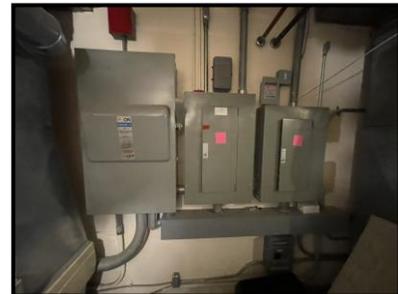
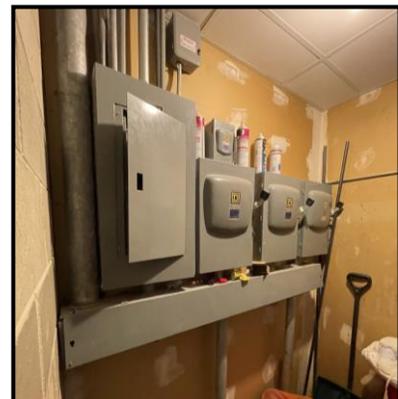
B. Gymnasium: The existing building is served by an overhead electrical service on the east side of the building

via pole mounted transformers and weatherhead. The electrical service is 600 amp, 120/240 volt, single phase, three wire via an electrical gutter box with three 200 amp Square D fusible disconnect switches. The equipment doesn't appear to be from the original 1975 building, but perhaps from an addition project in 1997 and is reaching end of life.

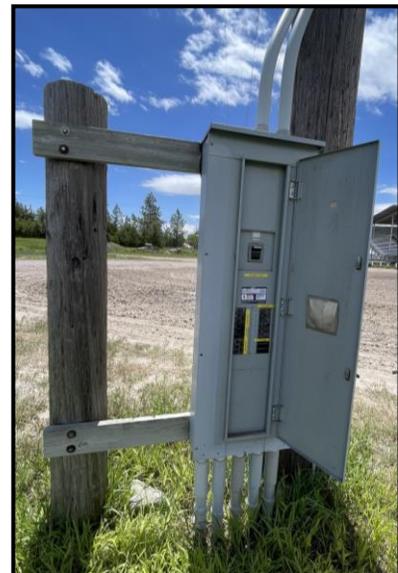
- I. Concessions Building: The existing building is served from a sub-panel that is located at the northwest field lighting pole by a 100 amp breaker. There is a load center within the

concessions building that is served by this breaker. The electrical service is 100 amp, 120/208 volt, three phase, four wire via a Siemens Load Center. The equipment appears to be from the original construction. The load center does not have any space for future electrical connections.

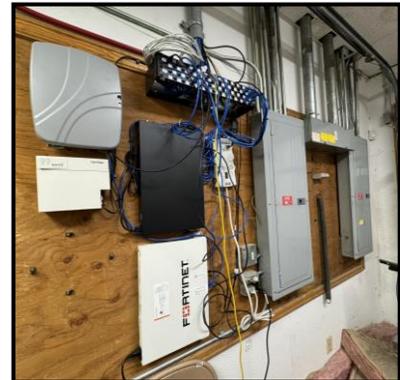
- L. South Campus Building: The existing building is served by an overhead electrical service on the south side of the building via pole mounted transformer and weatherhead. The electrical service is 400 amp, 120/240 volt, single phase, three wire via two 200 amp Siemens S3 panelboards. The equipment appears to be from the original construction. The two panelboards have existing space for future electrical connections.

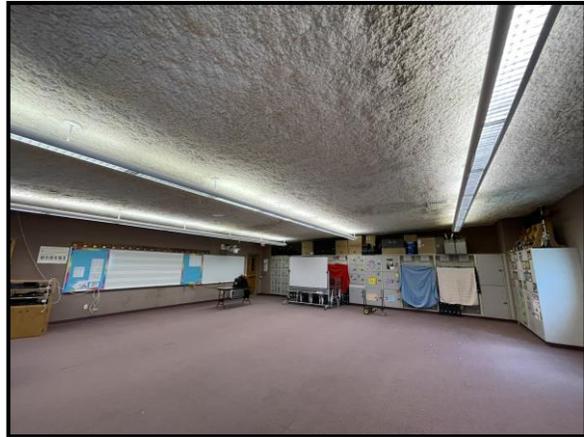
6. 1999 Music Addition: The existing lighting in the corridors is recessed lensed fluorescent troffers. The music classroom existing lighting is comprised of suspended linear fluorescent lighting and does have ceiling mounted occupancy sensor. The existing lighting in the office consists of recessed parabolic fluorescent troffers. Other than the music classroom, no other areas appear that the lighting controls within the area meet current energy code requirements for automatic lighting control.

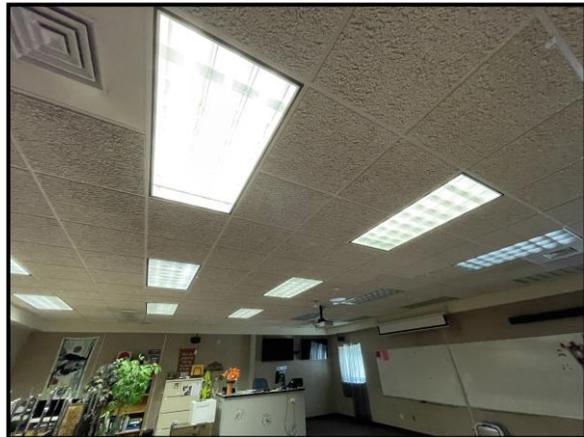
7. 1999 Distance Learning Addition: The existing lighting in the distance learning classroom and work room consists of recessed parabolic fluorescent troffers. The distance learning classroom has a ceiling mounted occupancy sensor. The existing lighting in the storage and restroom consists of recessed fluorescent troffers. Other than the distance learning classroom, no other areas appear that the lighting controls within the area meet current energy code requirements for automatic lighting control.

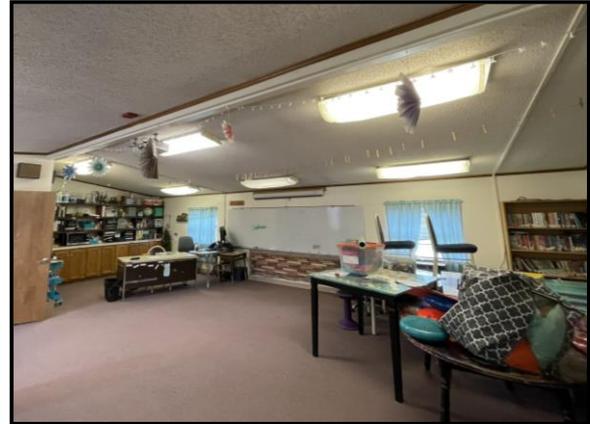
C. 1995 Middle School Modular: The existing lighting within the classroom area is a lensed fluorescent wrap that is surface mounted. The teacher's work room consists of fluorescent troffers and the restroom is compact fluorescent downlight. The exterior lighting is comprised of wall packs that appear to be metal halide and socket type jelly jar lights. The exterior lighting appears to be controlled via local photocell. It does not appear that the lighting controls within the building meet current energy code requirements for automatic lighting control.

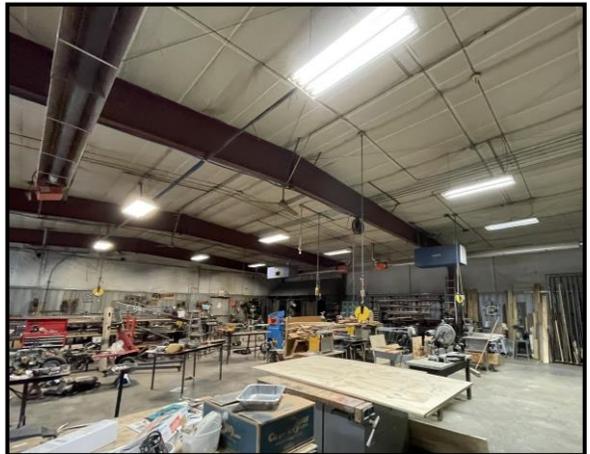
E. Ag Shop: The existing lighting throughout the building is fluorescent. The large shop area consists of suspended high bay fixtures. It does not appear that the lighting controls within the building meet current energy code requirements for automatic lighting control.

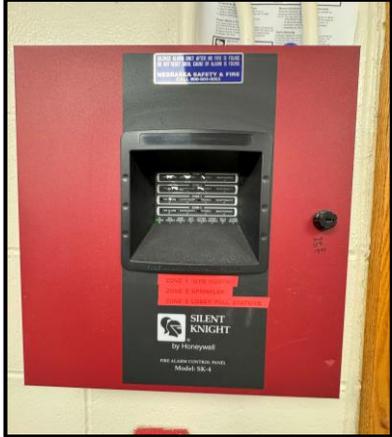
- B. Gymnasium: The existing facility is served by a Silent Knight conventional zoned system. The zones include gym north, sprinkler, and lobby pull stations. The Fire Alarm Control Panel (FACP) is located within the lobby. The date of installation of the FACP is unknown, but it appears to be functioning normally with no fault or trouble alarms present. There appears to be no exterior weatherproof horn/strobe above the Fire Department Connection (FDC).

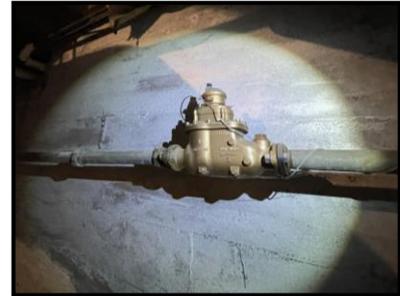
- a. A 1-1/2" domestic water service with a meter and backflow preventer is located in the 1980 Admin mechanical room and serves the entire main school building, except for the 1926 Elementary portion. The capacity and pressure of the service appear to be adequate for the existing facility.

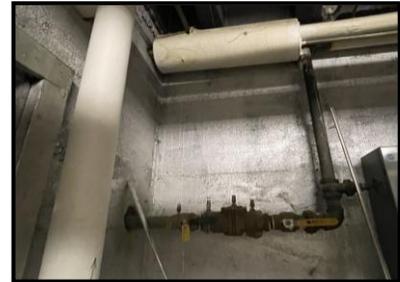
- b. A 2" domestic water service with a meter and backflow preventer is located in the 1926 Elementary basement mechanical room. The capacity and pressure of the service appear to be adequate for the existing facility.

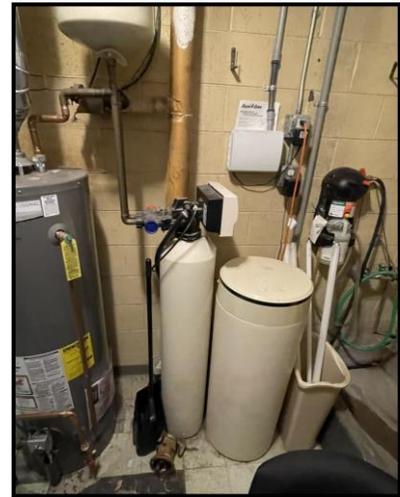
1. A simplex Culligan water softener treats the cold water inlet to the water heater in the 1966 High School mechanical room. The softener appears to be in acceptable condition.
2. A simplex Culligan water softener treats the cold water inlet to the water heater in the 1980 Admin mechanical room. The softener appears to be in acceptable condition.

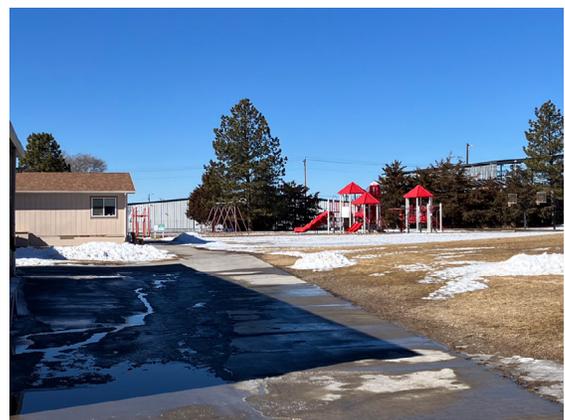
The courtyard is generally ADA-accessible next to the building. However, much of the grounds and playground is not due to the significant grade changes on the site and the un-level paved areas.

Grade leading to the playground.

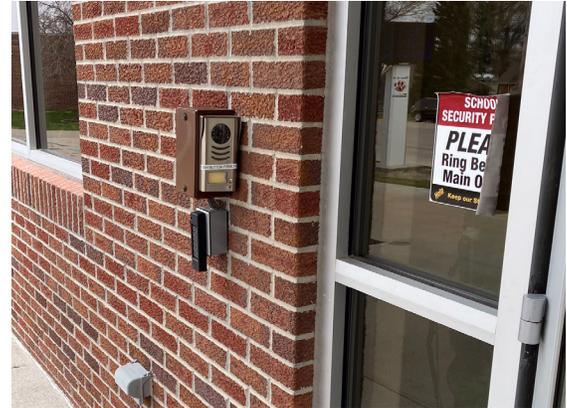
The school has a camera system and controlled access at each of the doors (photo on the right). Visitors and students entering in the morning come through the main entry on the south side of the building (Red Zone). This is directly adjacent to the main office, but there is no secondary set of doors or vestibule. Access is controlled at the exterior. However, there is a project currently planned to address this and add a second set of doors, with access control being updated as well.

Camera/Controlled access near the Red Zone Building.

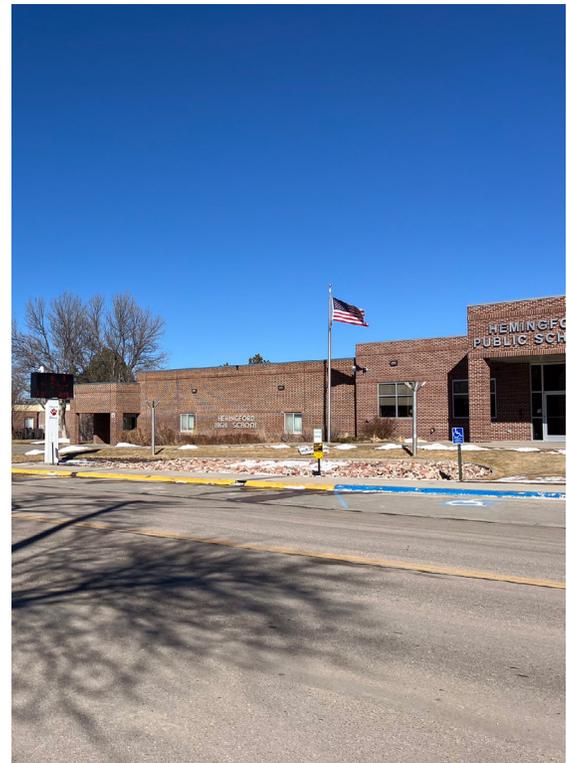
An ADA stall near the Red Zone entrance.

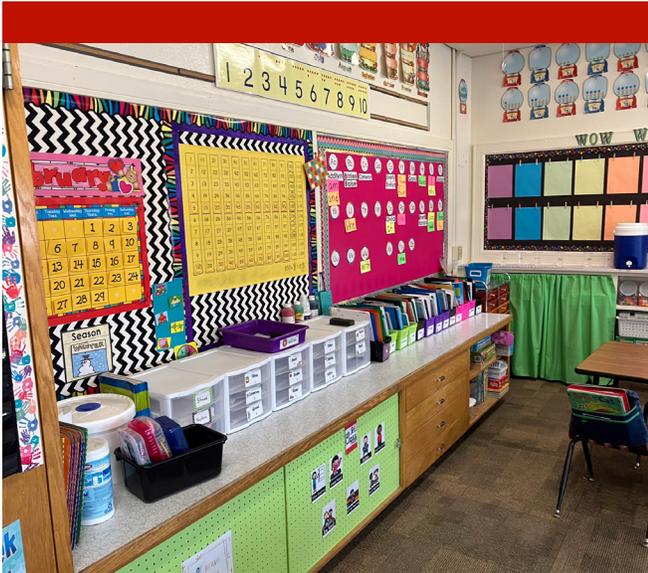
The classrooms are notably small. The absence of adequate storage poses a significant issue, leading to cluttered classrooms and hindering organization. The second floor appears particularly crowded, increasing the space constraints throughout the building. Furthermore, there's a clear lack of overall space and designated breakout areas, limiting opportunities for collaborative learning and extracurricular activities. Additionally, the shortage of electrical outlets adds a layer of inconvenience, hampering the integration of technology into the educational environment.

Typical classroom with cluttered areas of storage added with furniture.

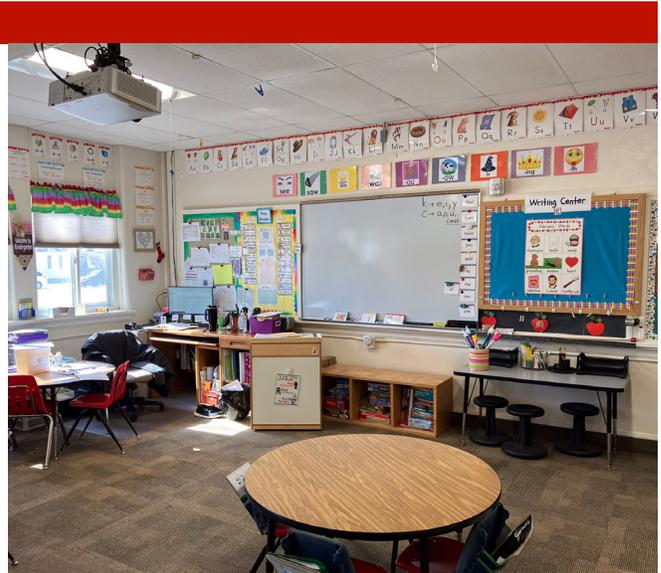
Classroom casework with added storage on top.

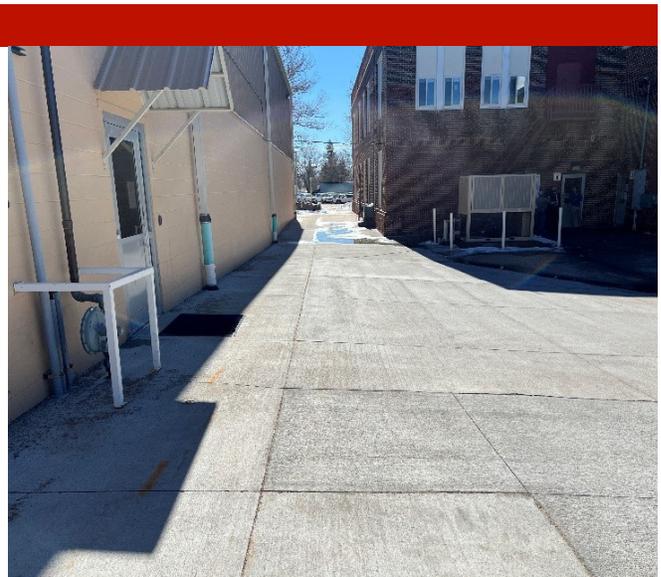
- The finished grade at the exterior of the building on the east and north sides (the sides with rooms 310, 311, and 312) slopes downward towards the building (see photos on pages 28 through 30). This creates a situation where the rainwater will accumulate against the building's foundation. Exterior grade should be adjusted so the slope is downward away from the building.

Ground level exterior grade looking south.

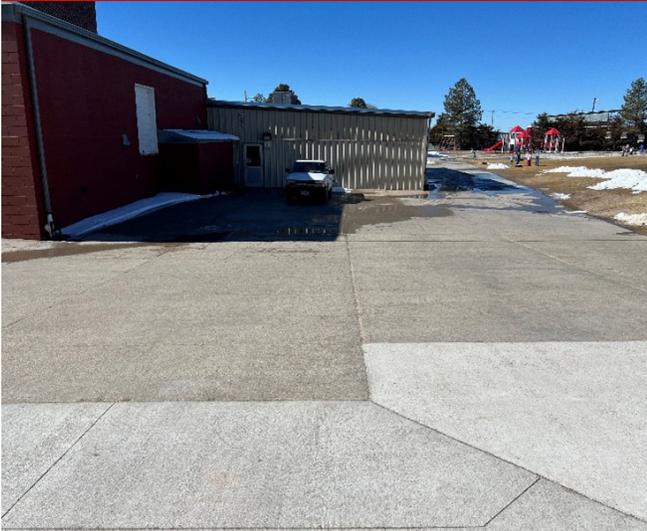
Ground level exterior grade looking west.

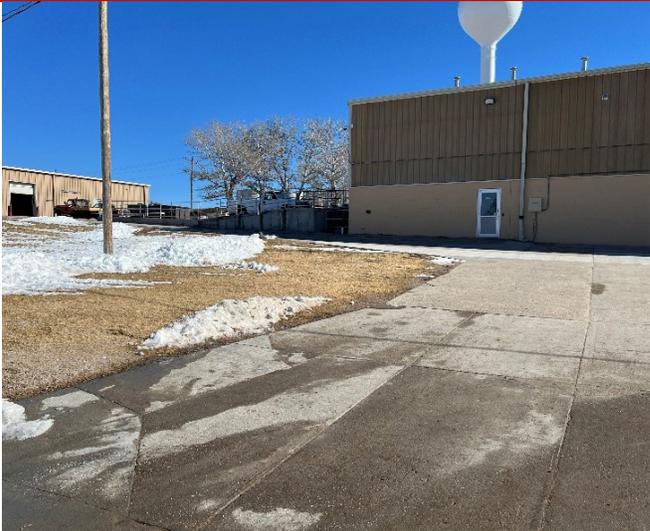
Ground-level exterior grade looking northeast.

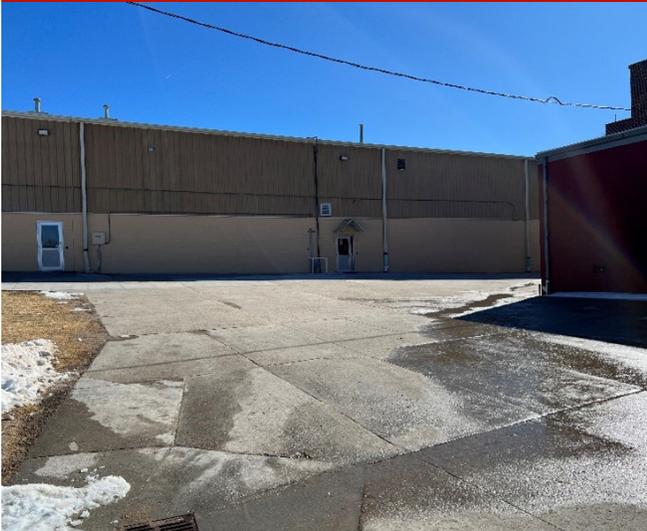
Ground level exterior grade looking southeast.

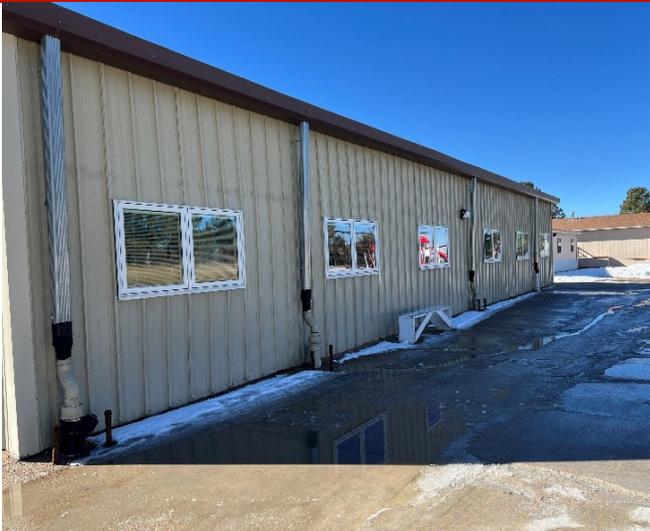
Ground level exterior grade looking southwest.

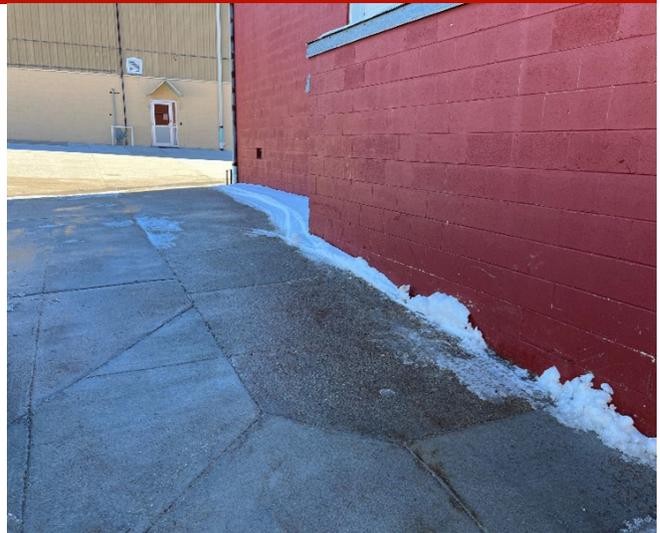
Ground level exterior grade looking southeast.

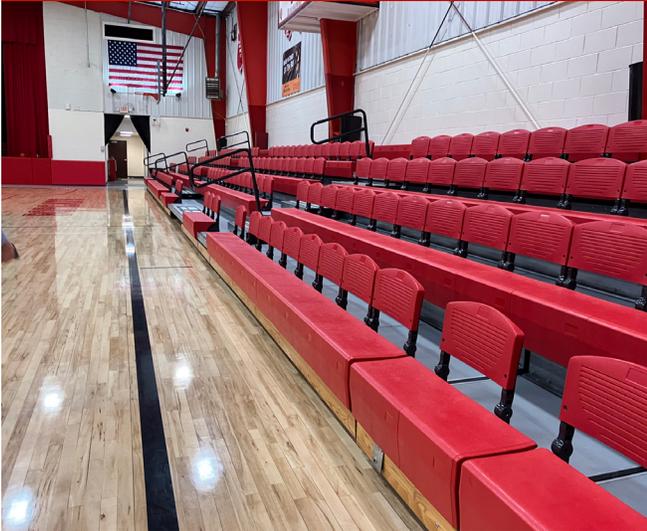
Bleachers extended - close to floor edge.

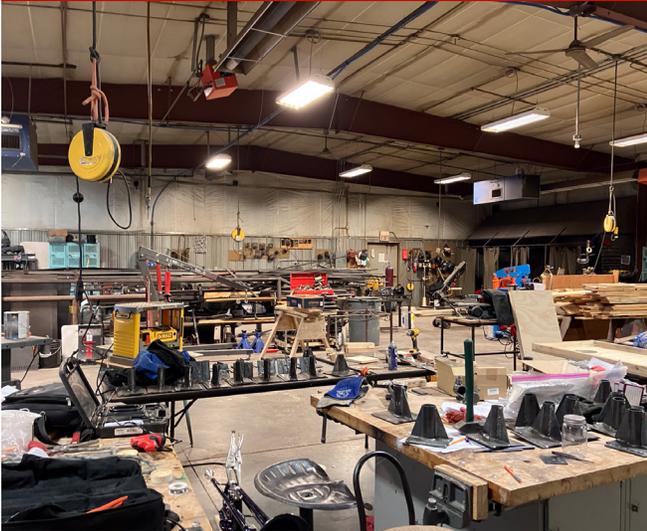
The close proximity of the welding and wood shop poses concerns about fire hazards. The building does not have a fire suppression system in the main shop area.

Overall, the use is generally good for shop space. The classroom space is very limited due to the size, and the overall area is very congested. Additional storage or expanded space for welding would be ideal but not necessarily required.

Shop area.

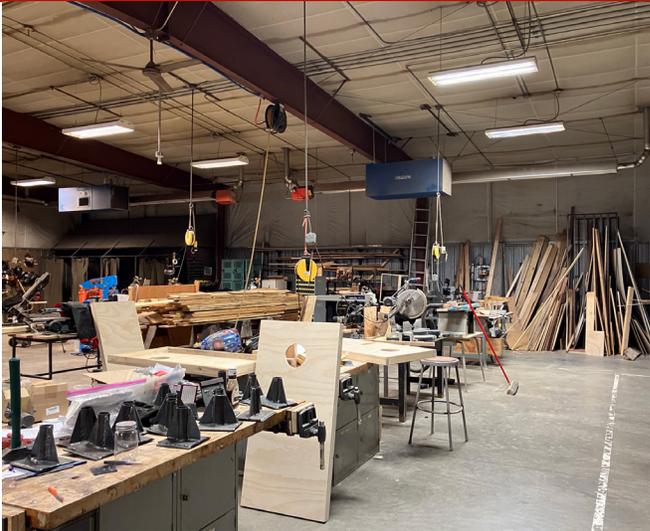
Shop area.

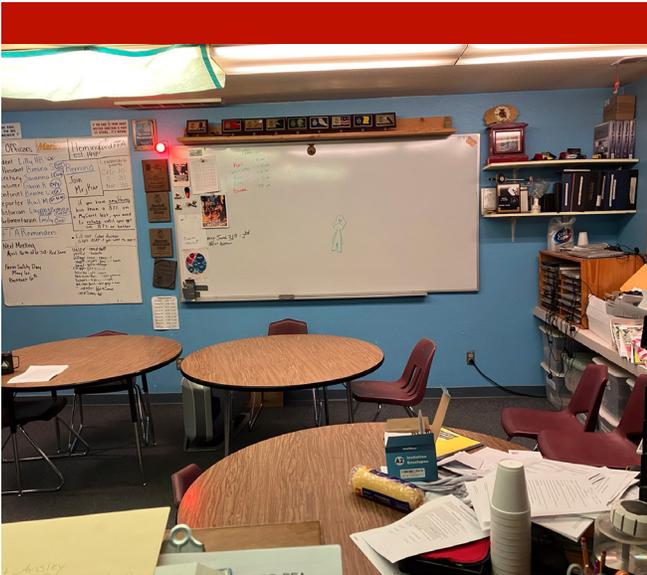
Classroom area.

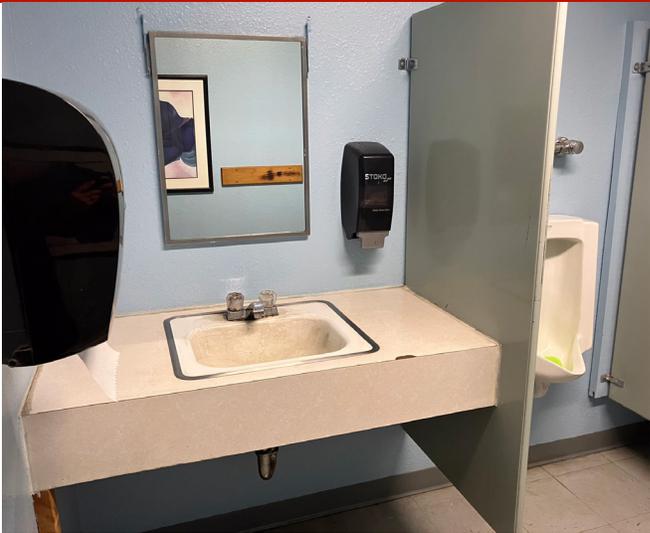
The shop, built in 1991, was intended for use as a wood shop. It includes a paint booth, a welding area, and small classrooms/office space. Currently the space is also used for automotive/engine repair as well as wood shop, welding and classroom space. The paint booth is not in use; it is used for storage. Overall the space is adequate for the use, but it is very crowded in the classroom area. For the number of students and tables in the space, the area is very small. The shop area is very crowded and seems to be congested with equipment and project materials. The restrooms are adequate for the number of students but do not provide ADA accessibility.

Restrooms.

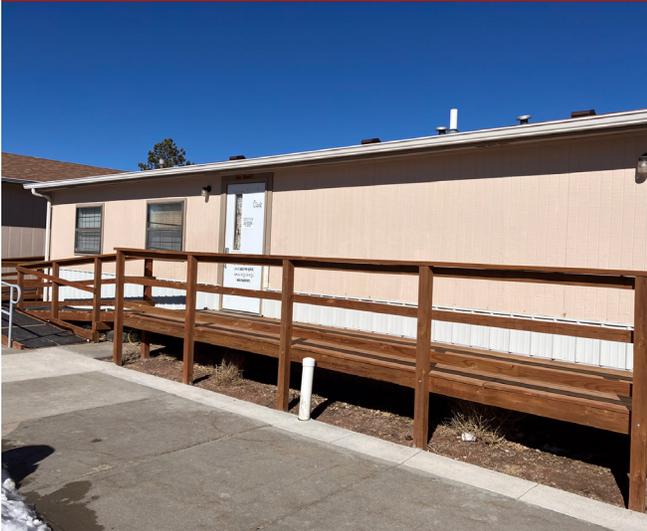
The modulars are in fair condition for their age and do not appear to have issues with weather. They are not ideal in terms of insulation and energy efficiency.

Overall, the buildings serve their purpose and are only used for limited times of the year. The modulars have served their purpose, but are well beyond the intended life and use.

Exterior of the modular structure.

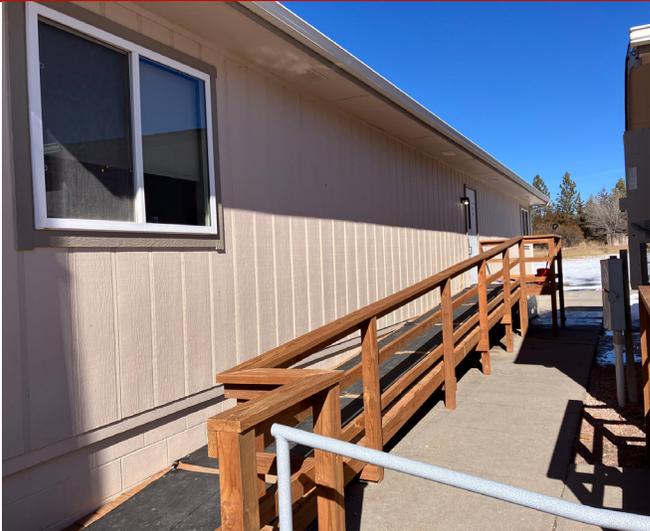
ADA ramp on the exterior of the modular structure.

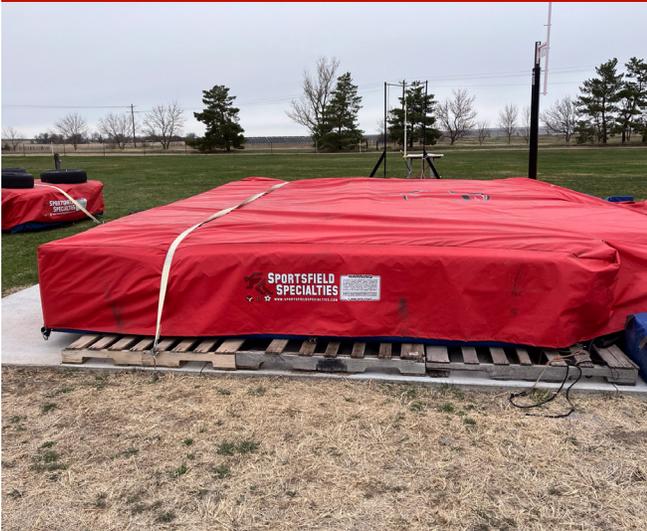
The track facility is in very poor condition and does not work well for practice or training. It is well below standard or average condition.

High jump mat.

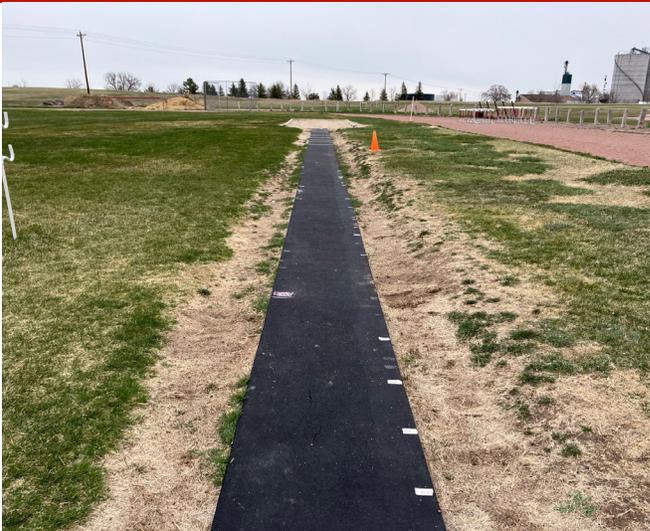
Long and triple jump runway.

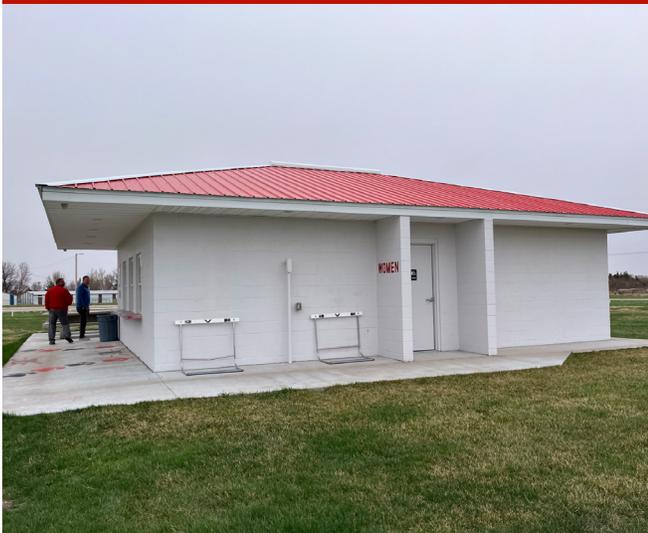
The concession building is large enough to accommodate ADA use, but the layout of the restrooms does not allow for enough clearance for one ADA stall. With some relocation of the partitions, one end stall could be available for ADA use, and this change would be recommended.

Concession stands.

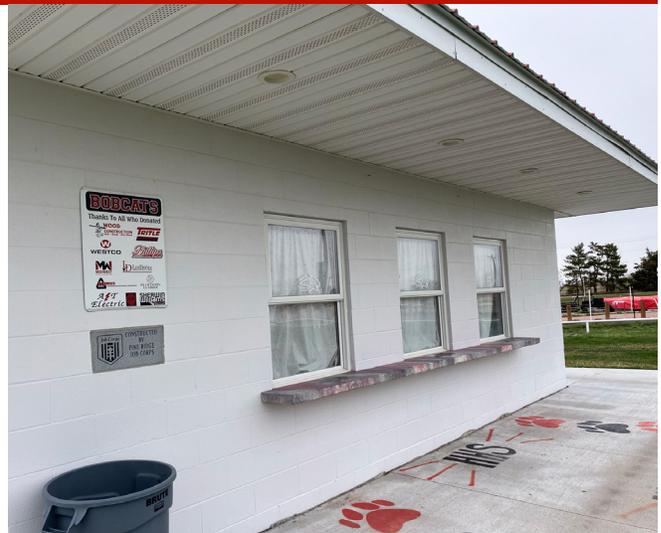
Concession stands.
