Board of Education Study Session
Monday, June 12, 2023 5:30 PM

Seward Elementary

Condition Summary

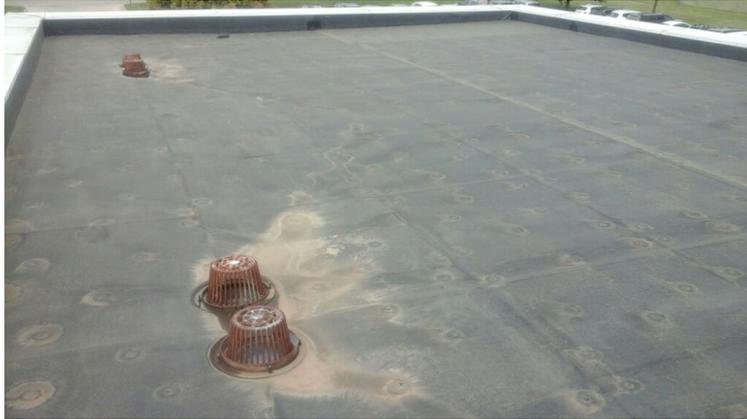
This roof is in good condition and appears to be performing well.

Photo showing overview of Area 01 Roof.

I recommend continued inspections and maintenance.

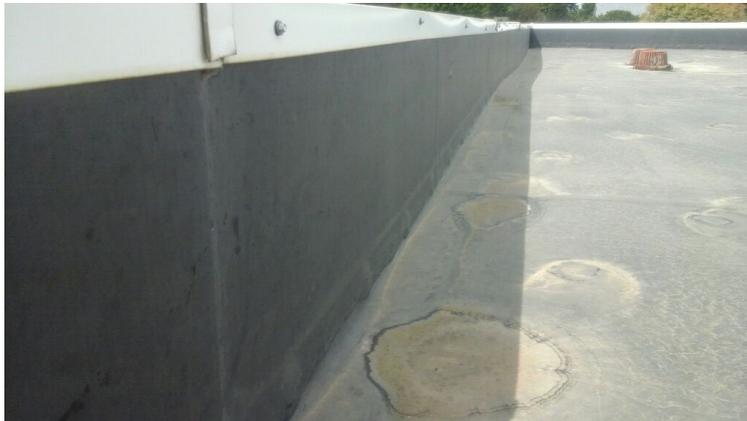
Photo showing condition of the perimeter flashings.

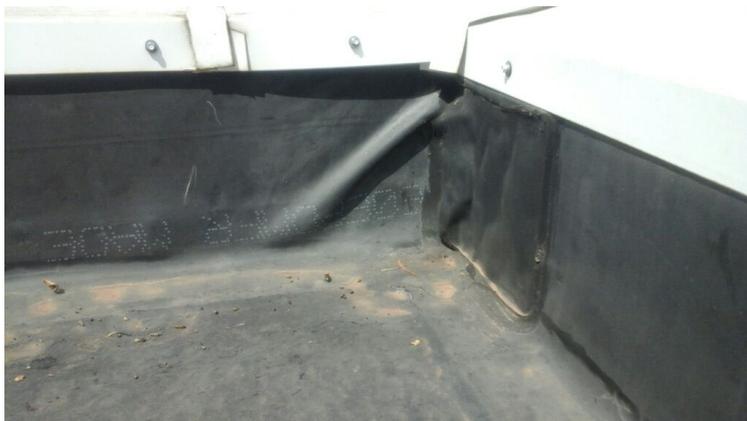
Photo showing condition of the perimeter flashings in the corner.

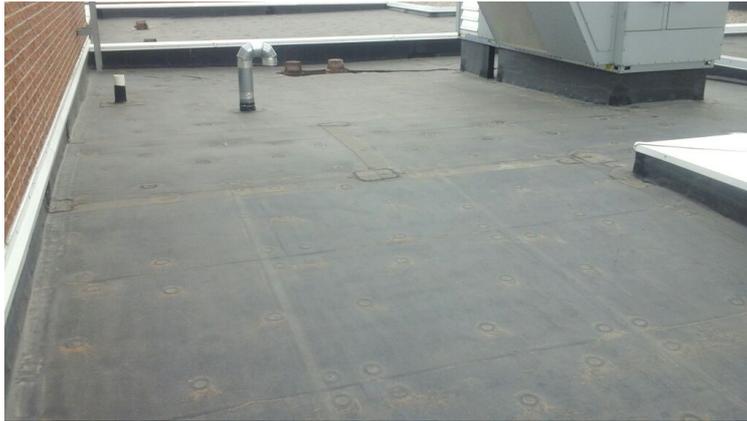
This roof is in good condition and appears to be performing well.

Photo showing overview of Area 02 Roof.

I recommend continued inspections and maintenance.

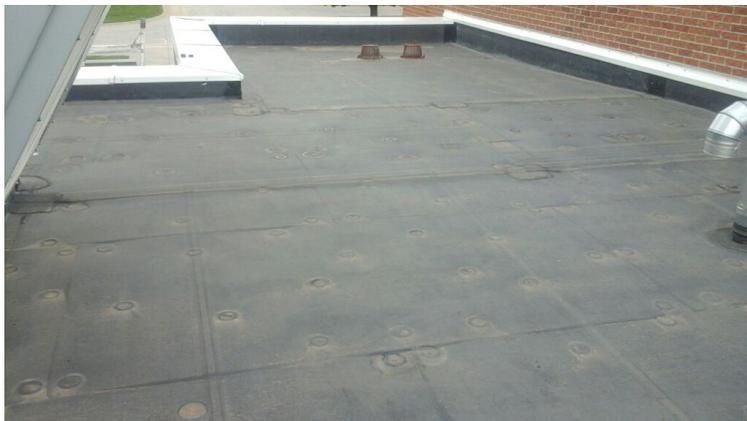
Photo showing additional overview of Area 02 Roof.

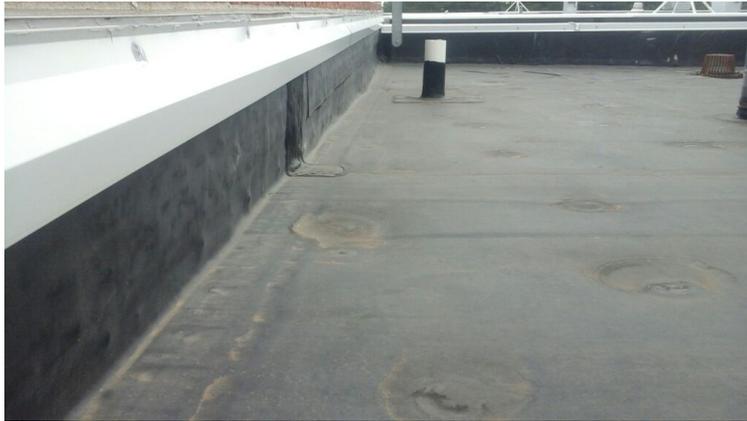
Photo showing condition of the perimeter flashings.

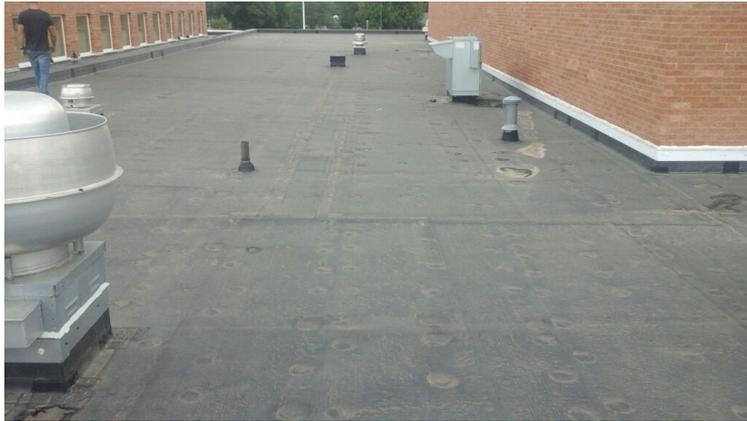
This roof is in good condition and appears to be performing well. There is one projection located in a drain sump that could become a problem in the future.

Photo showing overview of Area 03 Roof.

I recommend continued inspections and maintenance.

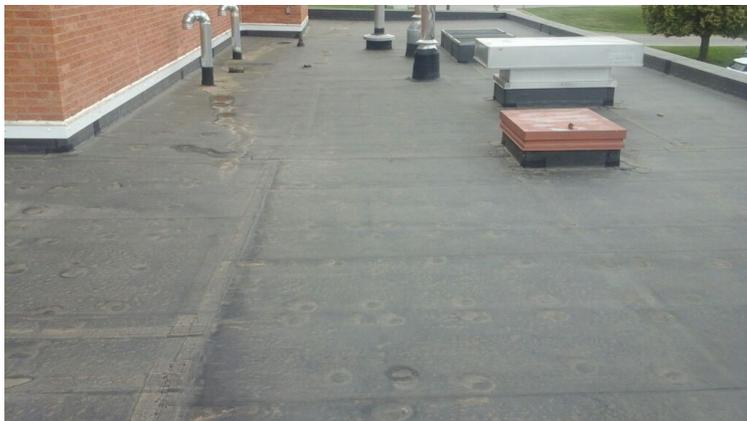
Photo showing additional overview of Area 03 Roof.

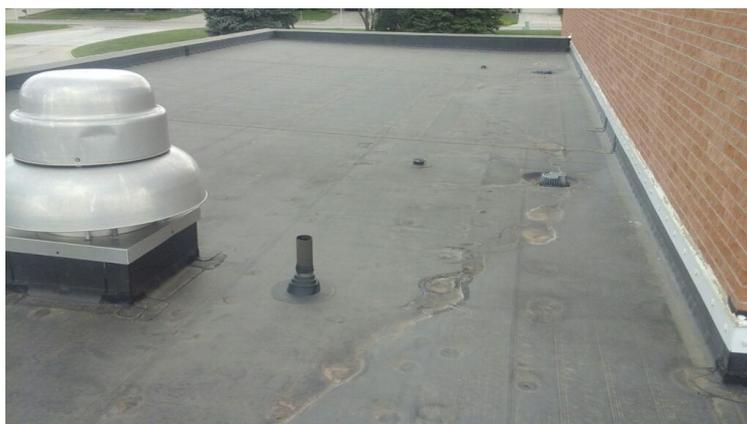
Photo showing additional overview of Area 03 Roof.

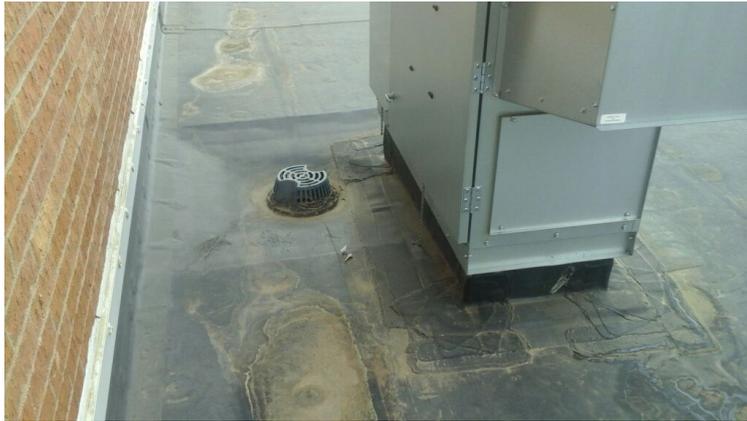
Photo showing HVAC unit located in drain sump.

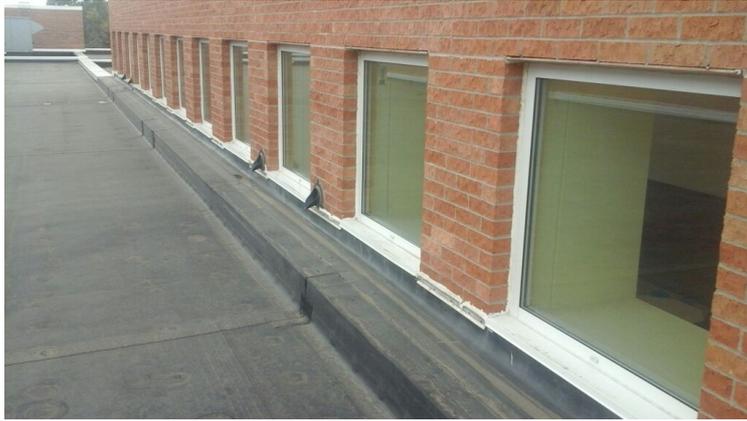
Photo showing condition of the perimeter flashings along window wall.

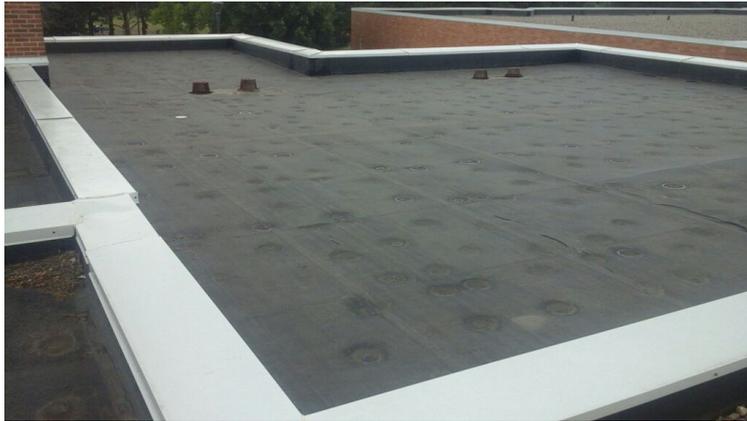
Photo showing overview of Area 04 Roof.

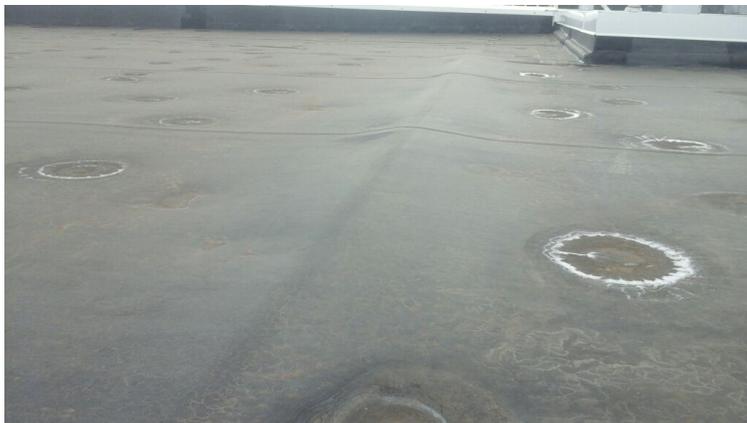
This roof is in good condition and appears to be performing well. There is an area where the cover board was not staggered and is pressing up against the field membrane that should be monitored.

Photo showing coverboard extruding under field membrane due to joints not being staggered on install.

I recommend continued inspections and maintenance.

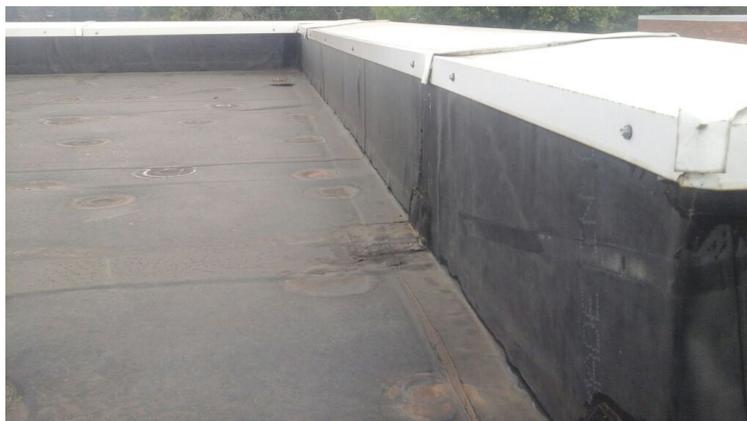
Photo showing condition of the perimeter flashings.

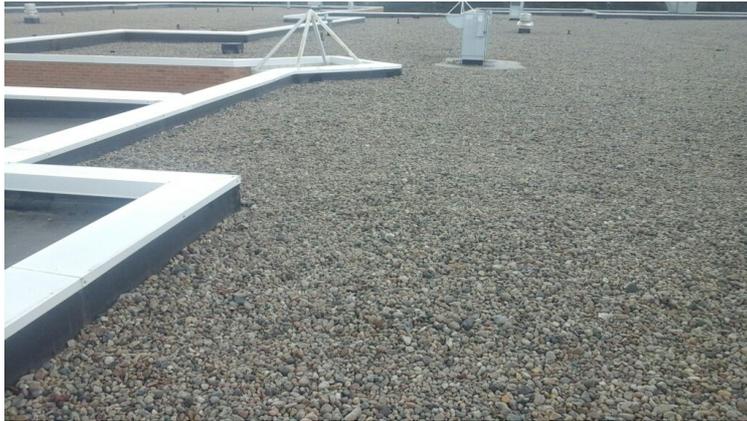
This roof is in fair condition and appears to be performing well. There are several areas where the membrane is being lifted up by extruding insulation.

Photo showing overview of Area 05 Roof.

I recommend continued inspections and maintenance.

For future consideration the estimated budget number for restoring this roof is \$80,000.
The estimated cost for replacing this roof is \$400,000.

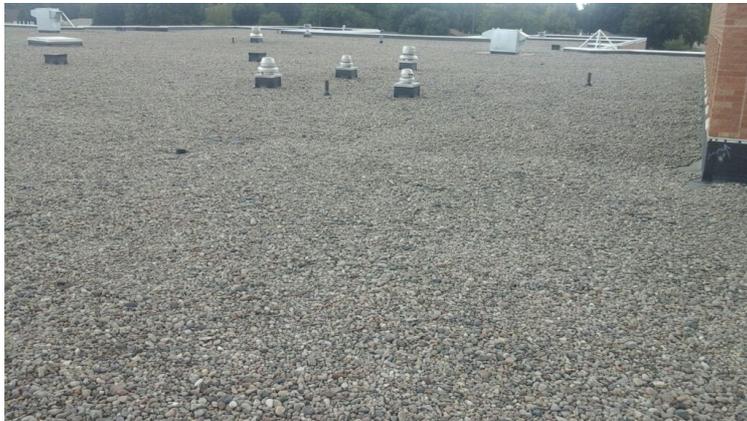
Photo showing additional overview of Area 05 Roof.

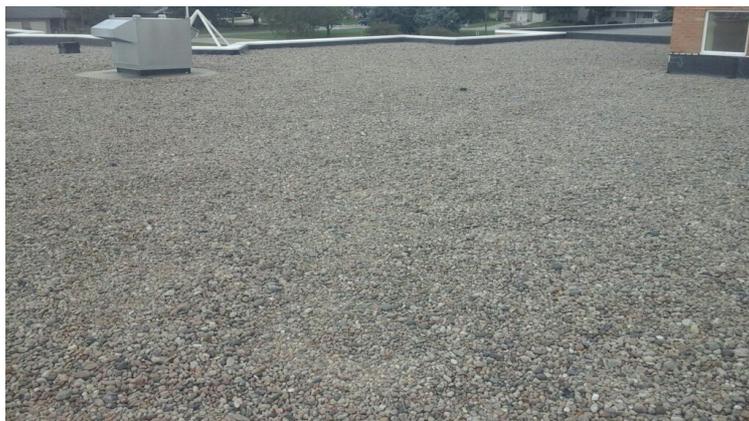
Photo showing additional overview of Area 05 Roof.

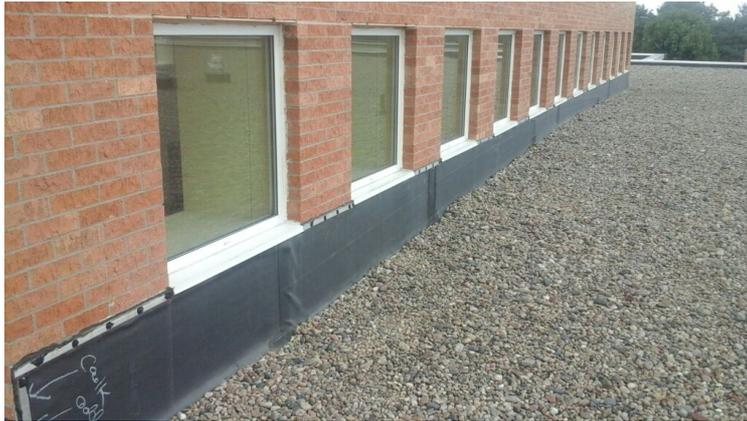
Photo showing condition of the perimeter flashings along the window wall.

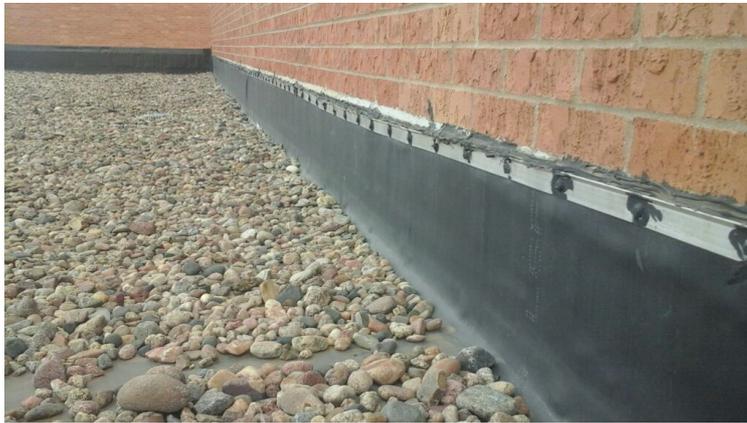
Photo showing condition of the perimeter flashings along the brick wall.

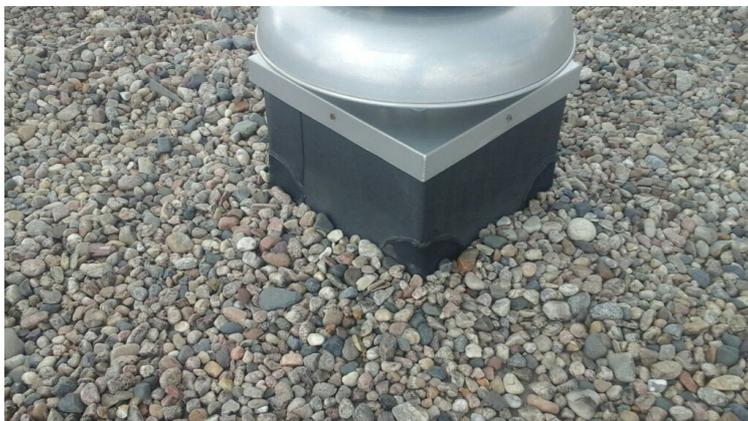
Photo showing condition of projection flashings.

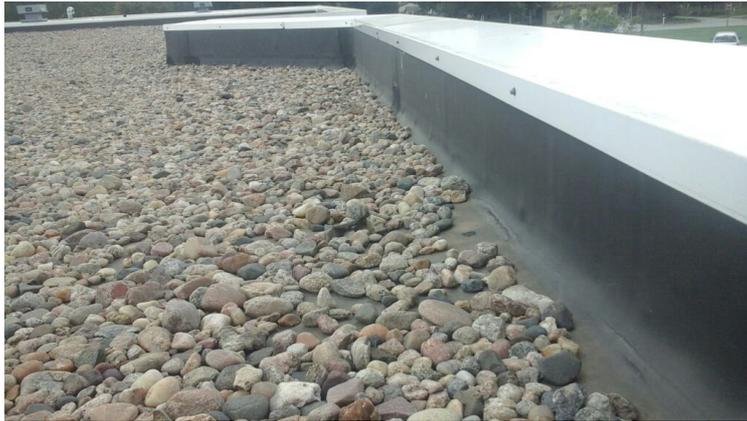
Photo showing condition of the perimeter flashings.

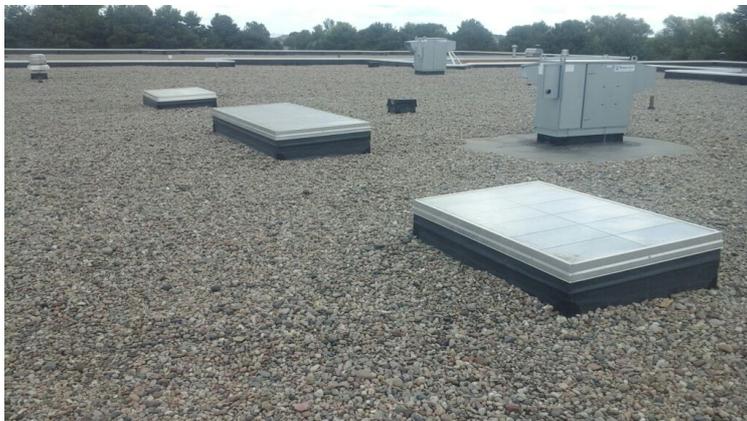
Photo showing condition of the skylights.

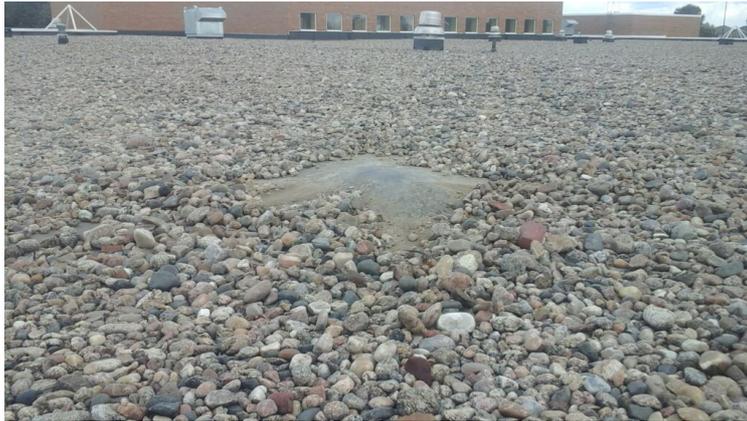
Photo showing area where insulation is pushing up on membrane.

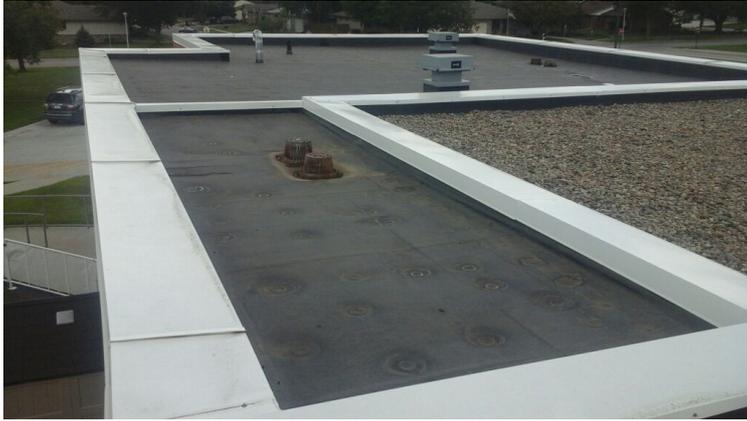
Photo showing overview of Area 06 Roof.

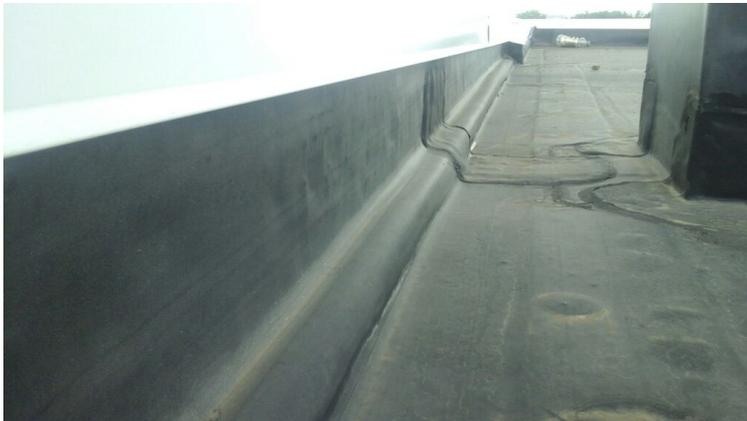
Photo showing condition of the perimeter flashings.

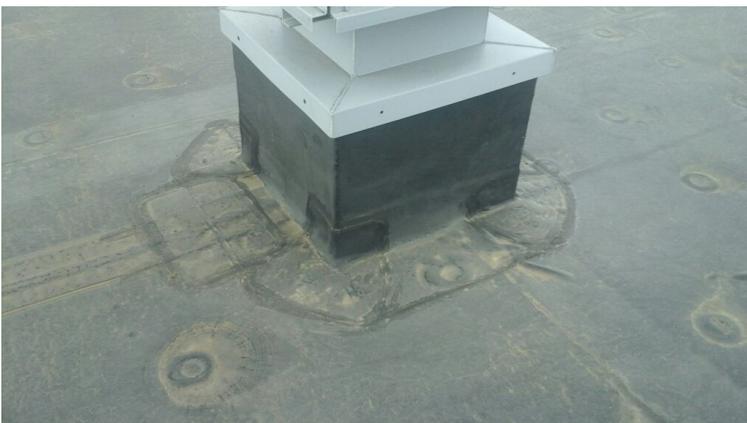
Photo showing condition of projection flashings.

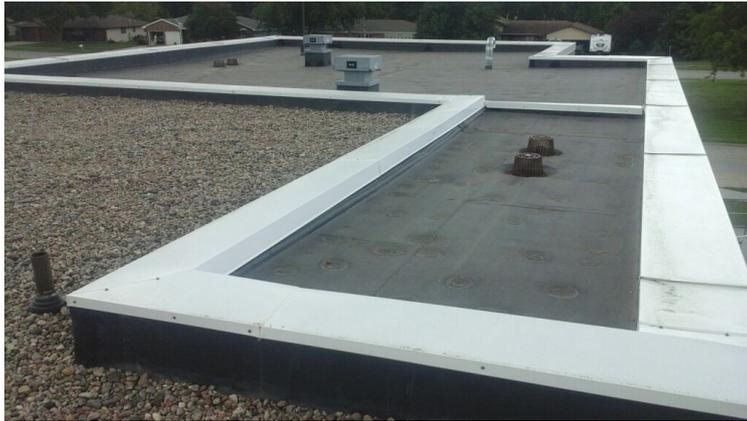
Photo showing overview of Area 07 Roof.

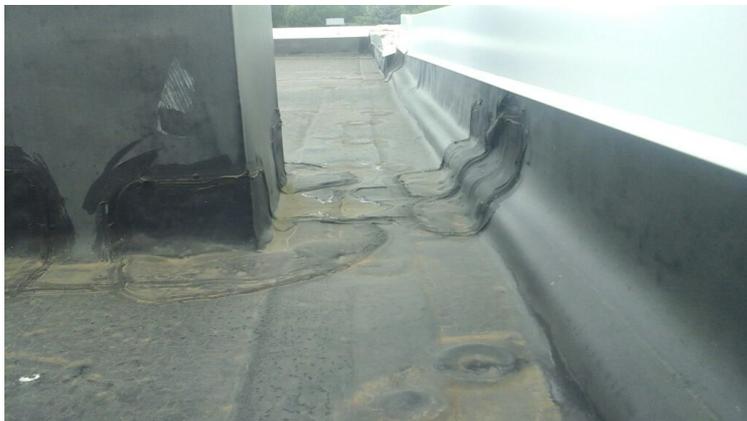
Photo showing condition of the perimeter flashings.

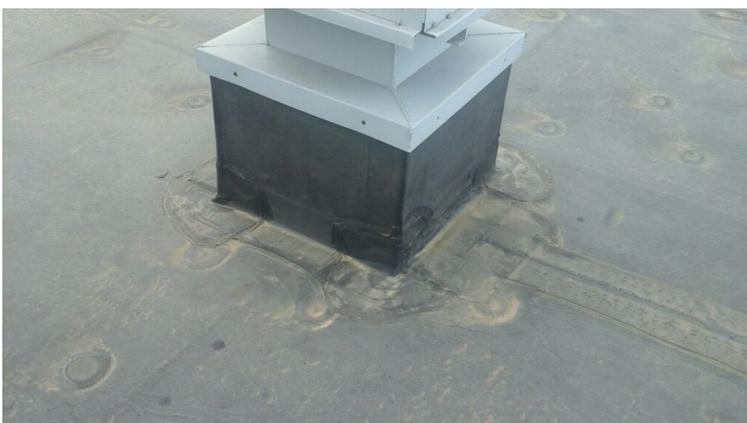
Photo showing condition of projection flashings.

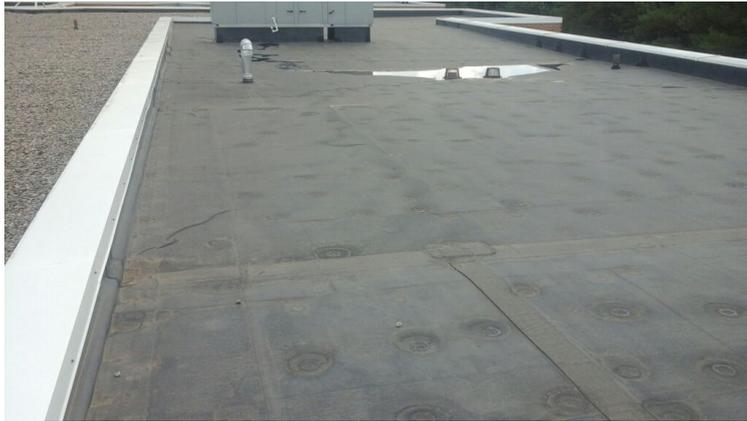
This roof is in good condition. There is some ponding water around the central drain do to missed taper design. There was one hole found in the field membrane.

Photo showing overview of Area 08 Roof.

I recommend patching hole and continued inspections and maintenance.

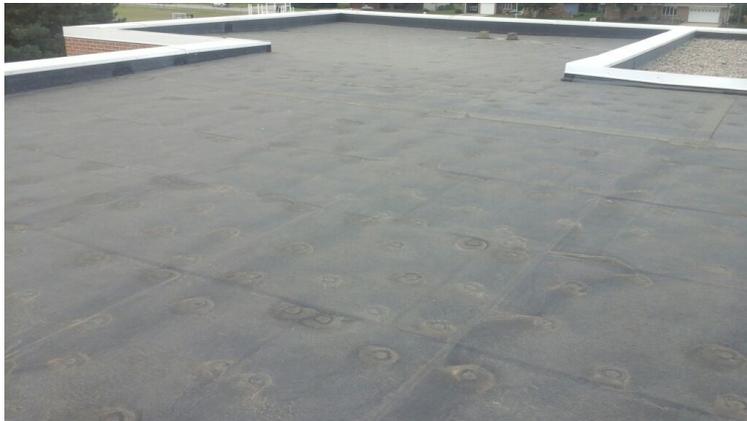
Photo showing additional overview of Area 08 Roof.

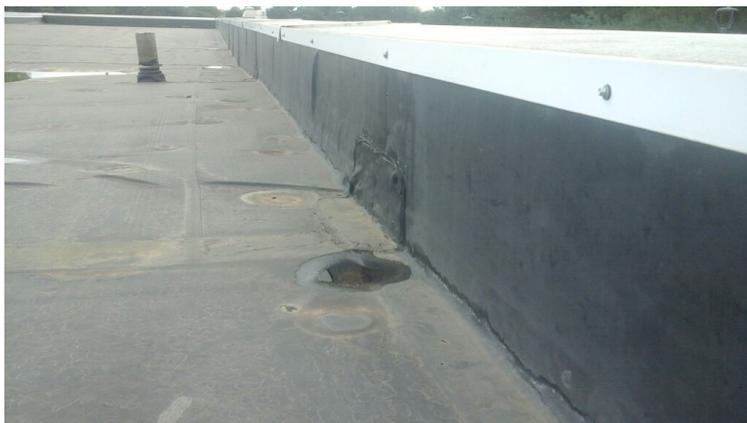
Photo showing condition of the perimeter flashings.

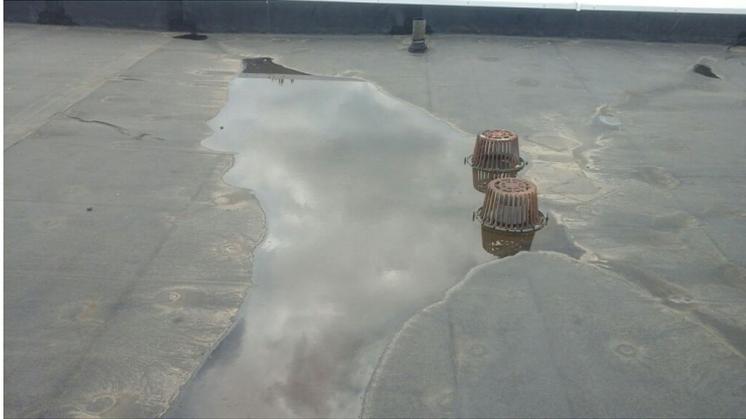
Photo showing ponding water due to lack of sump.

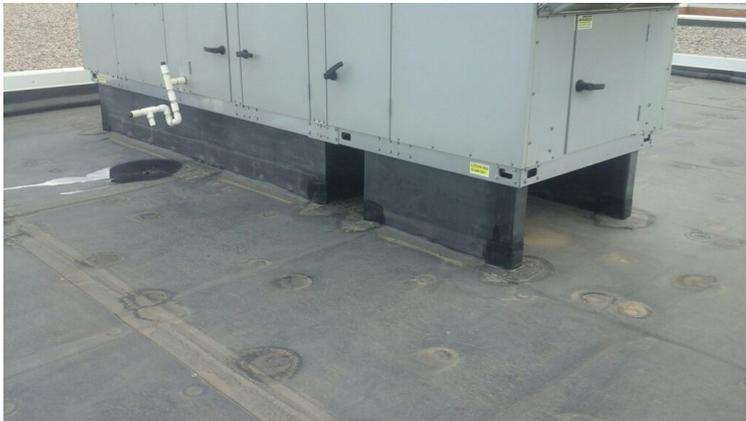
Photo showing condition of projection flashings.

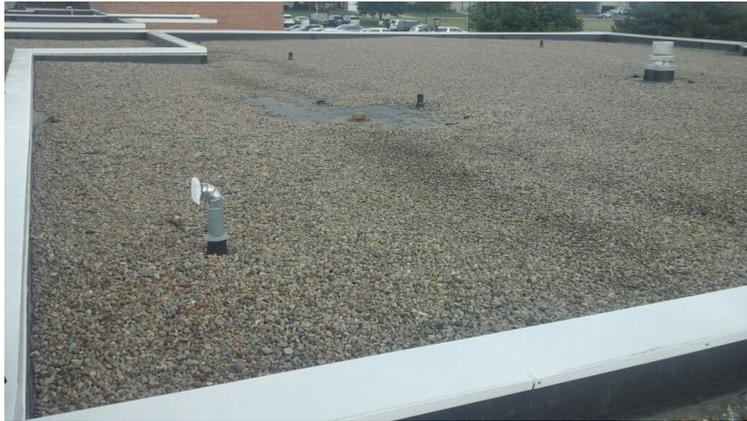
This roof is in fair condition due to the aging and tenting perimeter flashings. There were several areas where flashing patches were pulling loose.

Photo showing overview of Area 09 Roof.

I recommend repairing holes and monitoring perimeters which may eventually need to be relaxed. I recommend continued inspections and maintenance.

For future budget consideration the estimated cost for restoring this roof is \$70,000. The estimated cost for replacing this roof is \$180,000.

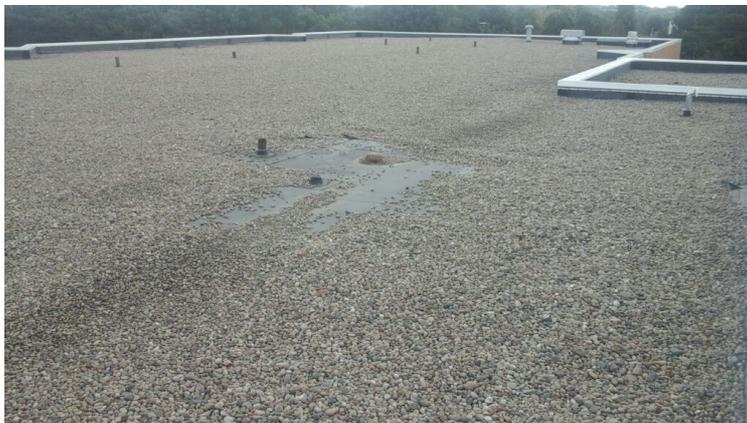
Photo showing additional overview of Area 09 Roof.

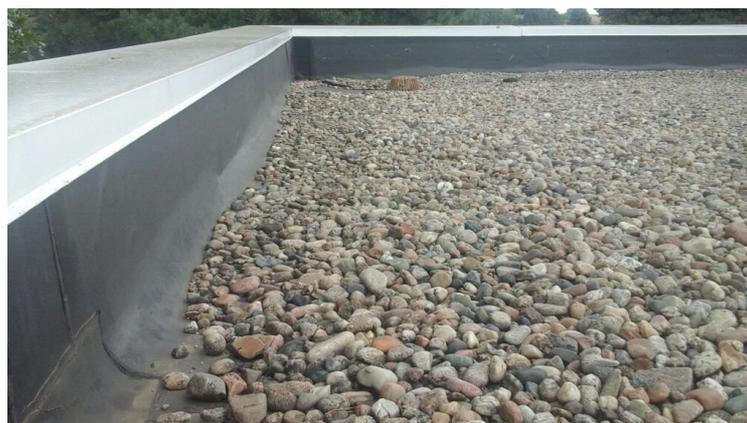
Photo showing minor tenting along the perimeter flashings.

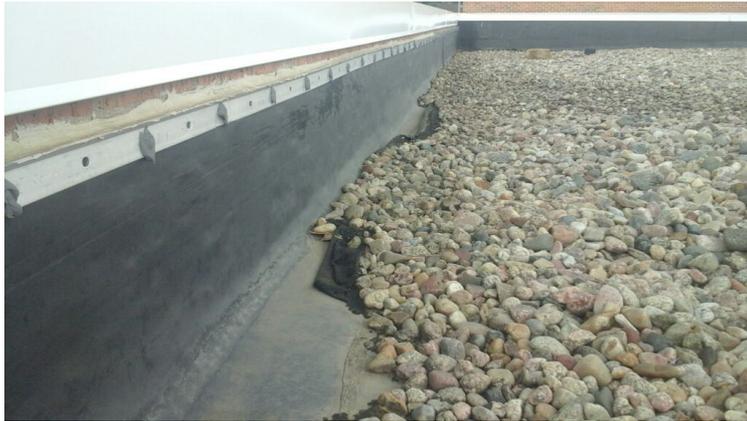
Photo showing where metal does not cover term bar.

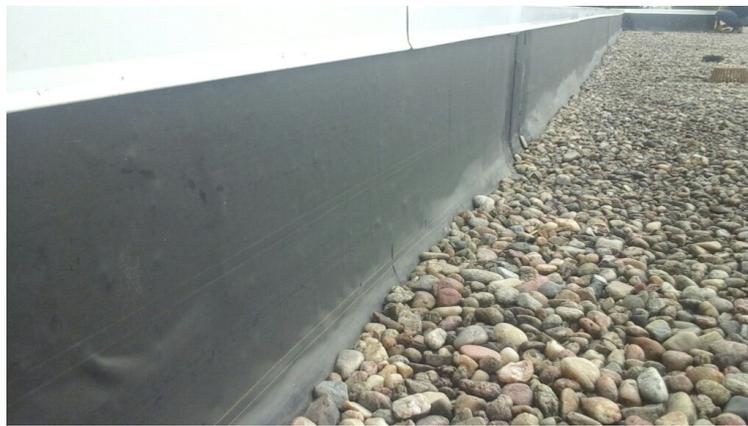
Photo showing additional tenting along the perimeter flashings.

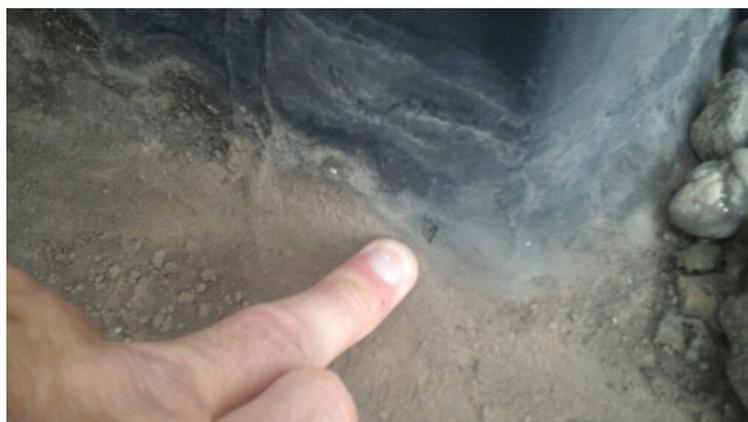
Photo showing a hole in the perimeter flashing.

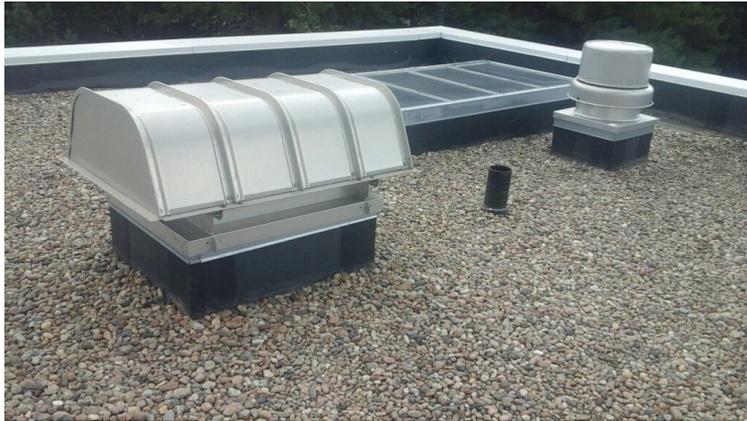
Photo showing condition of projection flashings.

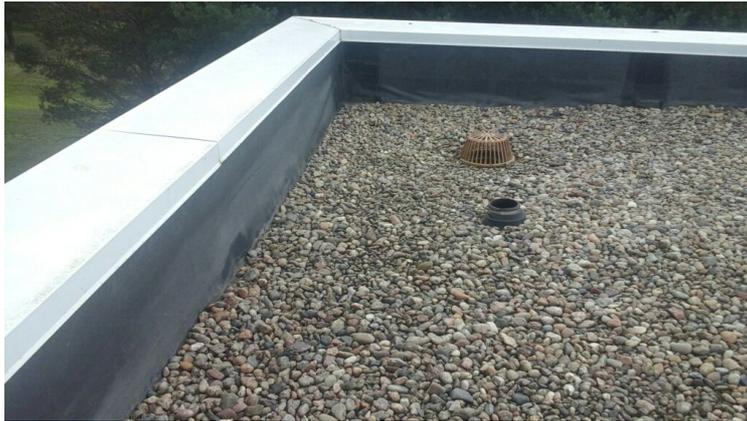
Photo showing tenting occurring corners.

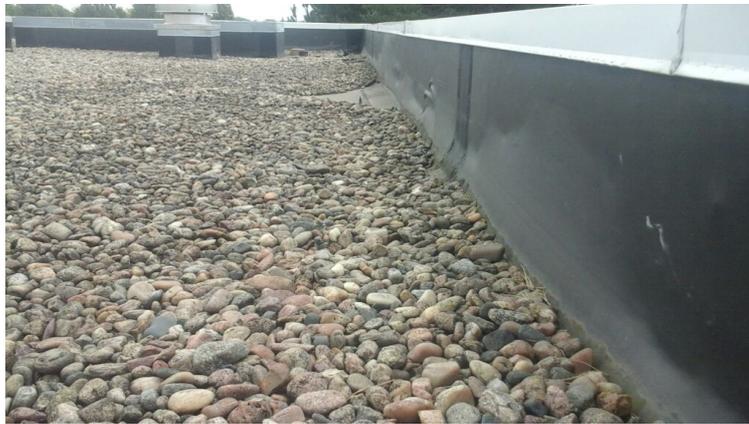
Photo showing tenting occurring along perimeter flashing and into corner.

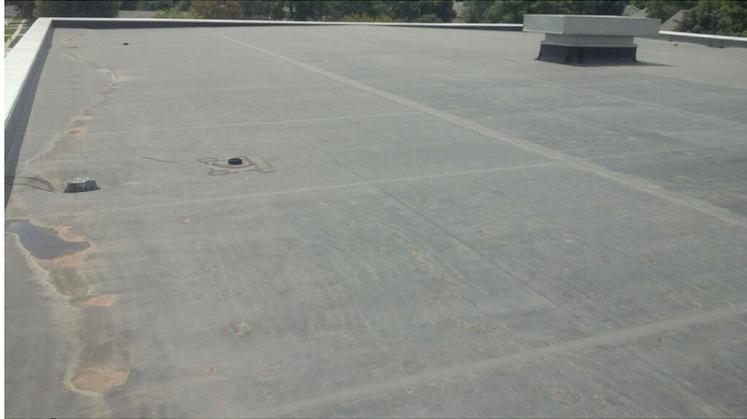
Photo showing overview of Area 10 Roof.

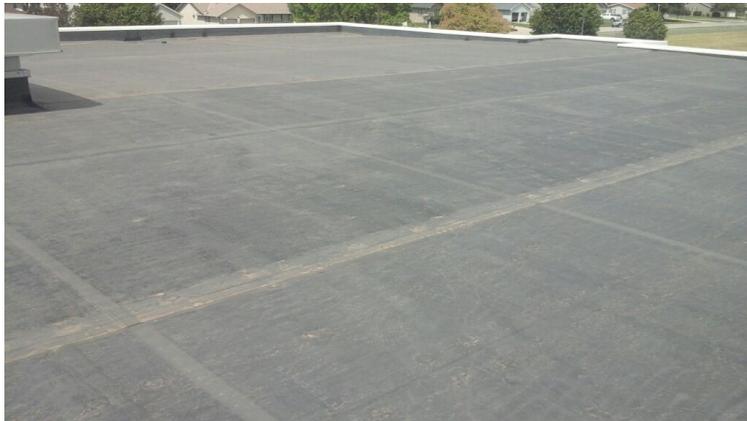
Photo showing additional overview of Area 10 Roof.

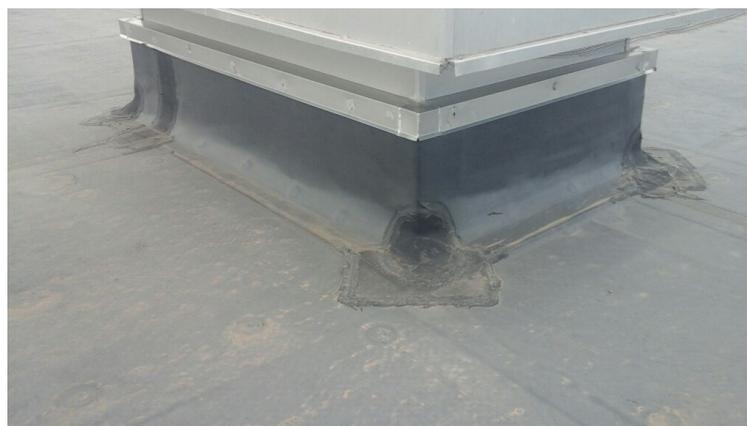
Photo showing condition of projection flashings.

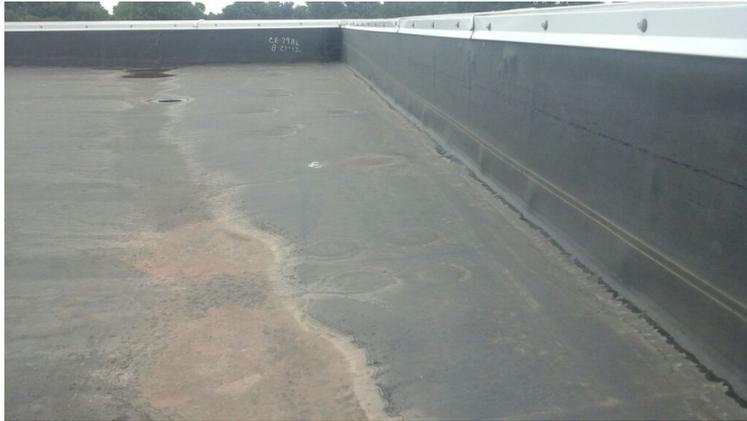
Photo showing condition of the perimeter flashings.

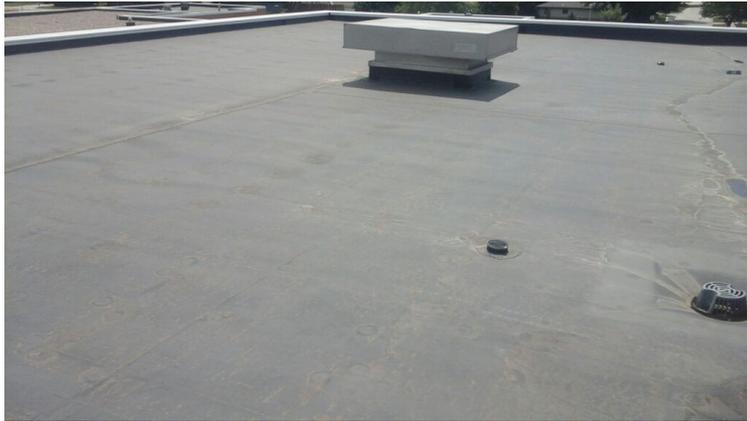
Photo showing overview of Area 11.

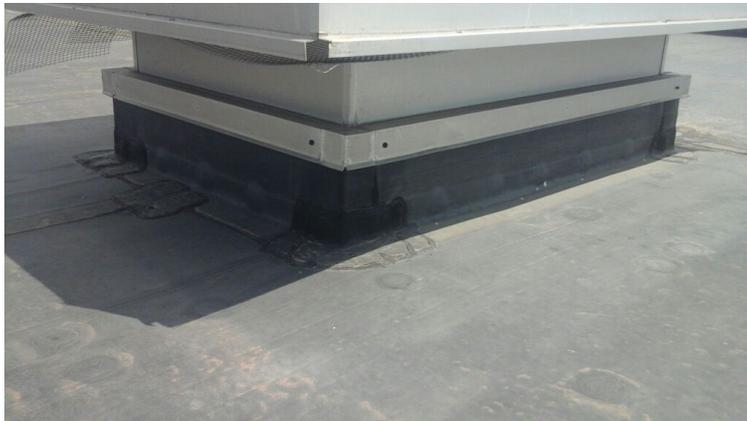
Photo showing condition of projection flashings.

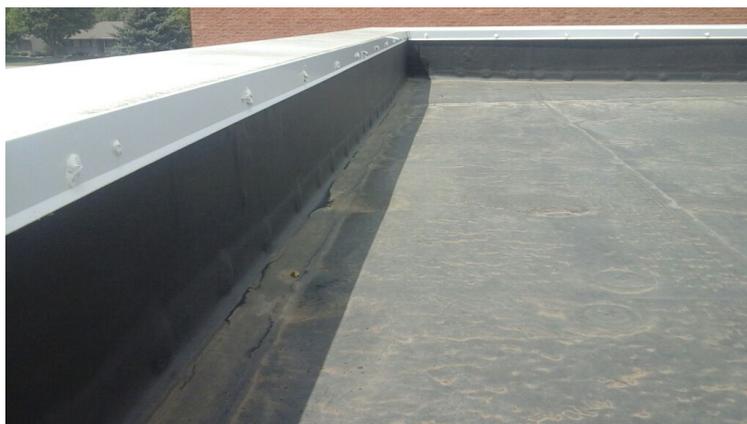
Photo showing condition of the perimeter flashings.

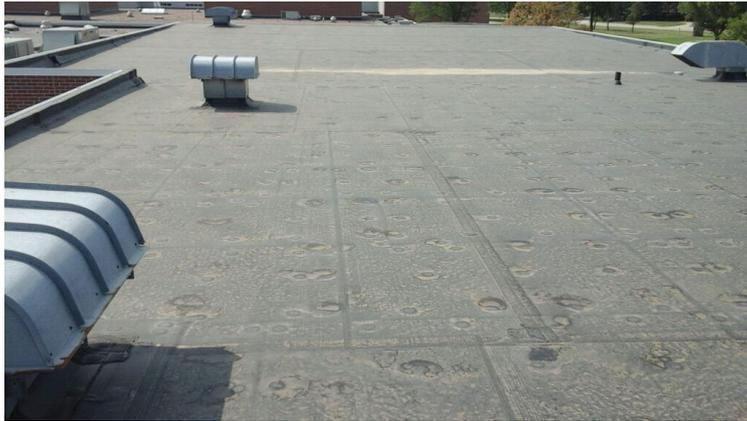
Photo showing overview of Area 01 Roof.

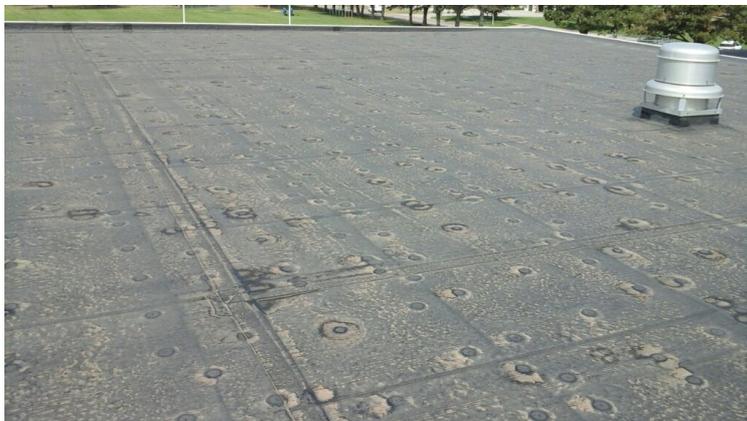
Photo showing additional overview of Area 01 Roof.

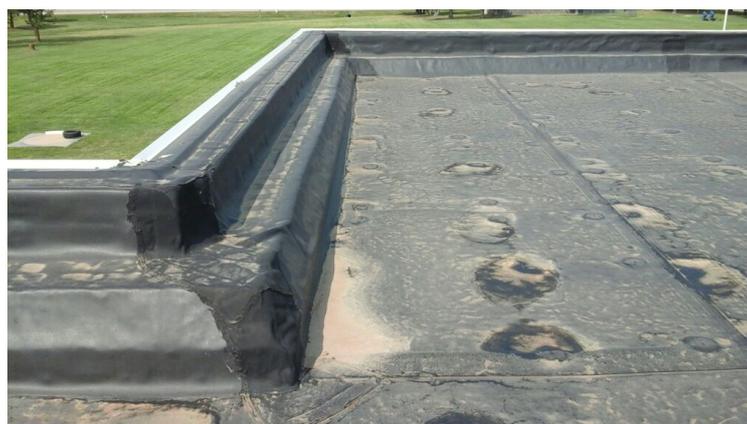
Photo showing condition of the perimeter flashings.

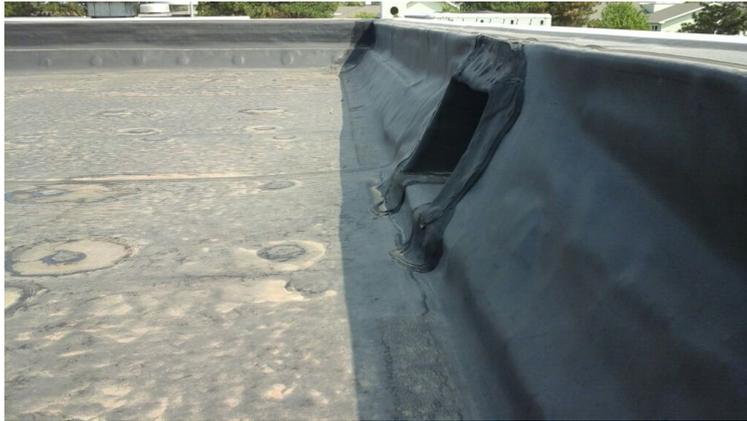
Photo showing condition of the perimeter flashings.

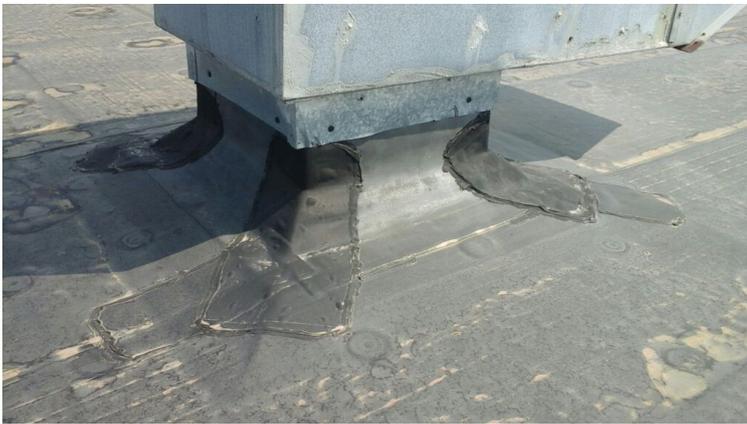
Photo showing condition of the projection flashings.

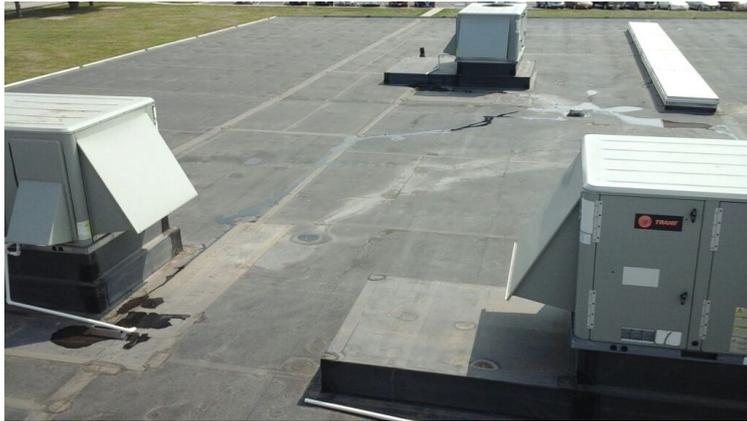
Photo showing overview of Area 02 Roof.

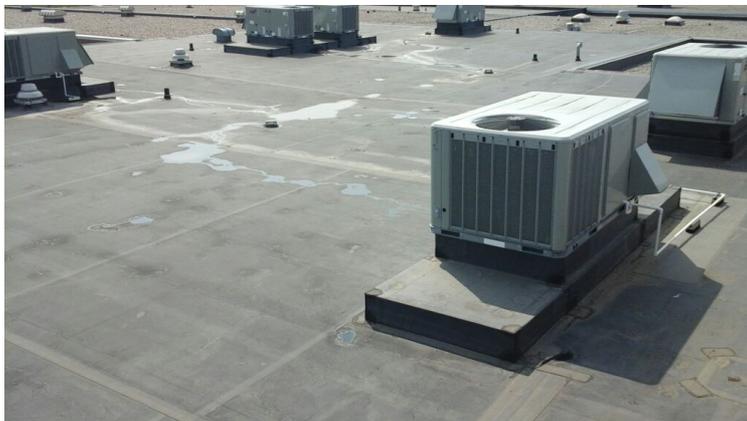
Photo showing additional overview of Area 02 Roof.

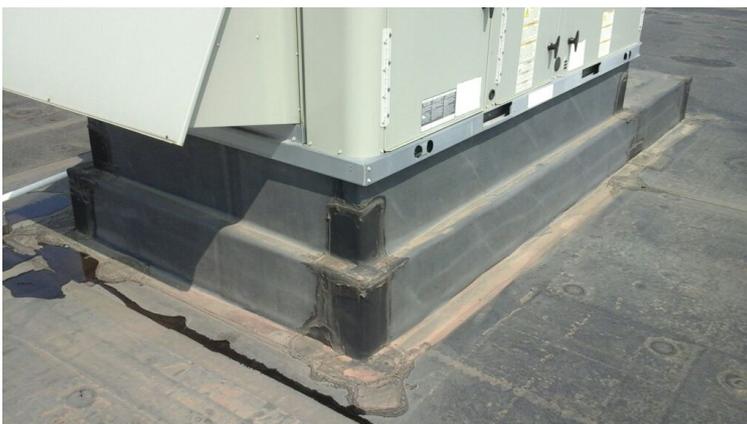
Photo showing condition of projection flashings.

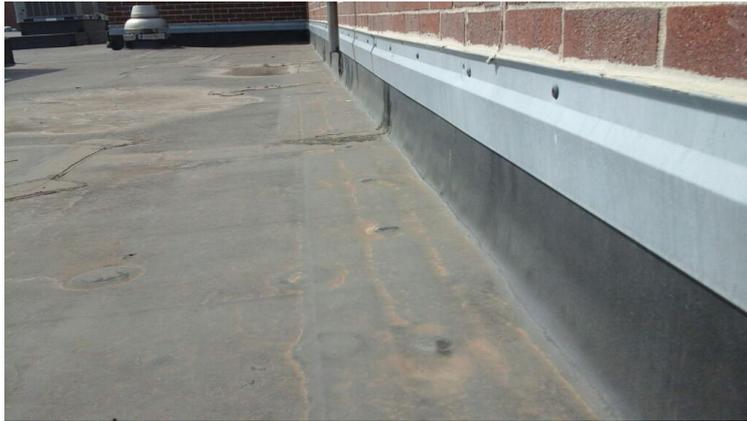
Photo showing condition of the perimeter flashings.

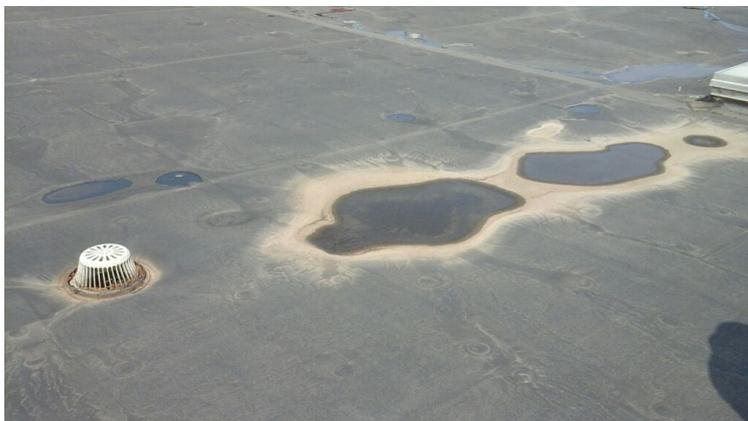
Photo showing minor ponding in the drain valley.

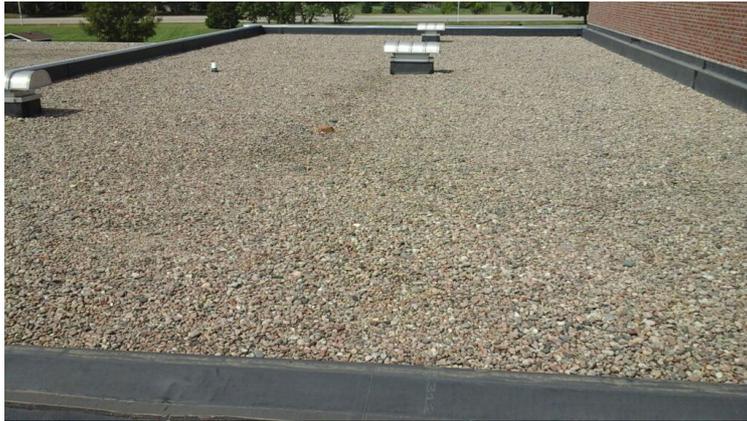
Photo showing overview of Area 03 Roof.

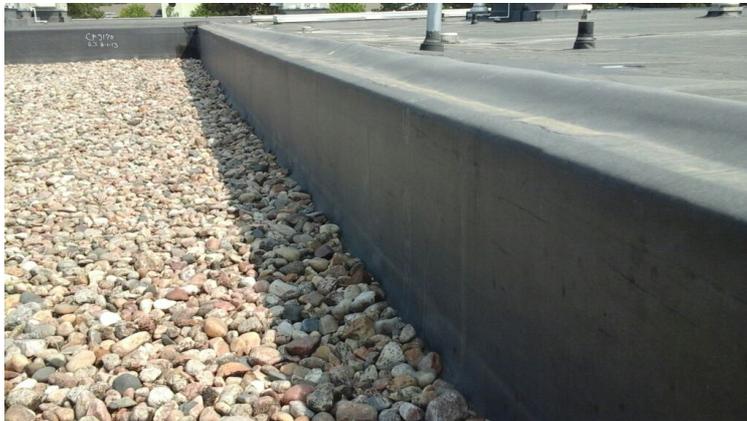
Photo showing condition of the perimeter flashings.

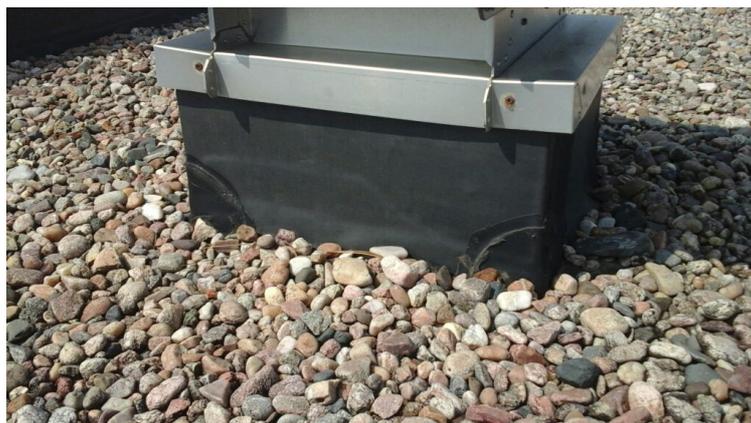
Photo showing condition of projection flashings.

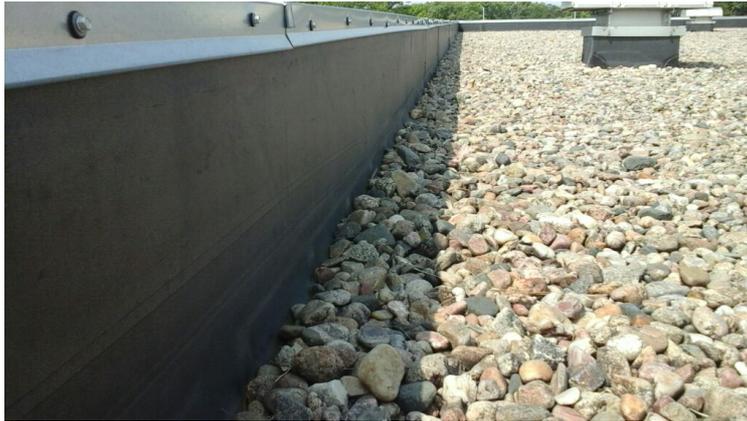
Photo showing condition of the perimeter flashings.

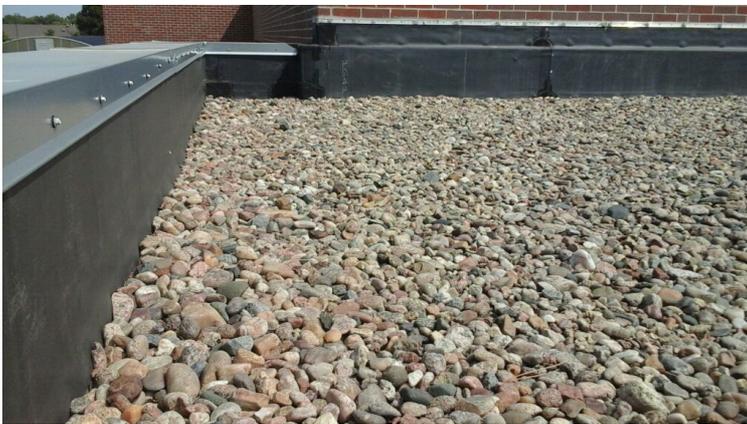
Photo showing condition of the perimeter flashings.

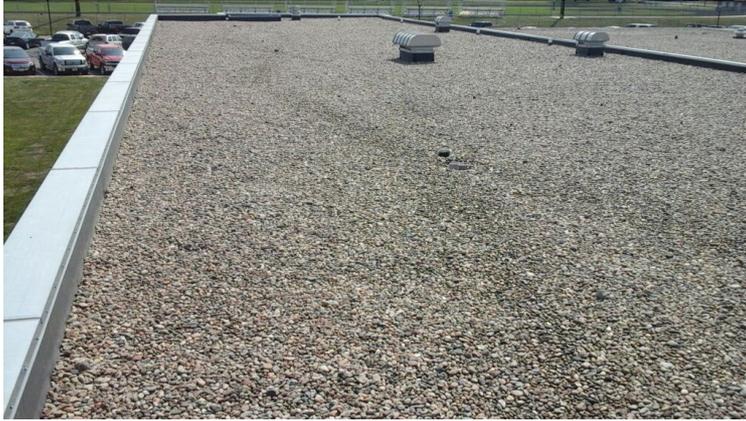
Photo showing overview of Area 04 Roof.

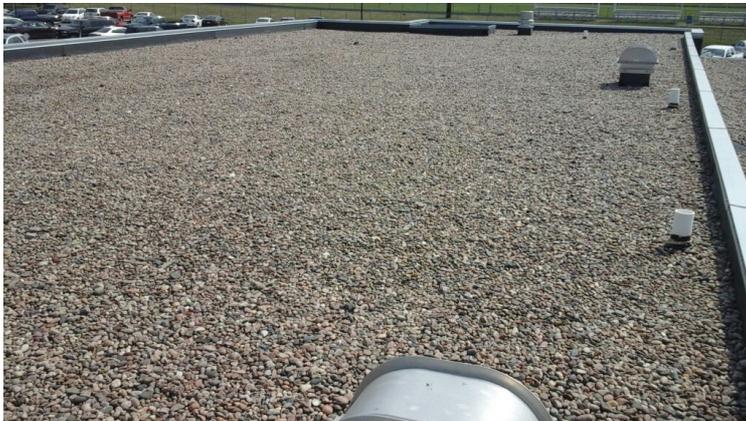
Photo showing additional overview of Area 04 Roof.

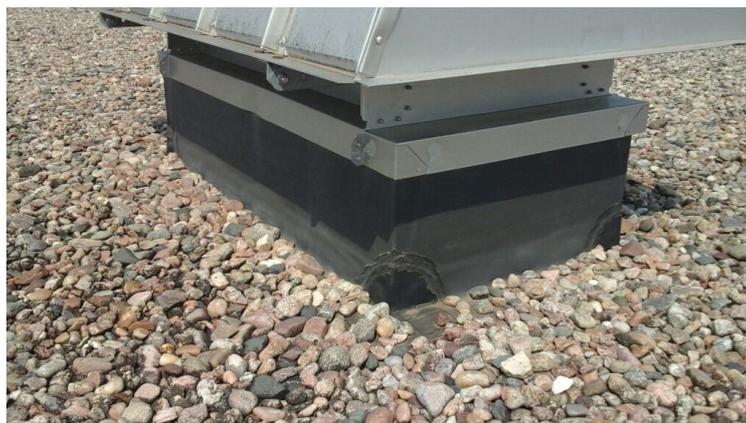
Photo showing condition of projection flashings.

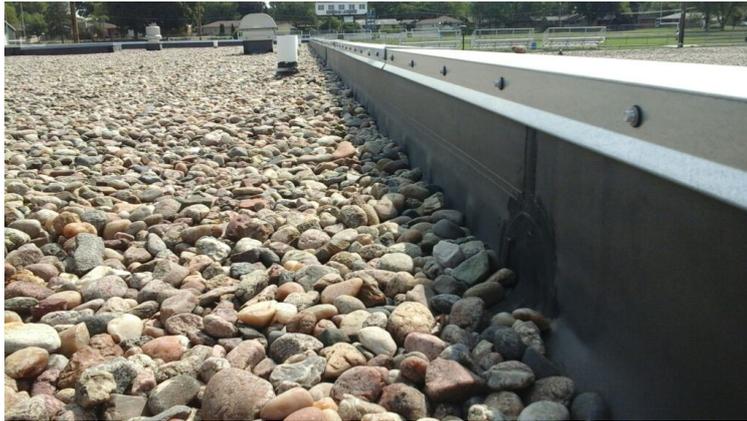
Photo showing condition of the perimeter flashings.
