Board of Education Study Session
Monday, June 12, 2023 5:30 PM

Seward Elementary

Condition Summary

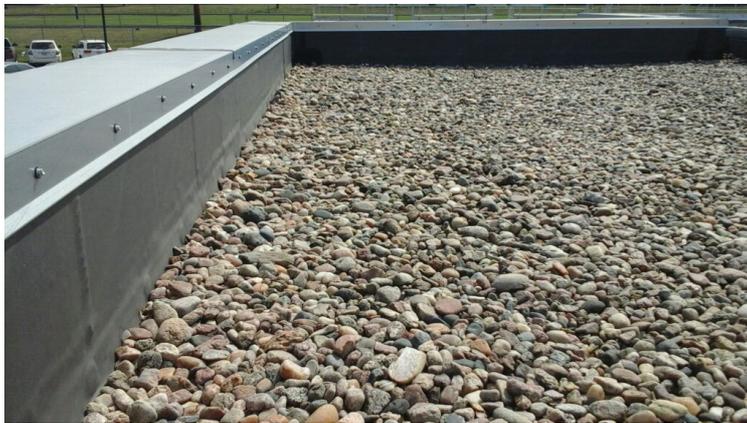
Photo showing condition of the perimeter flashings.

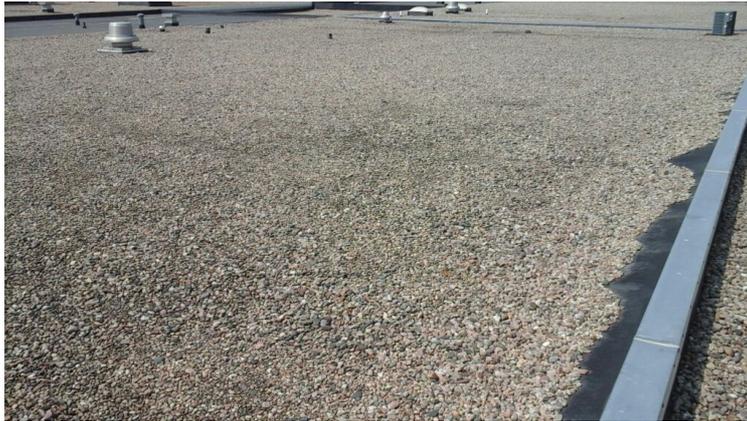
This roof is in fair condition and has deterioration around the projection and perimeter flashing seams due to age.

Photo showing overview of Area 05 Roof.

I recommend restoring the problem areas in the flashings and continued inspections and maintenance to extend the life of this roof. The estimated budget number for restoring this roof is \$30,000.

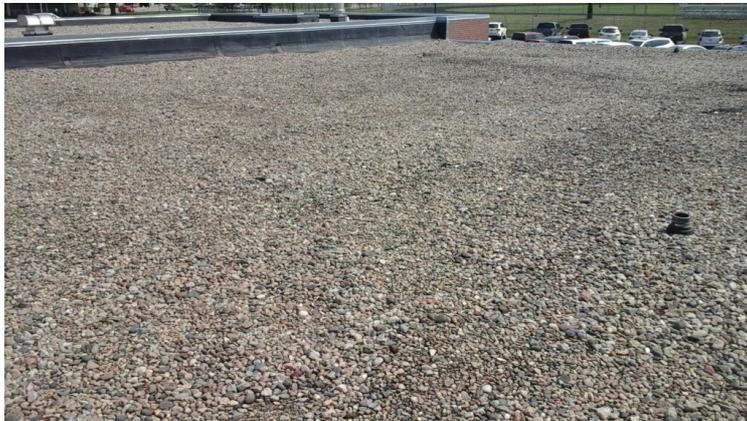
Photo showing additional overview of Area 05 Roof.

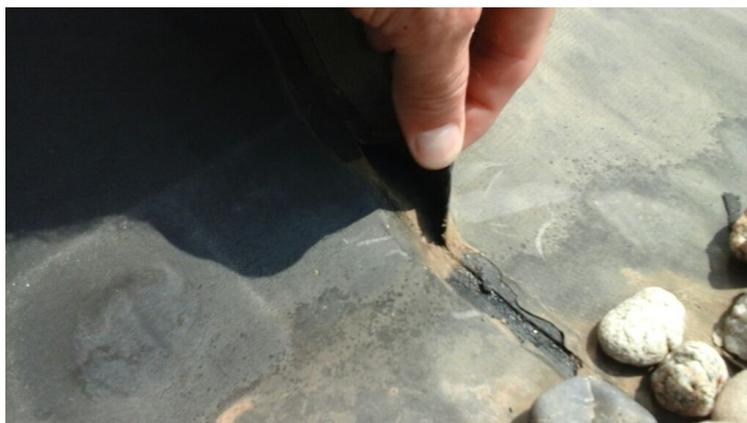
Photo showing additional blowout patch on perimeter pulling loose.

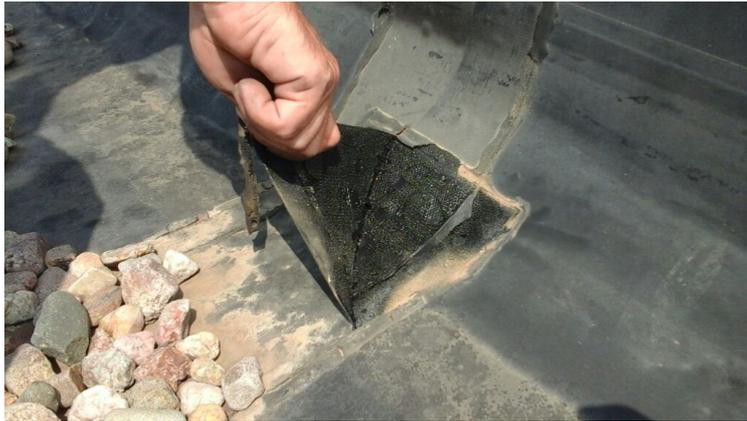
Photo showing a blowout patch on the perimeter flashing pulling loose.

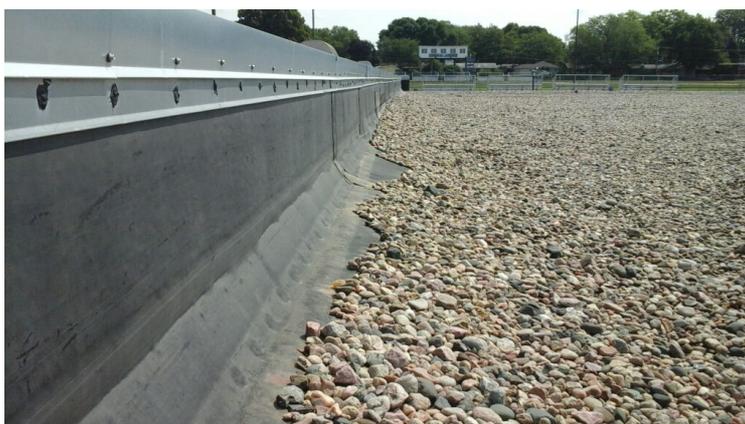
Photo showing condition of the perimeter flashings.

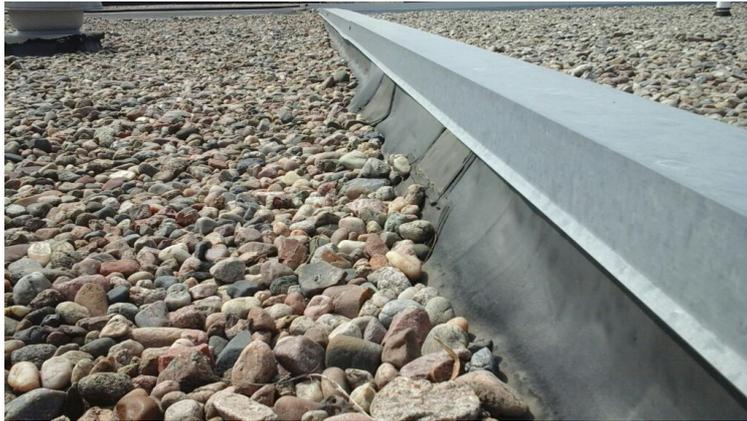
Photo showing tenting along the expansion joint.

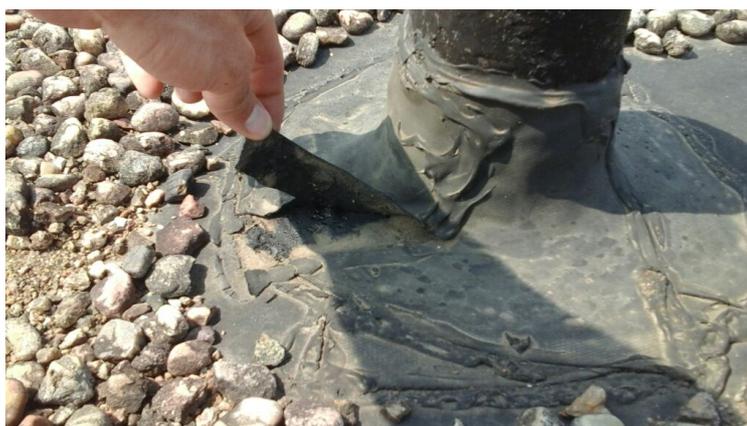
Photo showing flashing around soil stack beginning to pull loose.

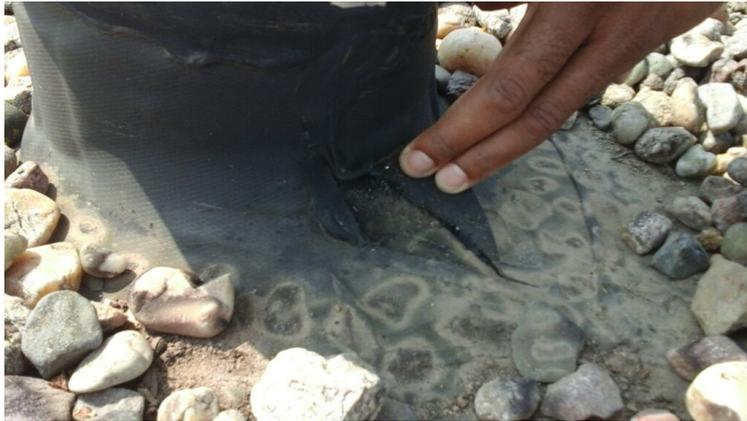
Photo showing flashing around projection that is pulling loose.

This roof is in fair condition but has several areas where blowout patches are beginning to pull loose. There was also a hole found in the perimeter flashing that was open down to deckin.

I recommend restoring the problem areas in the flashings and continued inspections and maintenance to extend the life of this roof. The estimated budget number for restoring this roof is \$30,000.

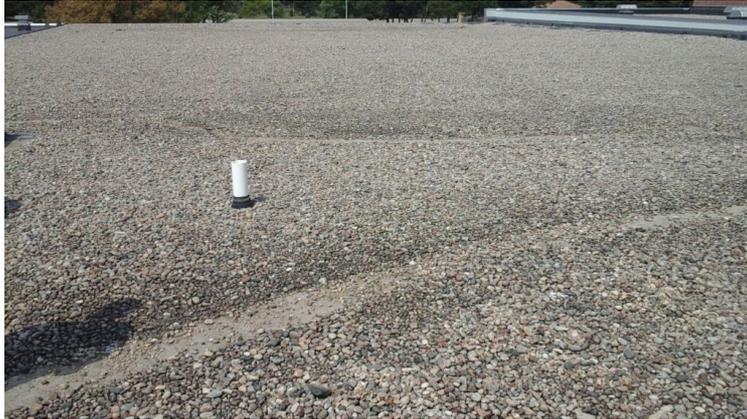
Photo showing overview of Area 06 Roof.

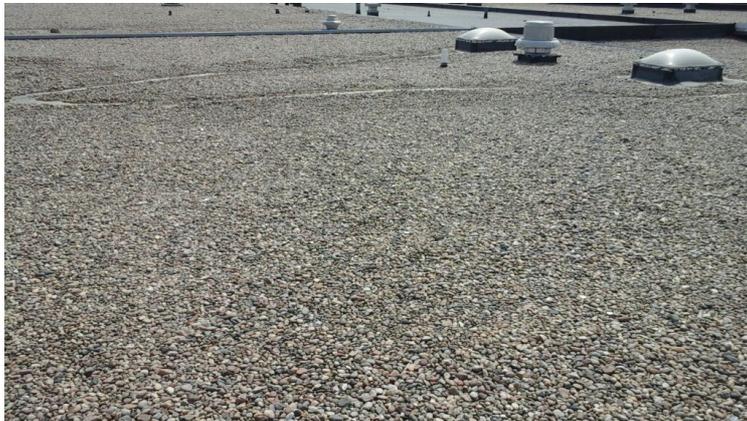
Photo showing additional overview of Area 06.

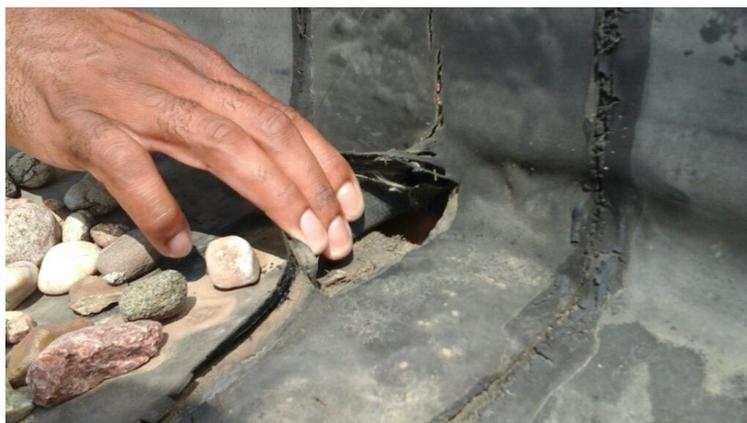
Photo showing a hole in the perimeter flashing. The decking is exposed and this is almost certainly a leak.

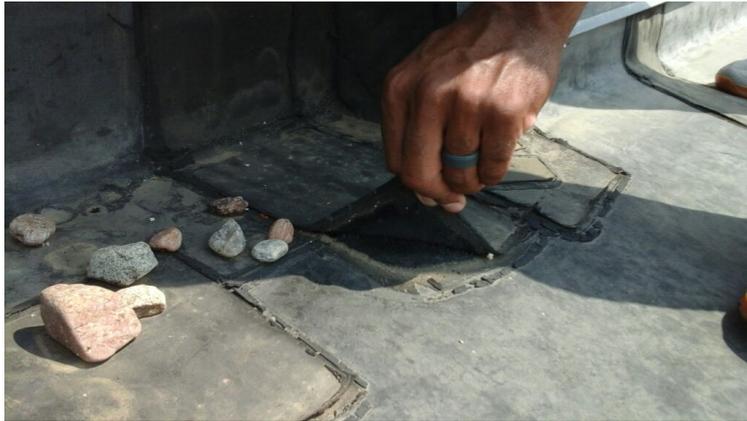
Photo showing a blowout patch in the perimeter flashing beginning to pull loose.

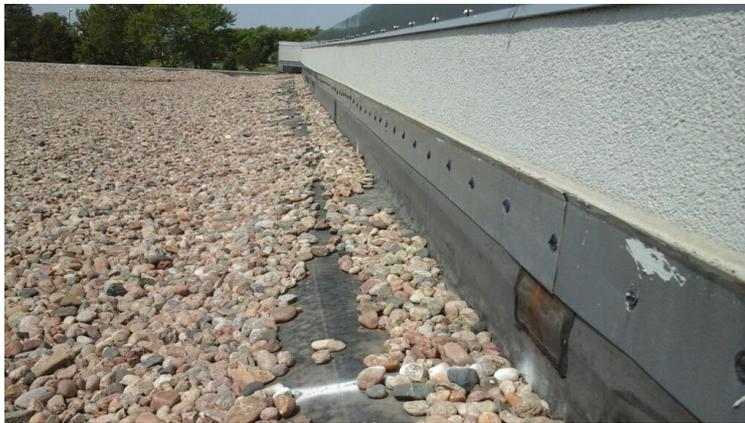
Photo showing condition of the perimeter flashings.

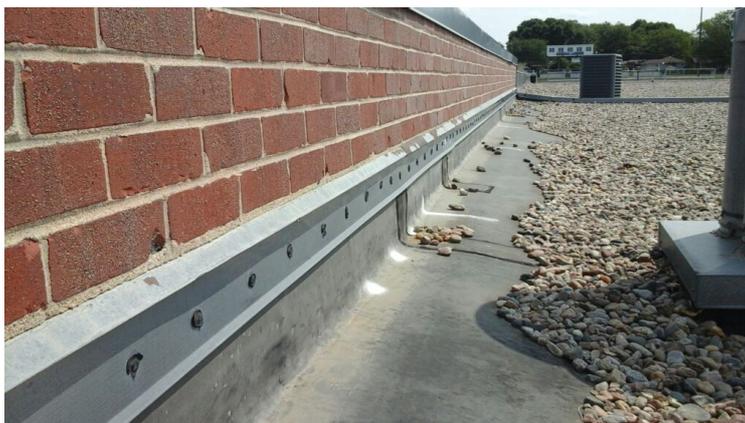
Photo showing condition of the perimeter flashings.

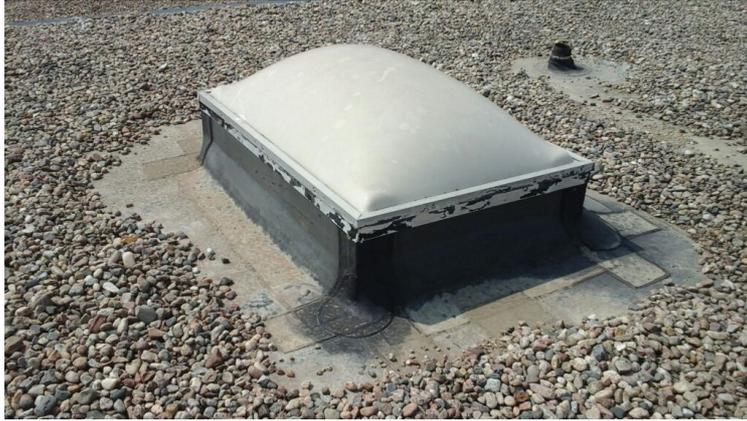
Photo showing condition of the skylights.

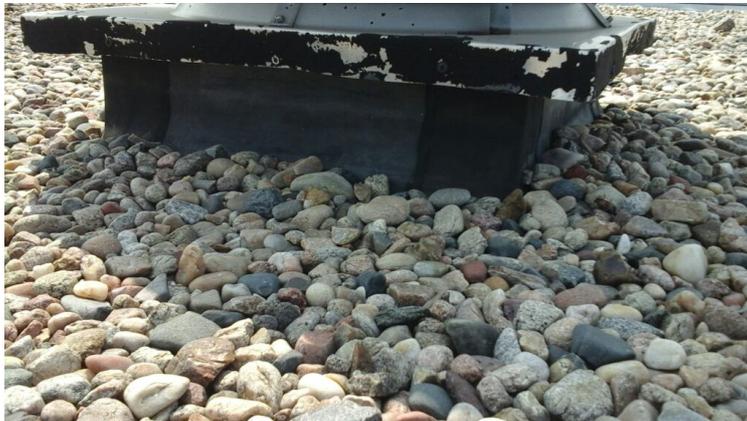
Photo showing condition of projection flashings.

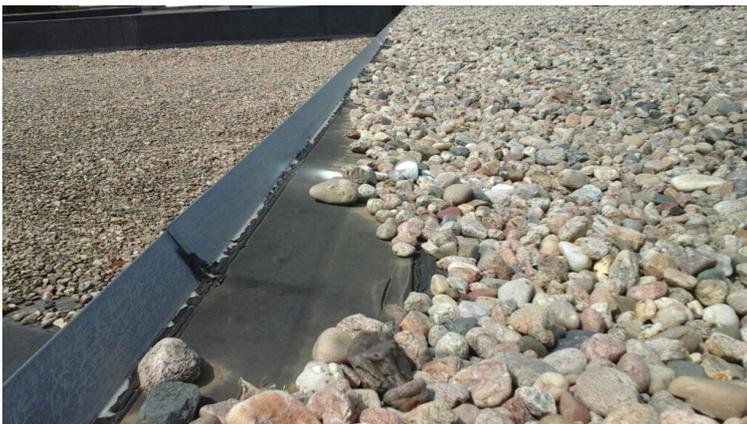
Photo showing condition of the form flashings.

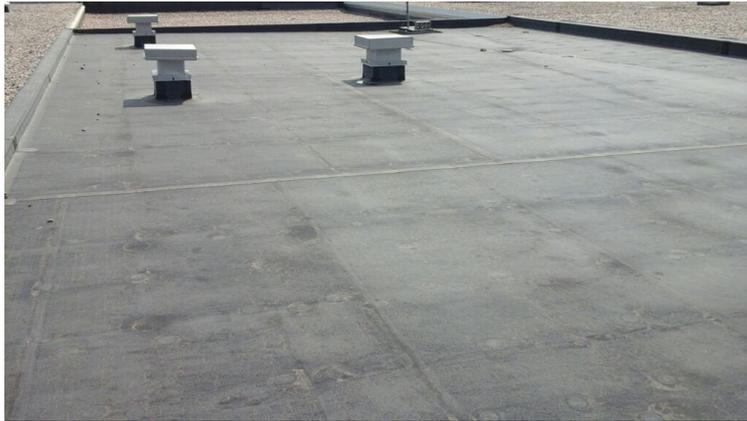
Photo showing overview of Area 07 Roof.

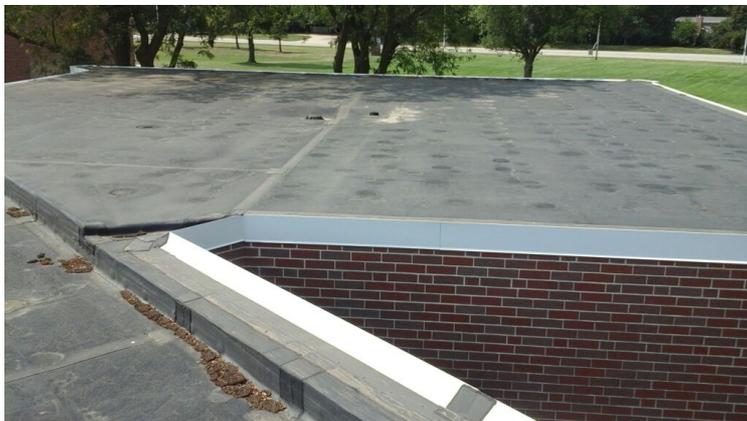
Photo showing additional overview of Area 07 Roof.

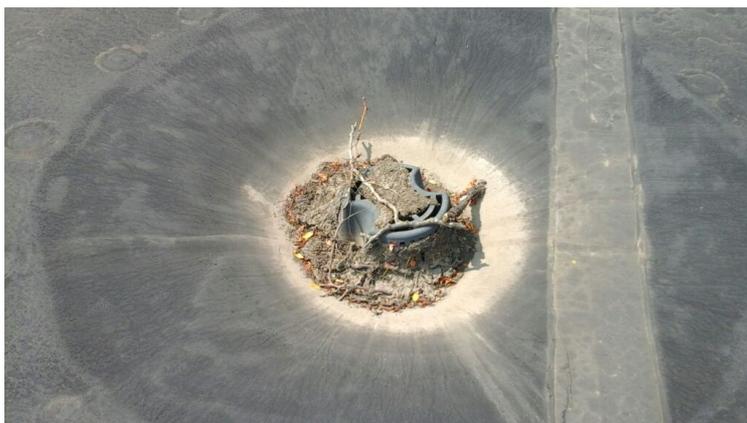
Photo showing clogged drain.

I recommend continued inspections and maintenance which would include clearing drains.

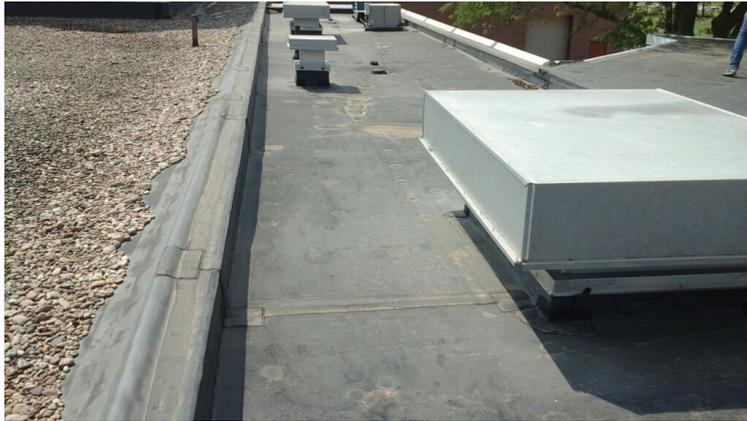
Photo showing additional overview of Area 07 Roof.

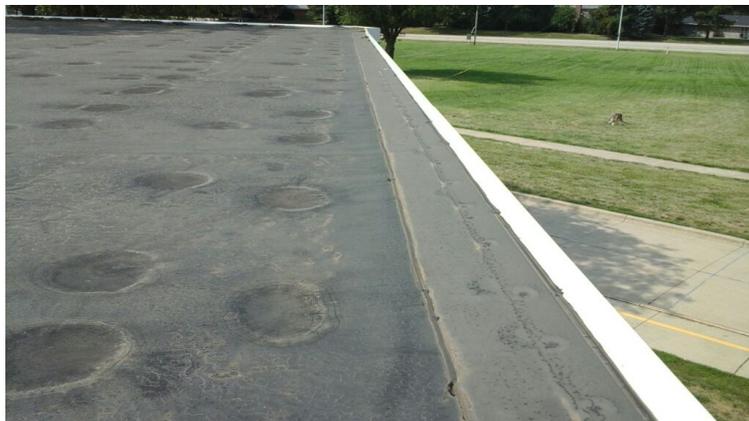
Photo showing condition of the form flashings.

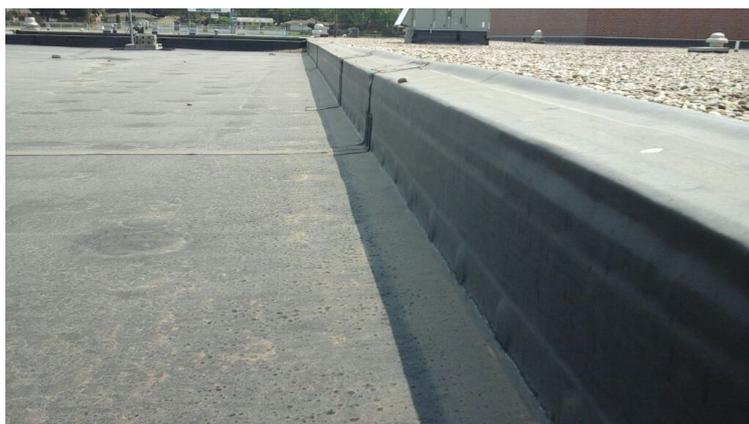
Photo showing condition of the perimeter flashings.

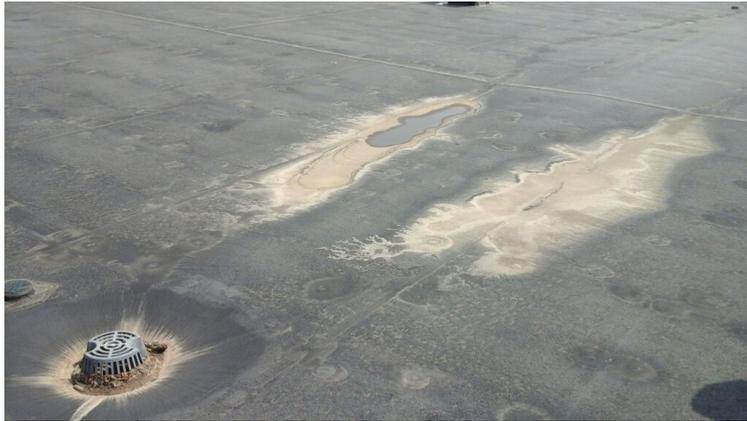
Photo showing evidence of ponding water in the drain valley.

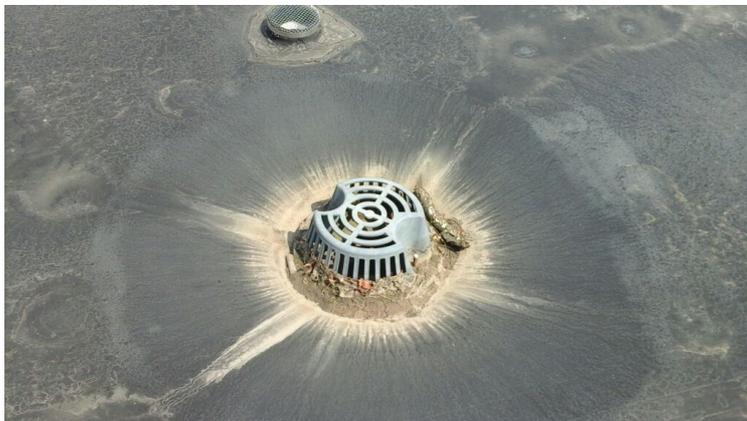
Photo showing additional clogged drain.

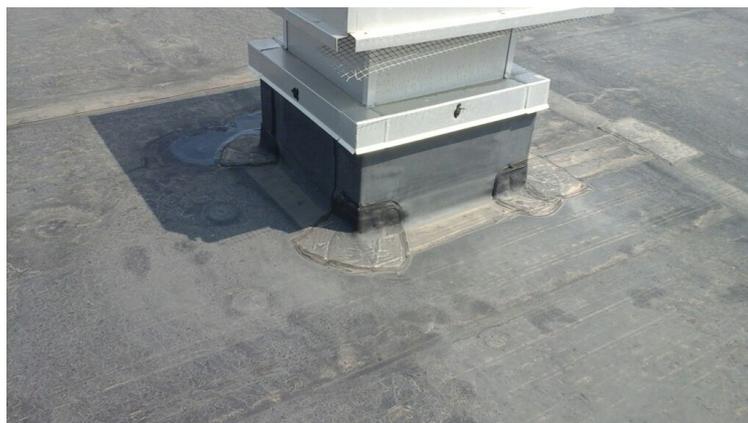
Photo showing condition of projection flashings.

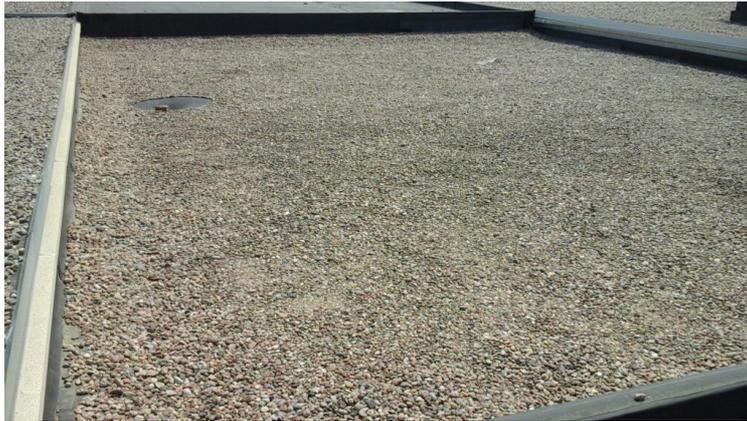
Photo showing overview of 08 Roof.

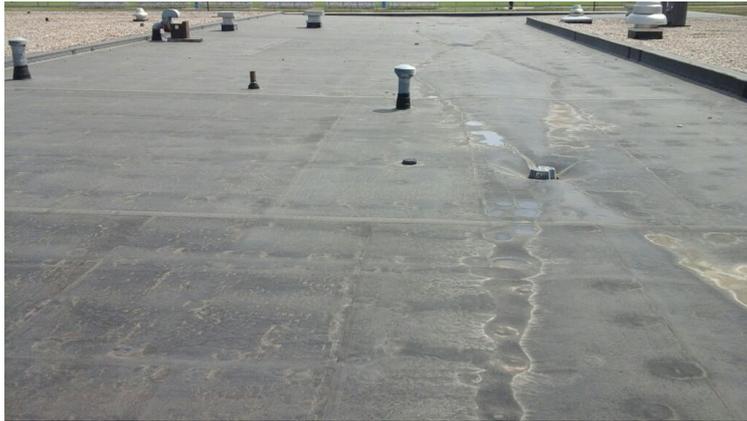
Photo showing overview of Area 09 Roof.

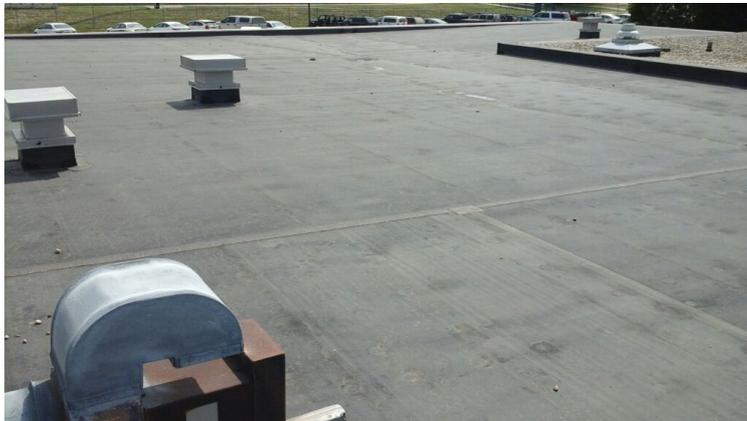
Photo showing additional overview of Area 09 Roof.

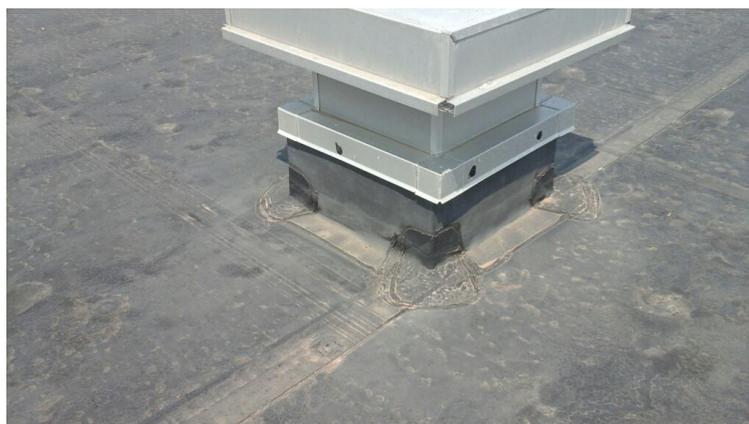
Photo showing condition of projection flashings.

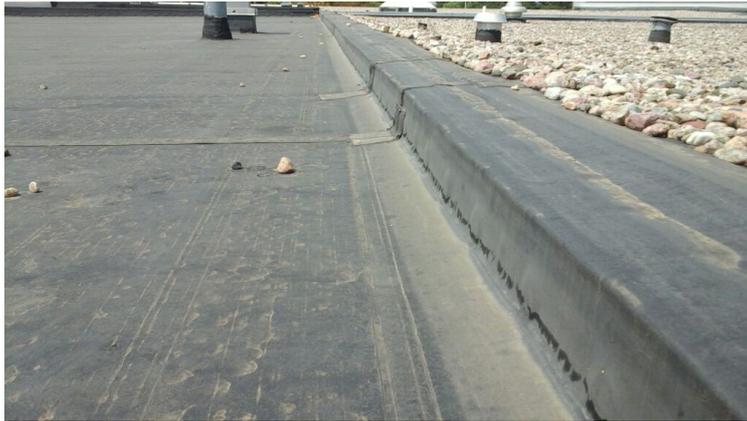
Photo showing condition of the perimeter flashings.

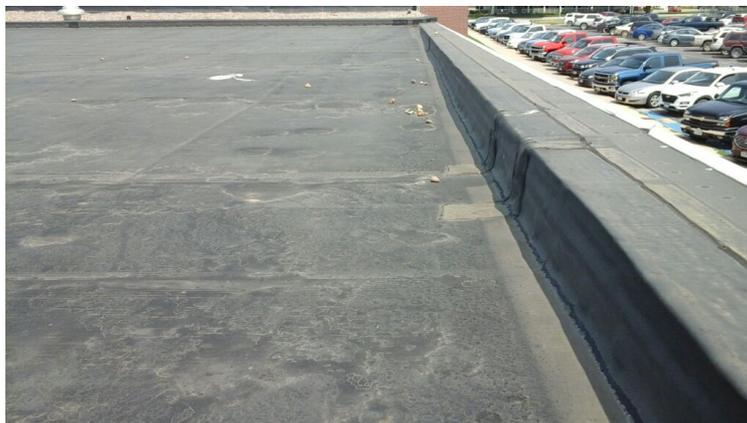
Photo showing condition of the form flashings.

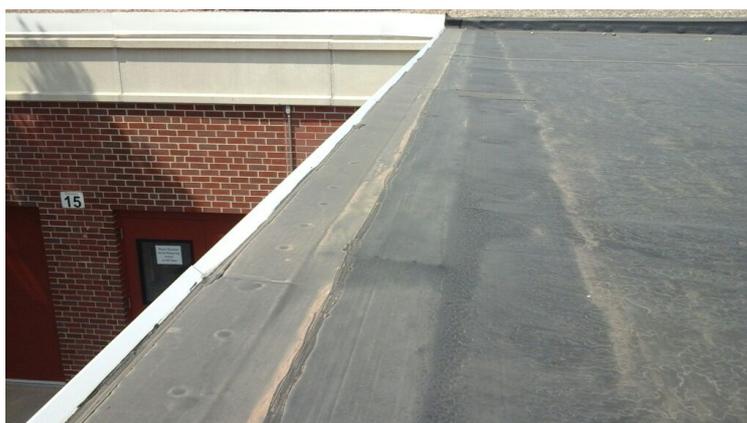
Photo showing condition of the form flashings.

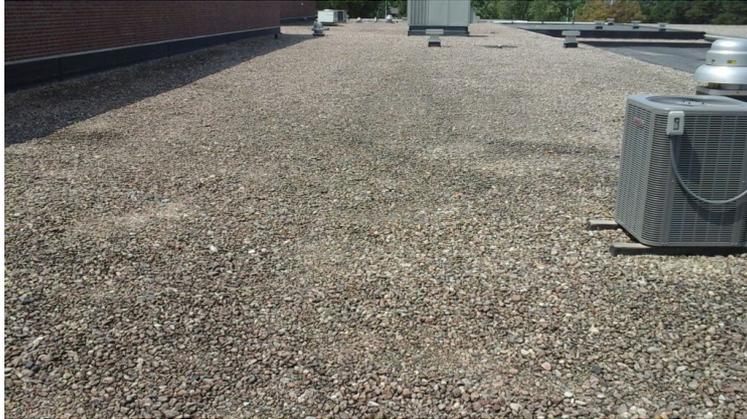
Photo showing overview of Area 10 Roof.

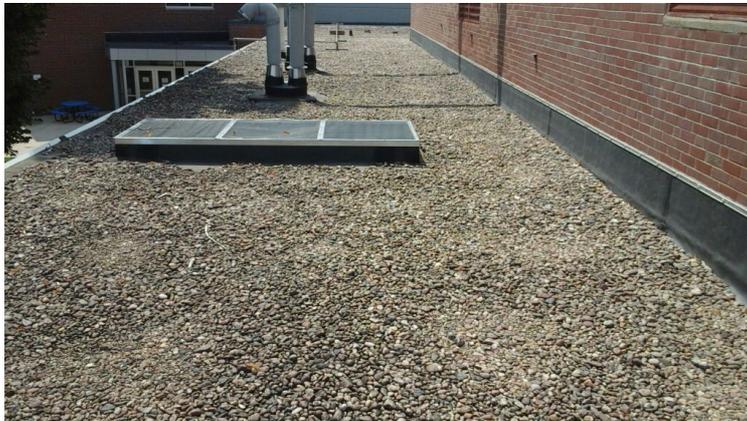
Photo showing additional overview of Area 10 Roof.

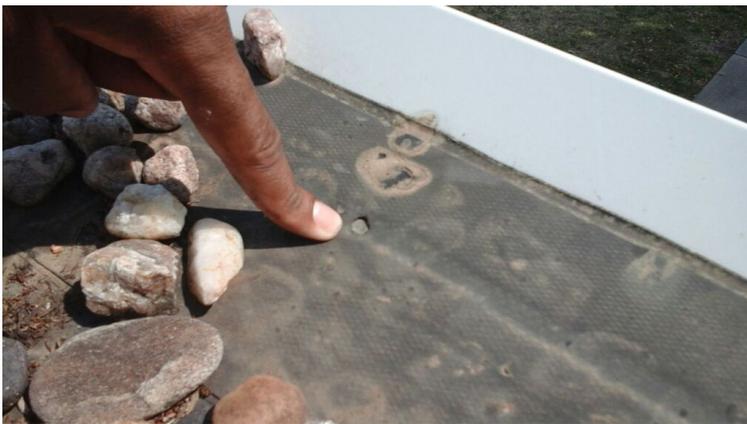
This roof is in poor condition. There are numerous holes in the projection flashings that need attention.

Photo showing an additional hole in the form flashings.

I recommend scheduling a restoration on the problem areas of this roof as budgets allow. I also recommend continued inspections and maintenance. The estimated budget number for restoring this roof is \$50,000.

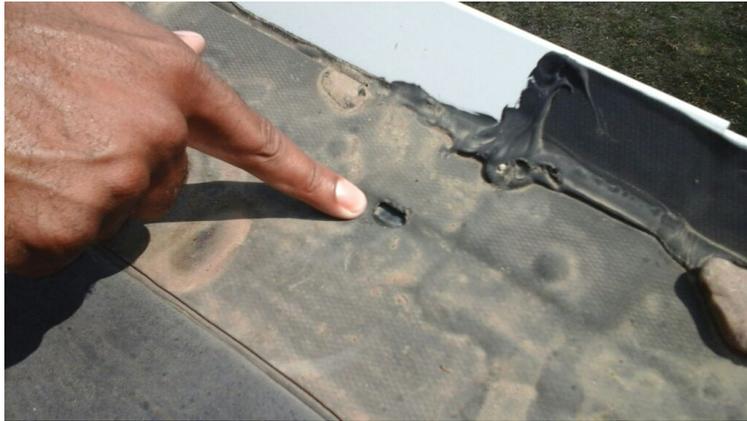
Photo showing a hole in the form flashings.

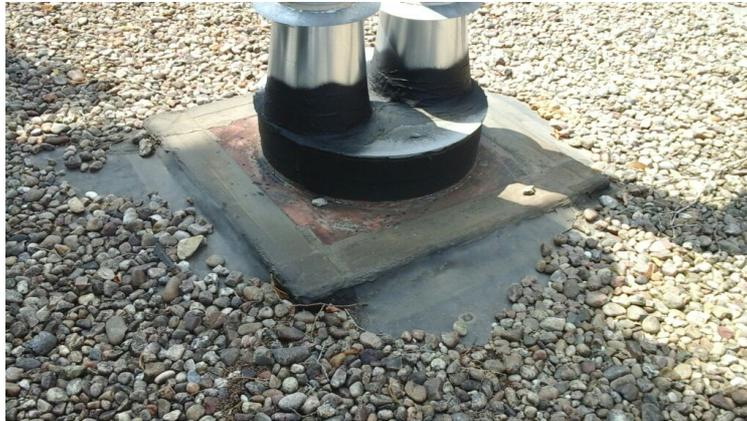
Photo showing condition of low projection flashings.

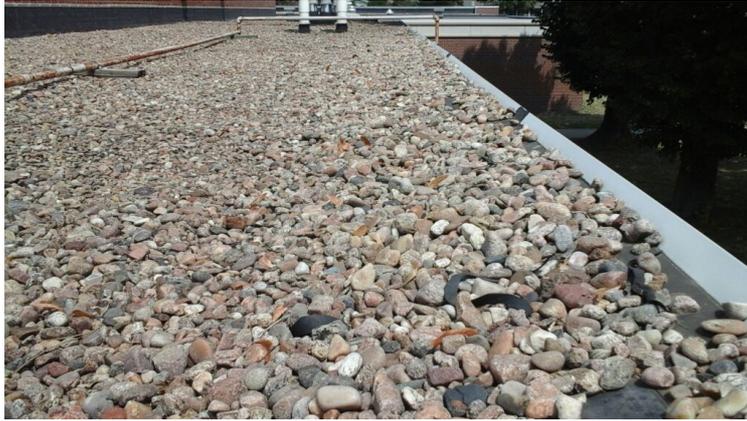
Photo showing condition of the form flashings.

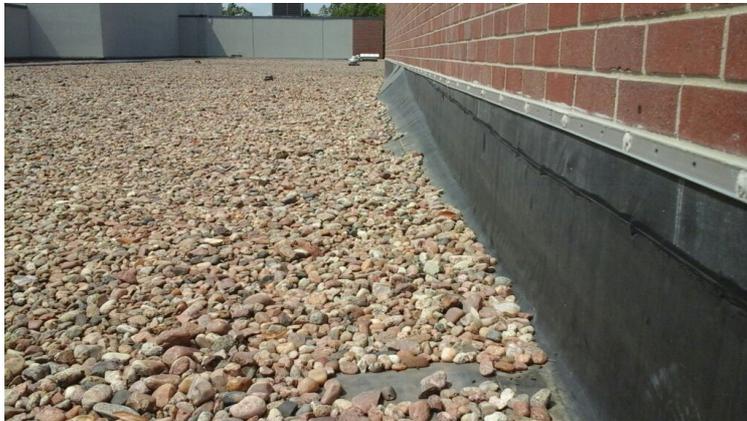
Photo showing tenting along the perimeter flashings.

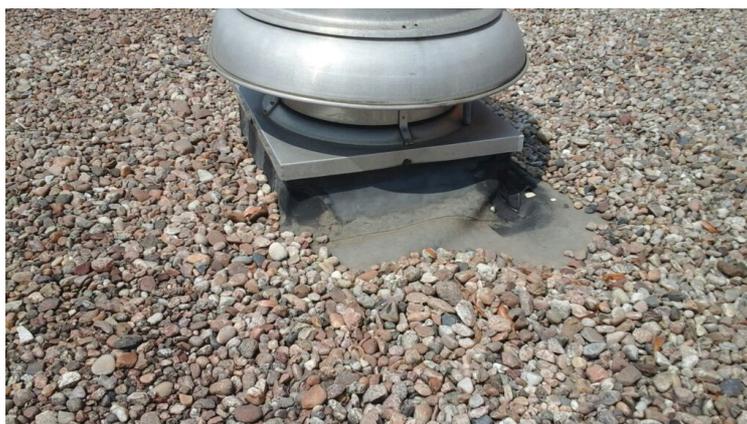
Photo showing tenting along the projection flashings.

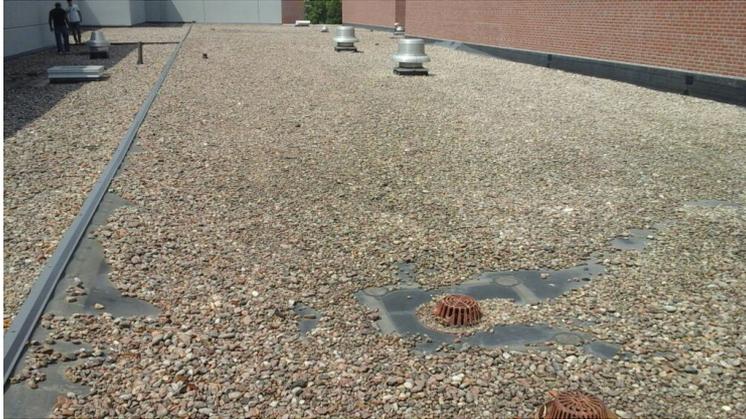
Photo showing additional overview of Area 10 Roof.

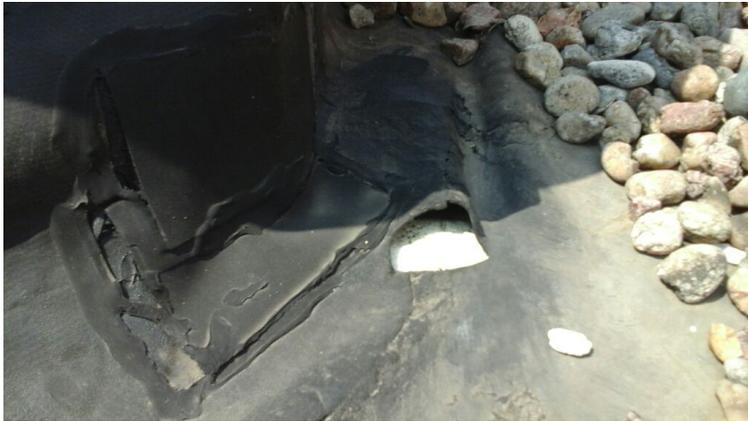
Photo showing a hole in the tenting projection flashings where EPS is exposed.

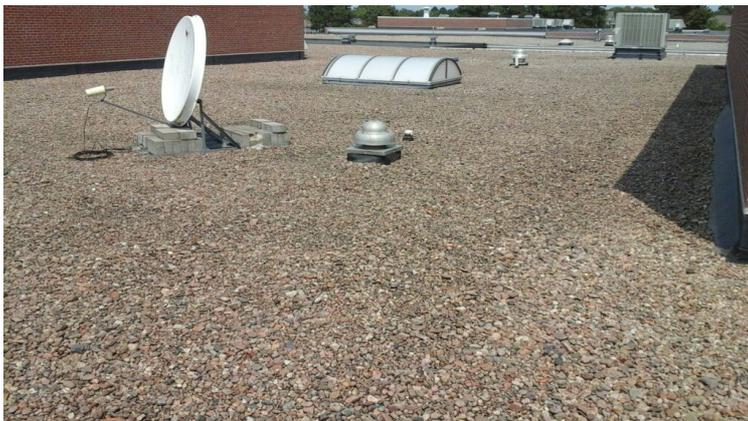
Photo showing additional overview of Area 10 Roof.

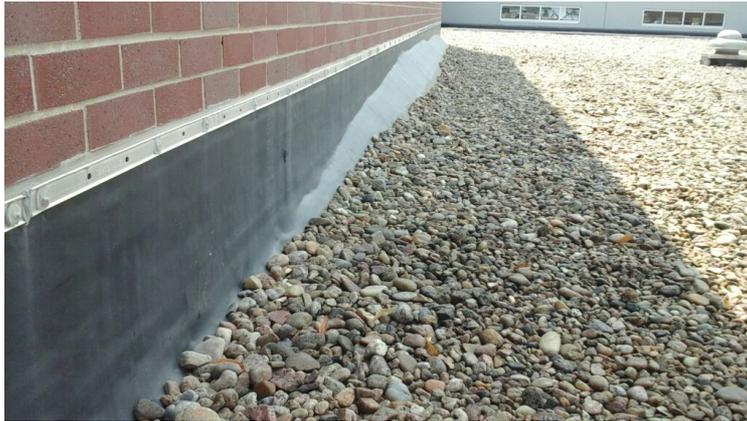
Photo showing tenting along the perimeter flashings.

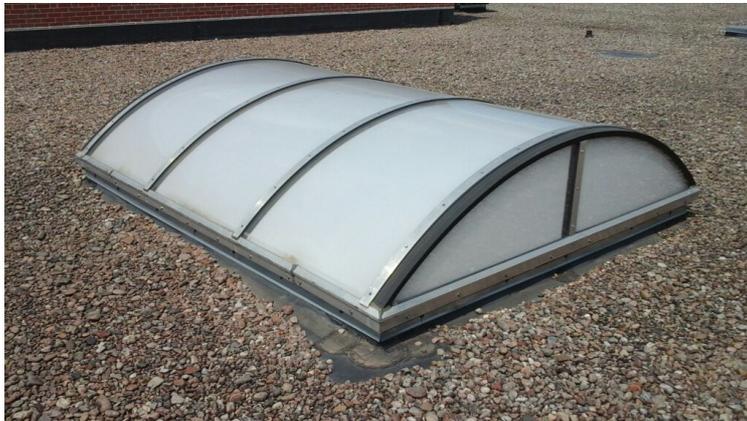
Photo showing condition of the skylight.

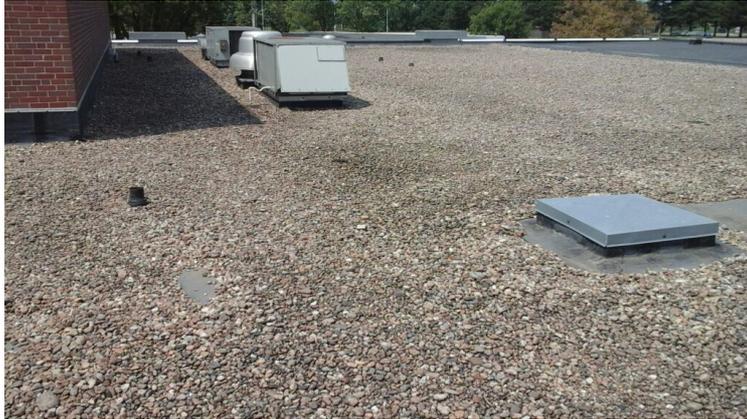
Photo showing additional overview of Area 10 Roof.

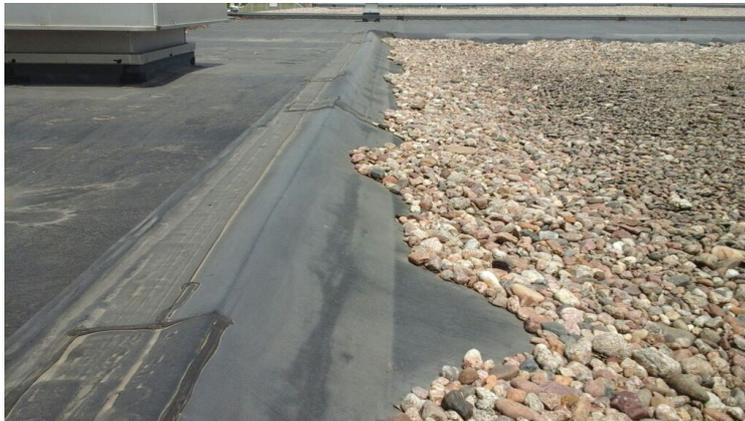
Photo showing condition of expansion joint.

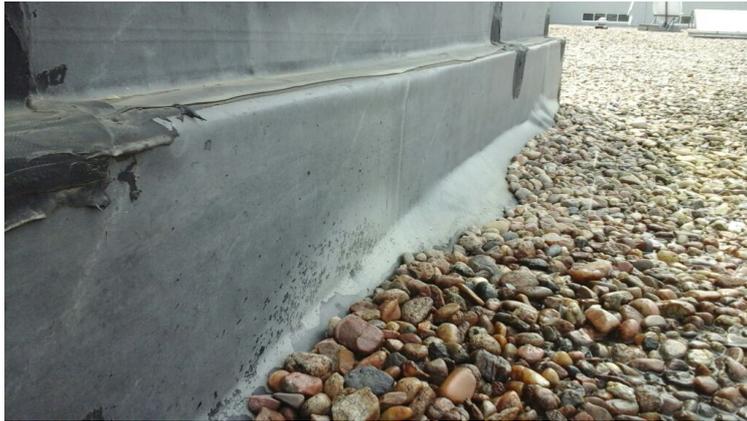
Photo showing tenting along the projection flashings.

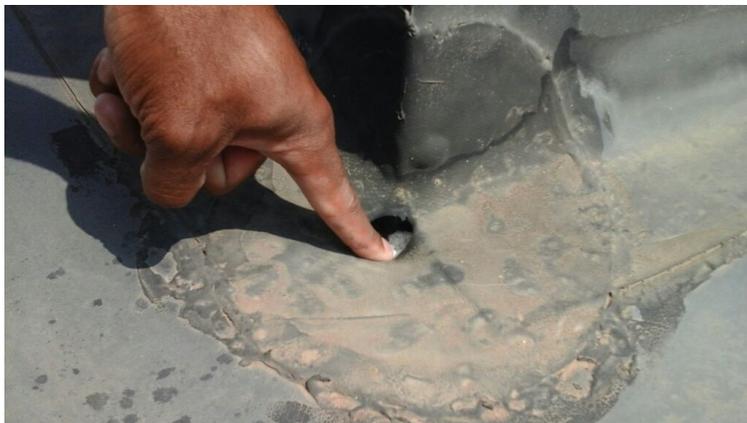
Photo showing a hole in the projection flashing where EPS is exposed.

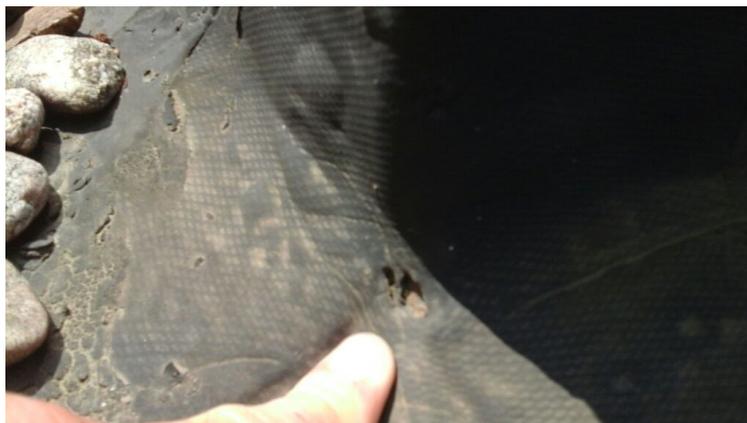
Photo showing a hole in the projection flashing.

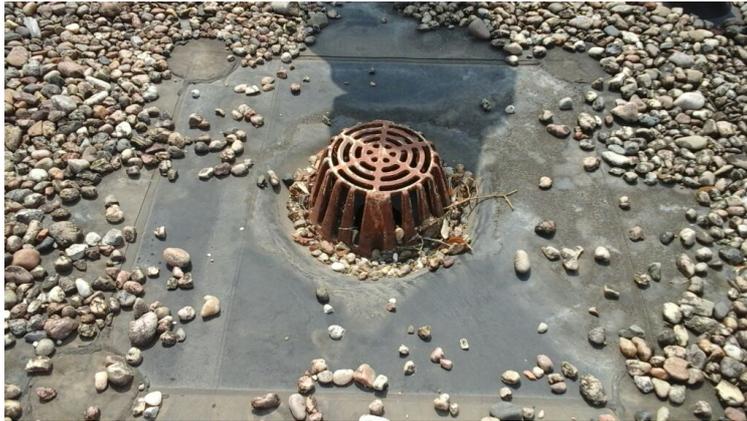
Photo showing a slightly clogged drain.

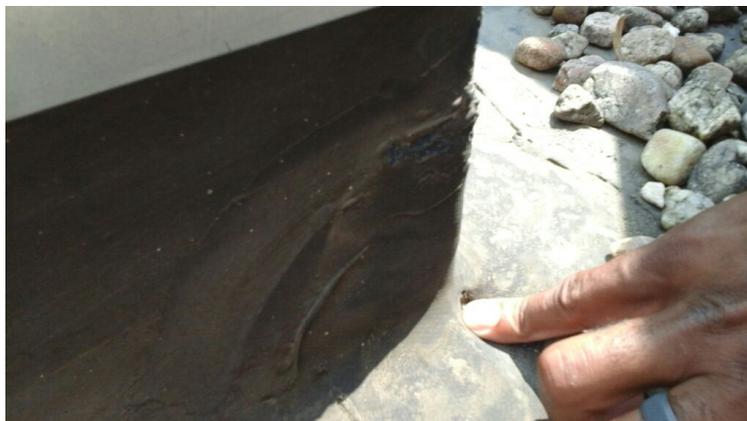
Photo showing another hole in a projection flashing.

This roof is in fair condition and appears to be performing well. There may be future issues along the perimeter flashing along the EIFS that should be monitored. There was a hole found in the corner of the perimeter flashings.

I recommend continued inspections and maintenance.

For future budgeting considerations the estimated restoration cost on this roof is \$15,000. The estimated replacement cost of this roof is \$65,000.

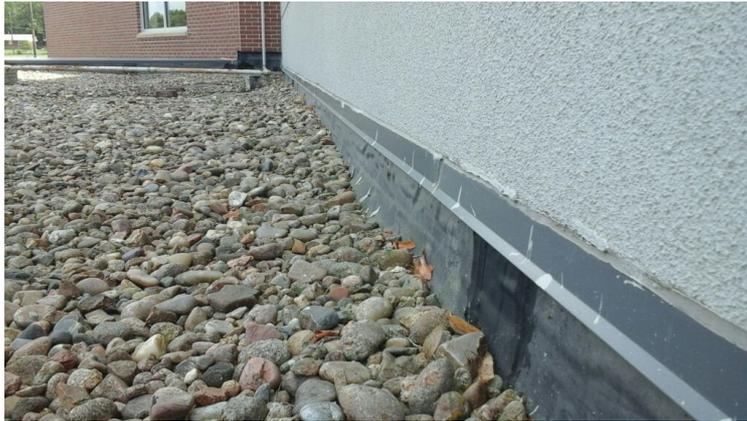
Photo showing condition of the perimeter flashings along the EIFS wall.

I recommend continued inspections and maintenance monitoring the counter flashing along the EIFS wall.

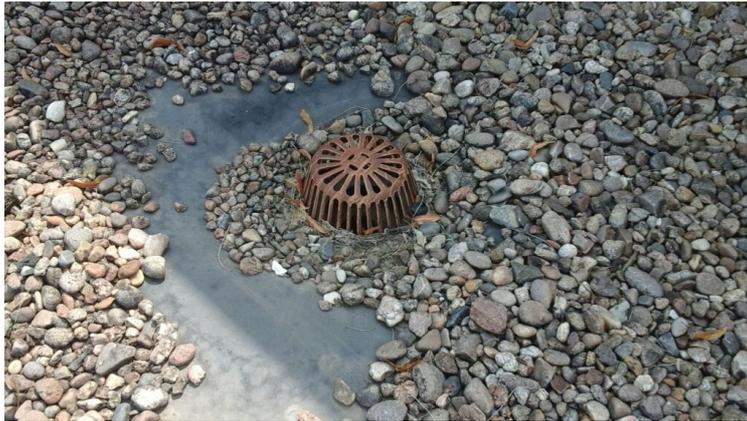
Photo showing clogged drain.

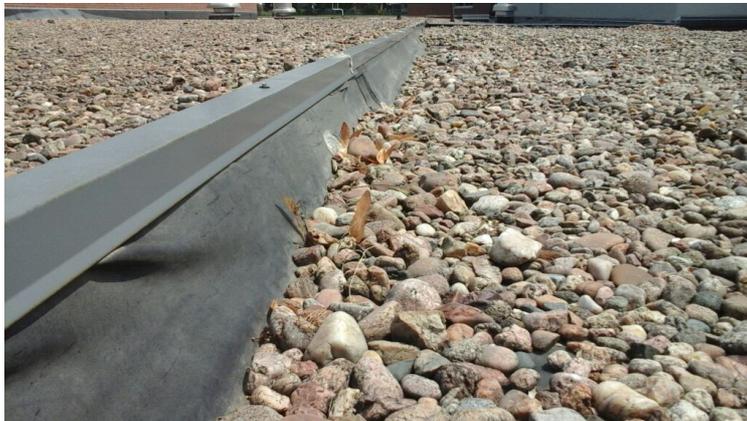
Photo showing minor tenting along the interior perimeter flashings.

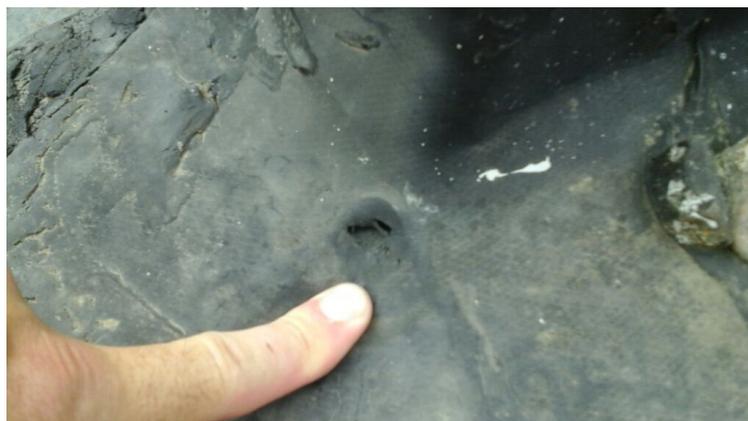
Photo showing a hole in the projection flashing.

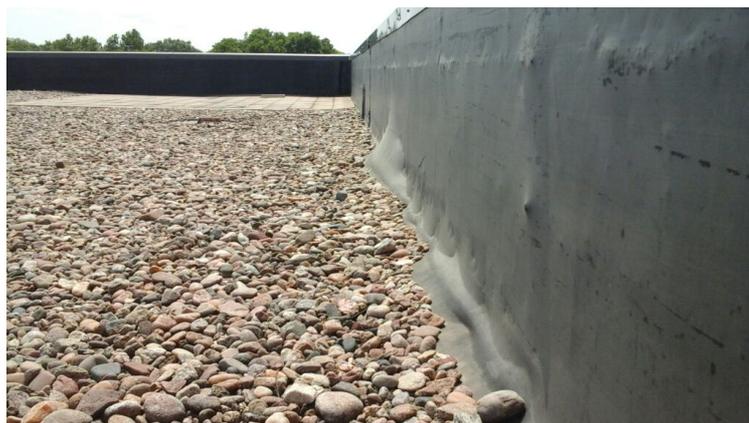
Photo showing minor tenting along the perimeter flashings.

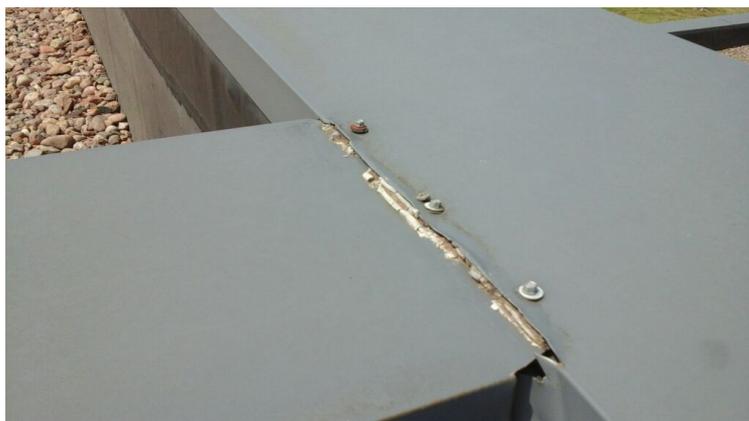
Photo showing caulking beginning to deteriorate on metal.

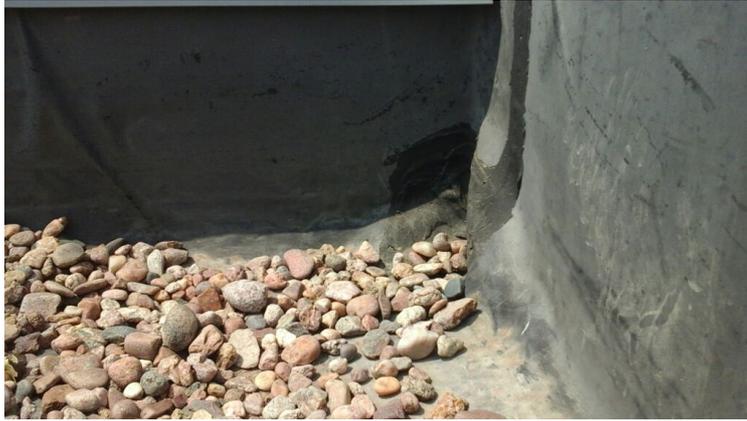
Photo showing tenting occurring in the corner of the perimeter flashings.

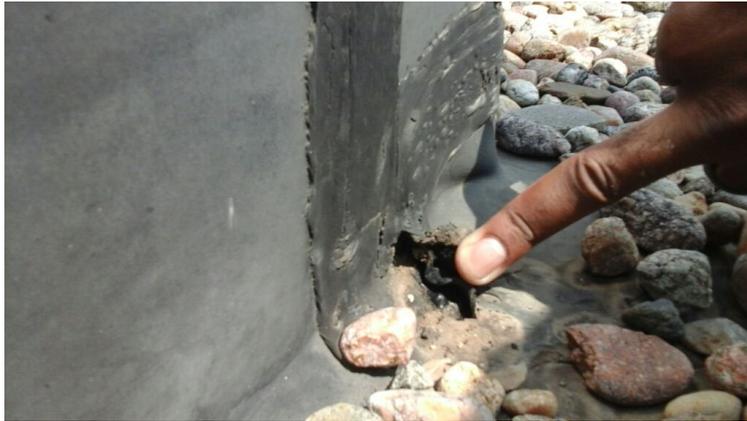
Photo showing projection flashings beginning to pull loose.

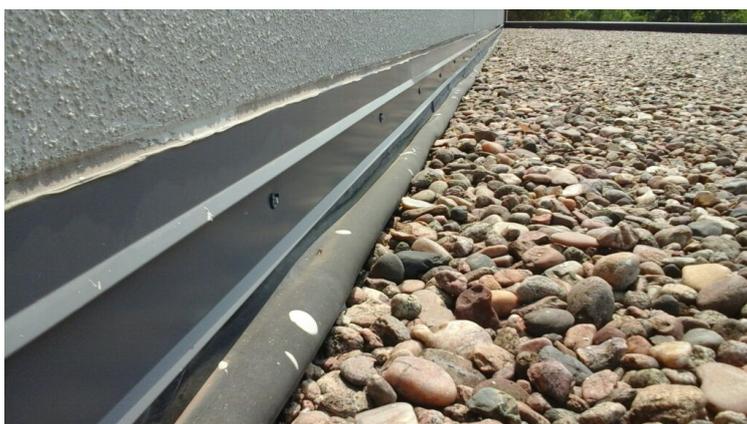
Photo showing condition of the perimeter flashings along the EIFS wall.

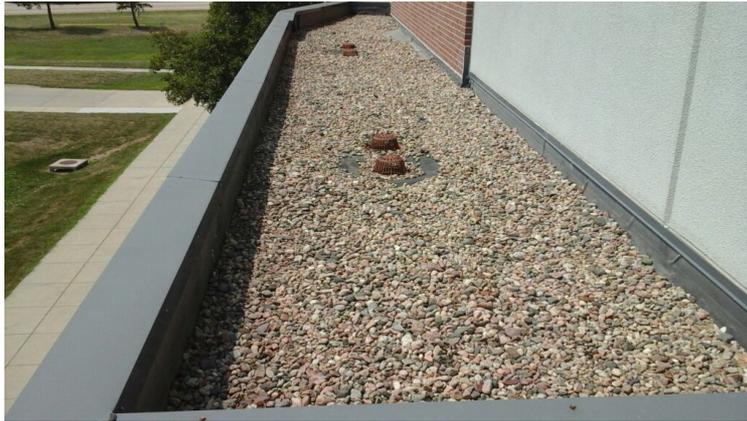
Photo showing overview of Area 18 Roof.

This roof is in good condition and appears to be performing well.

I recommend continued inspections and maintenance.

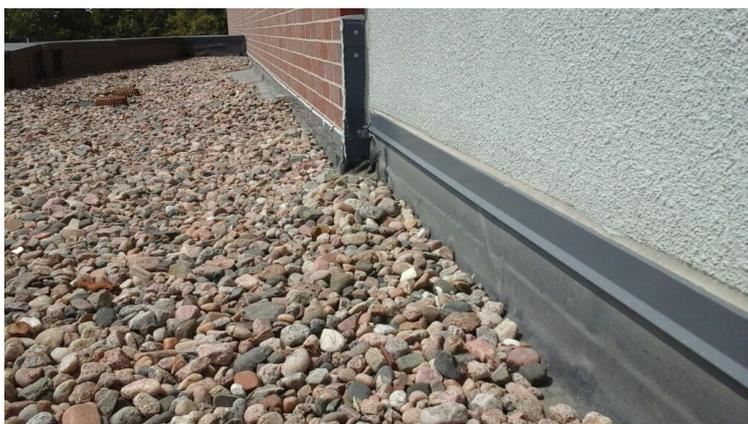
Photo showing condition of the perimeter flashings along the EIFS wall.

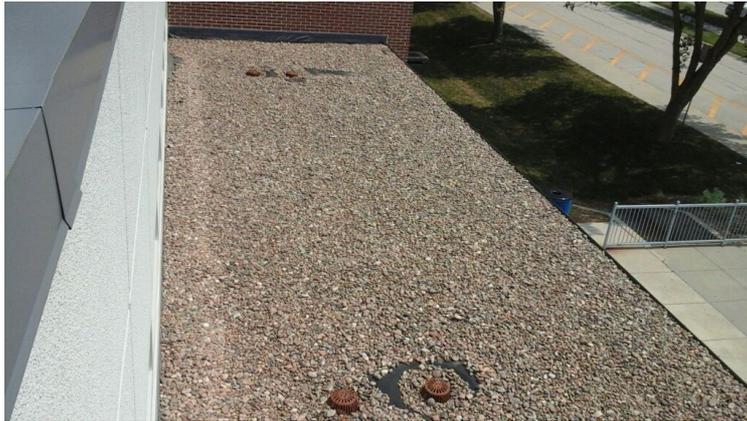
Photo showing overview of Area 19 Roof.

This roof is in good condition and appears to be performing well.

I recommend continued inspections and maintenance.

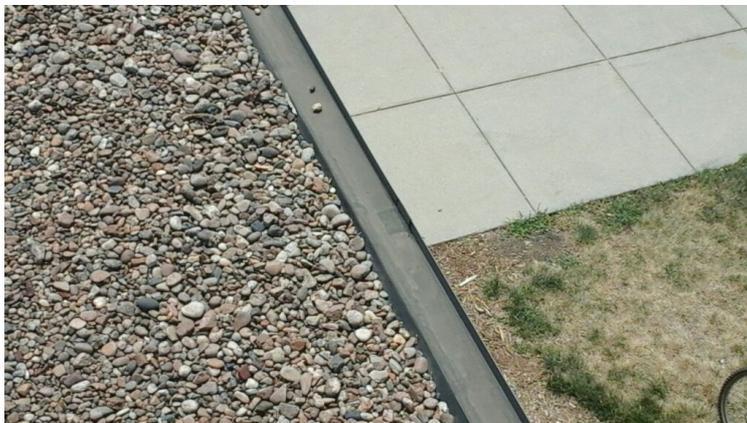
Photo showing condition of the form flashings.

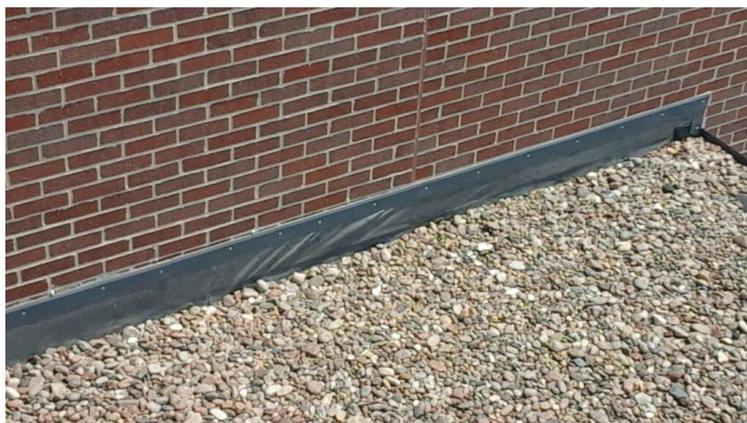
Photo showing condition of the perimeter flashings.
