Board of Education Study Session
Monday, June 12, 2023 5:30 PM

Seward Elementary

Condition Summary

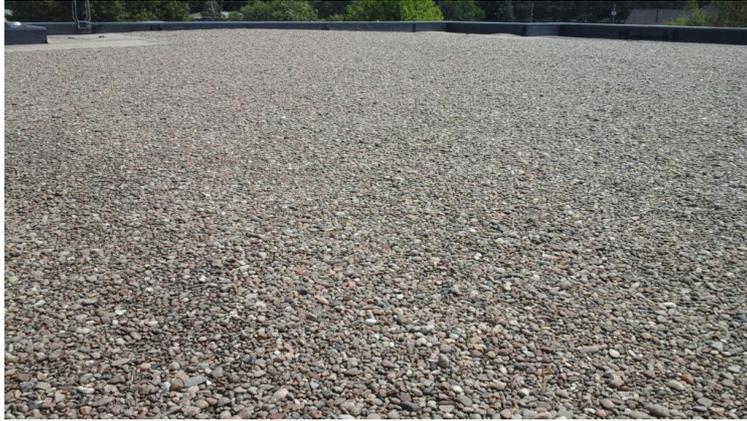
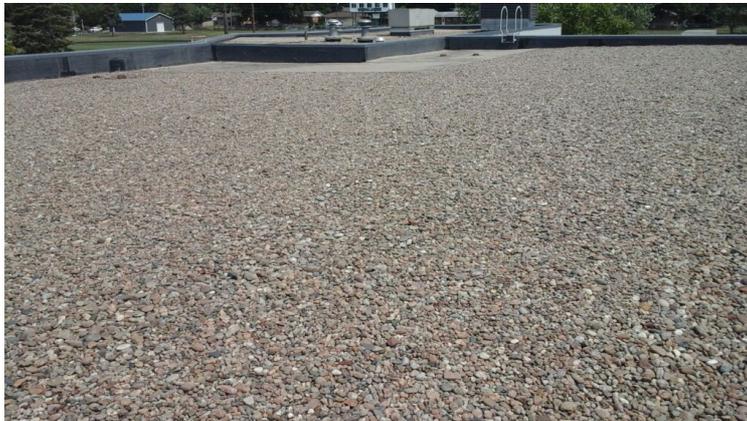
Photo showing overview of Area 20 Roof.

Photo showing additional overview of Area 20 Roof.

This roof is in good condition and appears to be performing well.

I recommend continued inspections and maintenance.

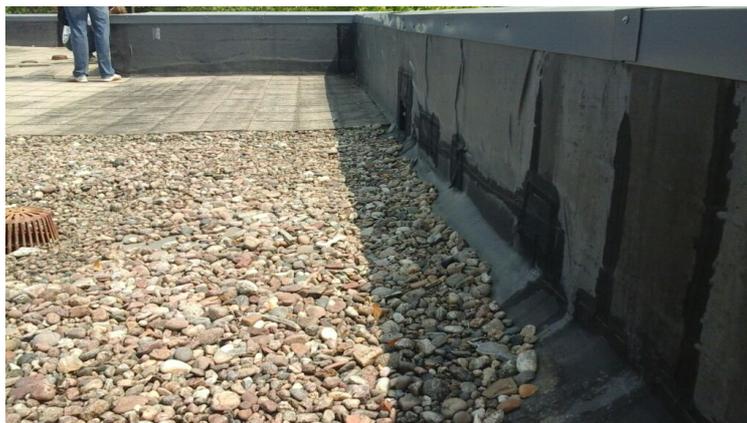
Photo showing condition of the perimeter flashings.

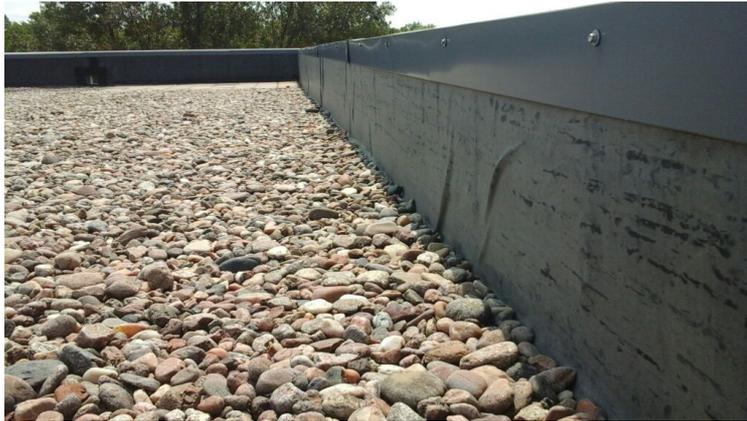
Photo showing condition of the perimeter flashings.

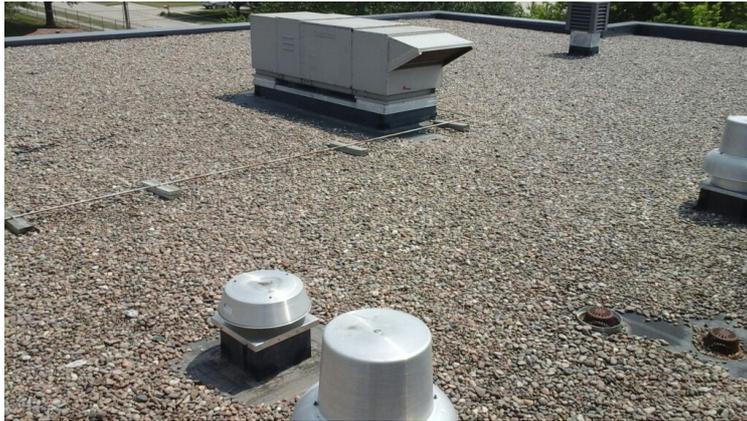
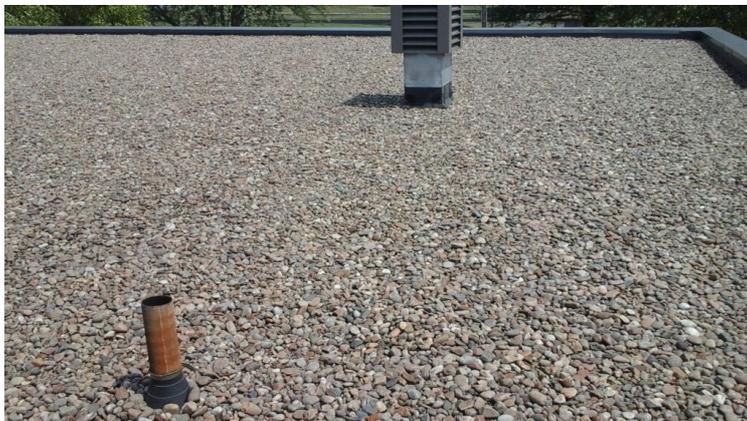
Photo showing overview of Area 21 Roof.

Photo showing additional overview of Area 21 Roof.

This roof is in good condition and appears to be performing well. There was one hole found in the projection flashing.

I recommend continued inspections and maintenance.

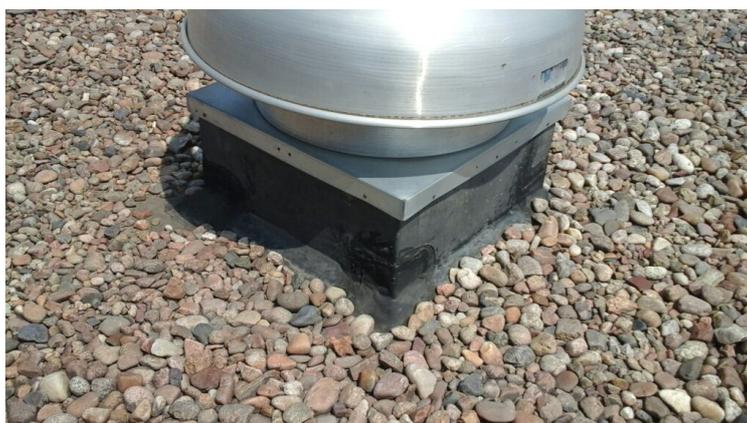
Photo showing condition of projection flashings.

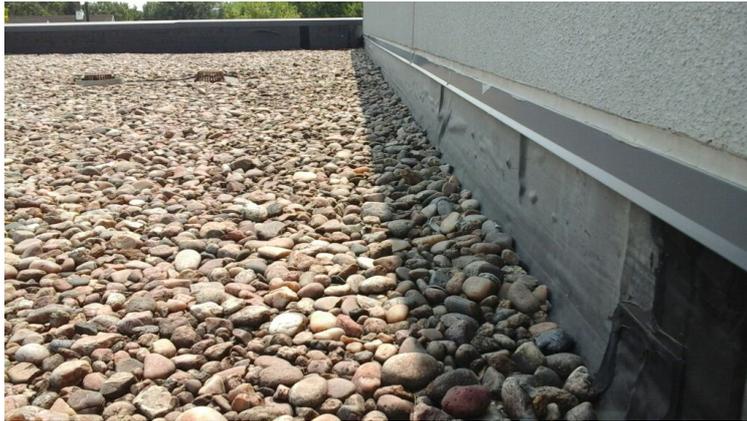
Photo showing condition of the perimeter flashings along the EIFS wall.

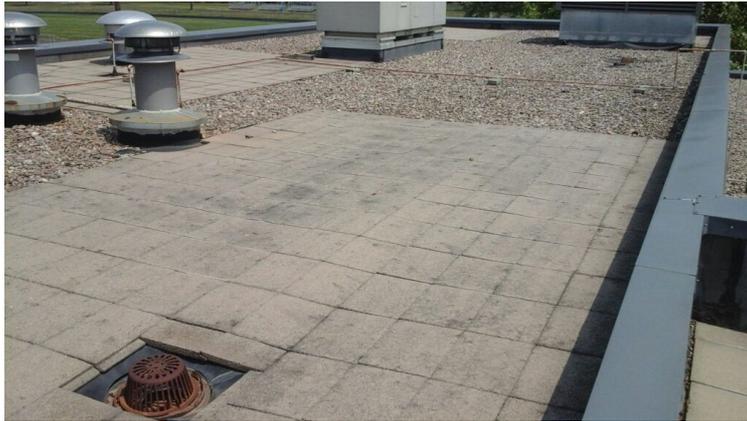
Photo showing overview of Area 22 roof.

This roof is in good condition and appears to be performing well.

I recommend continued inspections and maintenance.

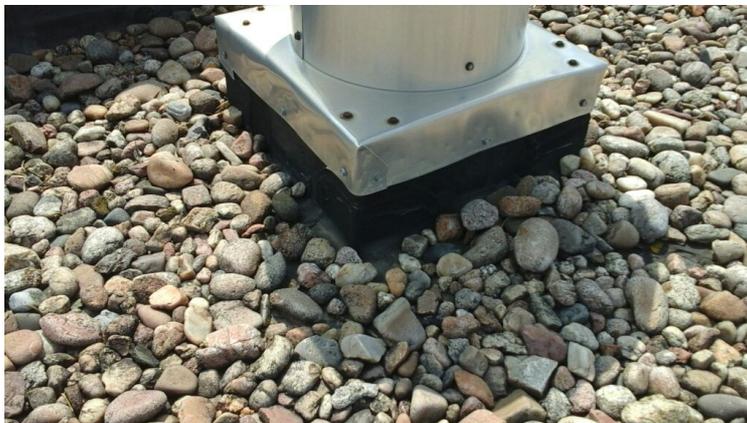
Photo showing condition of projection flashings.

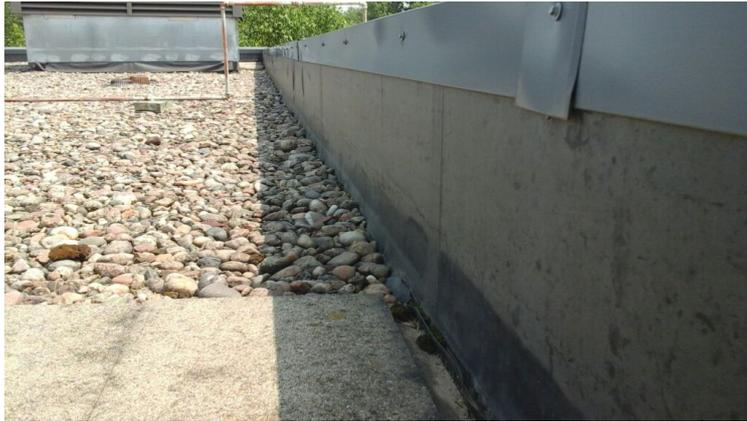
Photo showing condition of the perimeter flashings.

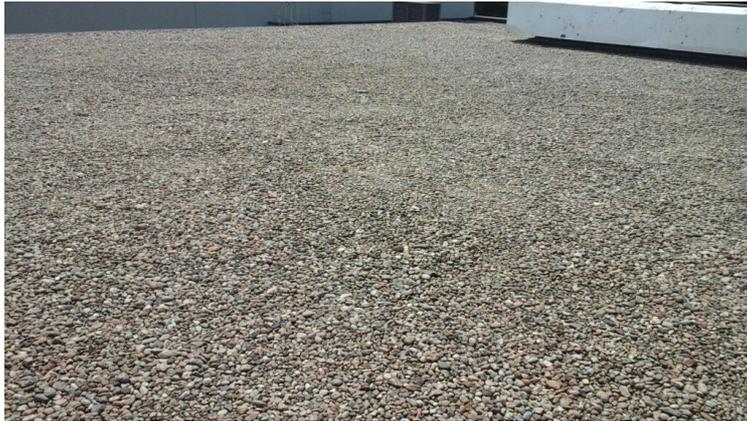
Photo showing overview of Area 23 Roof.

This roof is in fair condition and is beginning to tent and deteriorate along the perimeter flashings.

I recommend restoring the perimeter flashings along with continued inspections and maintenance.

For future budget considerations the estimated cost for restoring this roof is \$16,500. The estimated cost for replacing this roof is \$92,000.

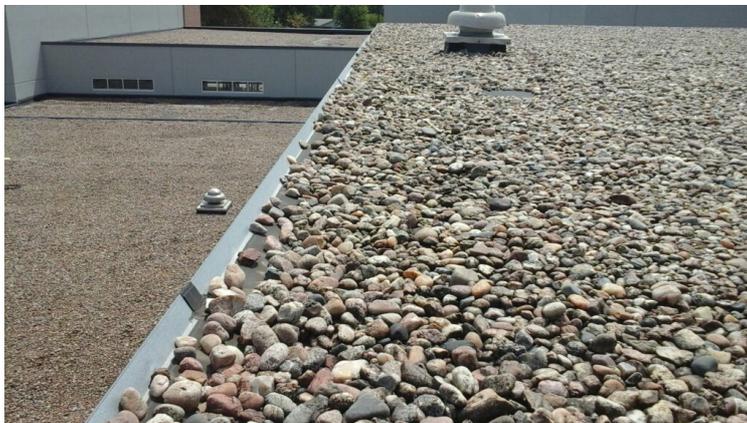
Photo showing condition of the form flashings.

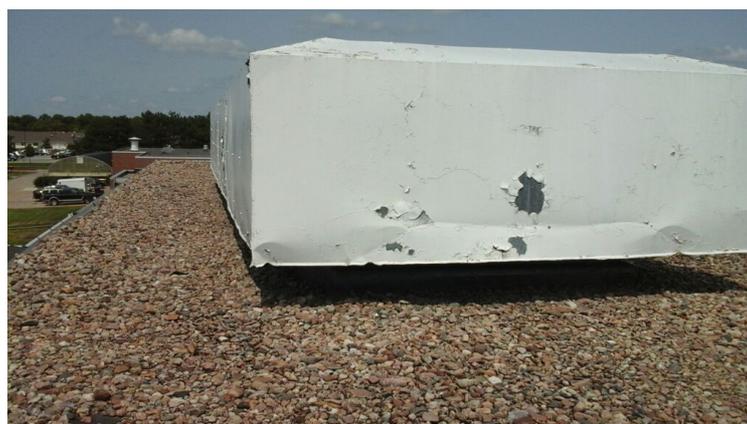
Photo showing condition of projection.

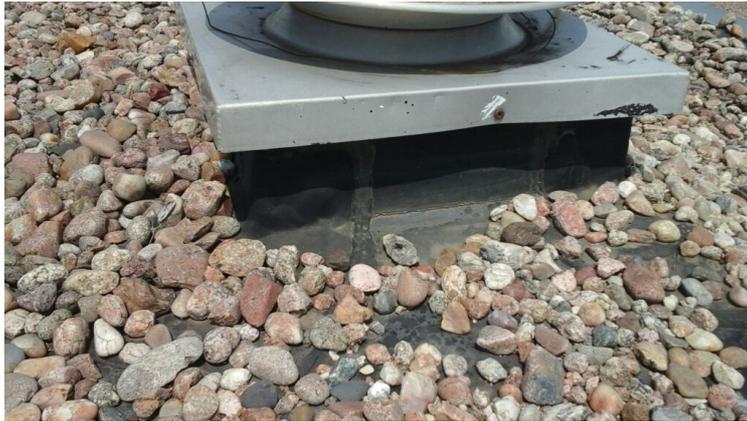
Photo showing condition of projection flashings.

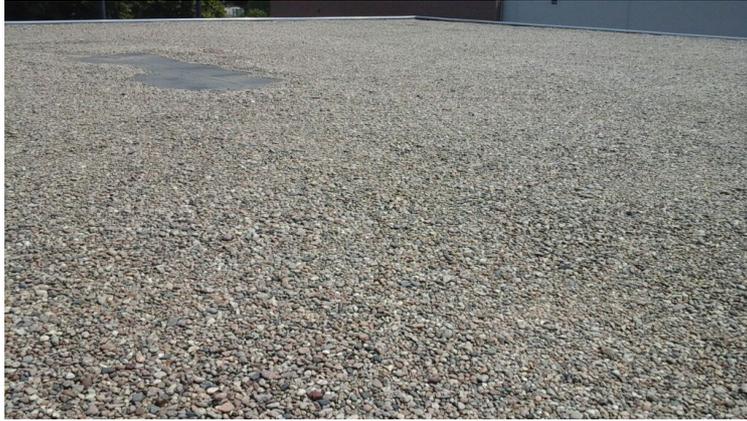
Photo showing overview of Area 24 roof.

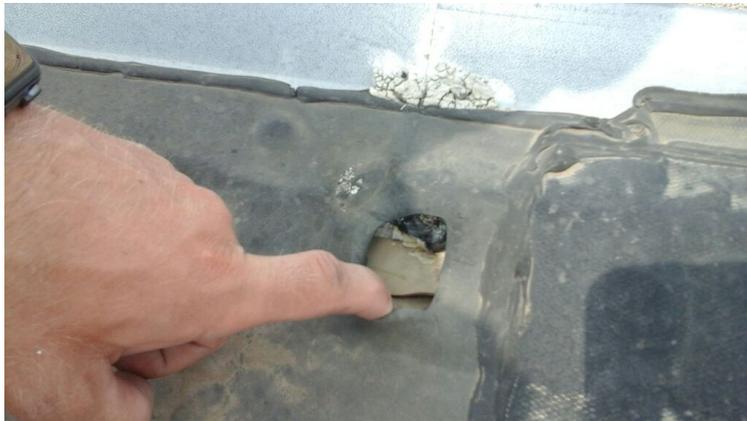
Photo showing a hole in the form flashings exposing interior.

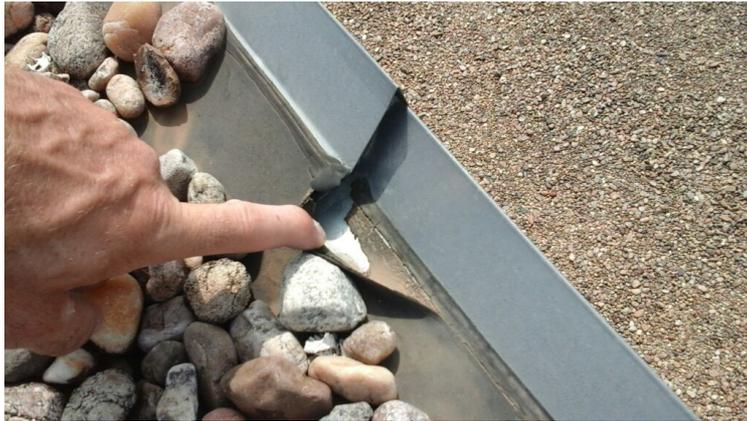
Photo showing form flashings opening up due to metal displacement.
